ENGINEERING AND INFRASTRUCTURE STANDING COMMITTEE  
MEETING OF  
**ISAAC REGIONAL COUNCIL**

TO BE HELD ON  
**WEDNESDAY, 12 MAY 2021**  
**COMMENCING AT 9.00AM**  
**COUNCIL CHAMBERS - MORANBAH**

## **5.5 ROAD NETWORK DEFECTS STATUS UPDATE**

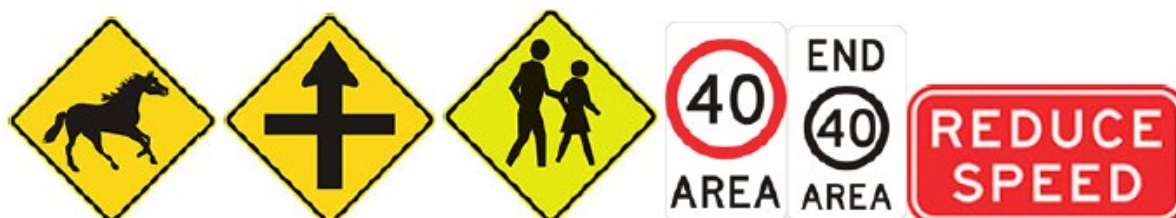
The Policy identifies a staged process to address issues and ranges from installation of signage through to re alignment. Examples of signage that could be installed to influence road user behaviour include additional warning and regulatory signage approaching the homestead area and/or additional hazards signage for the area.

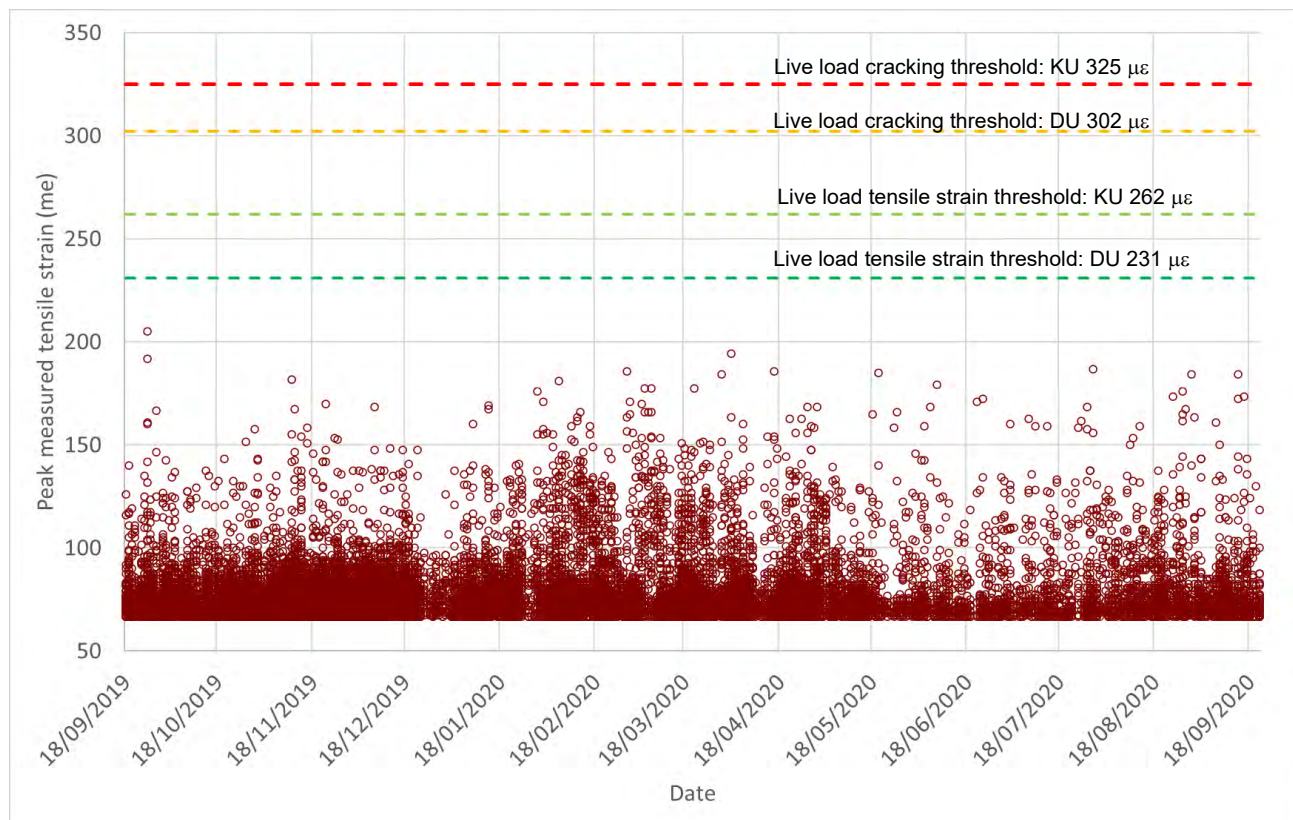
Figure 3.1 Peak tensile strains recorded with estimated live load cracking strain limits

Figure 3.1 presents a scatter plot of the highest strains measured by all fibre optic sensors during all heavy vehicle load events that have occurred over 12 months of monitoring from September 2019 to September 2020, together with theoretical live load tensile strain and cracking strain thresholds (Appendix A). The following observations were made:

- 21,920 events were recorded which caused a strain of more than  $\sim 66 \mu\epsilon$  (triggering waveform capture).
- Freight vehicles (road trains and B doubles) constitute the bulk of these events, and based on images, there are numerous examples of multiple presence events (two freight vehicles on the bridge simultaneously). As expected, the large events are generated by OSOM or Special Purpose Vehicles (SPV) such as large all-terrain cranes.

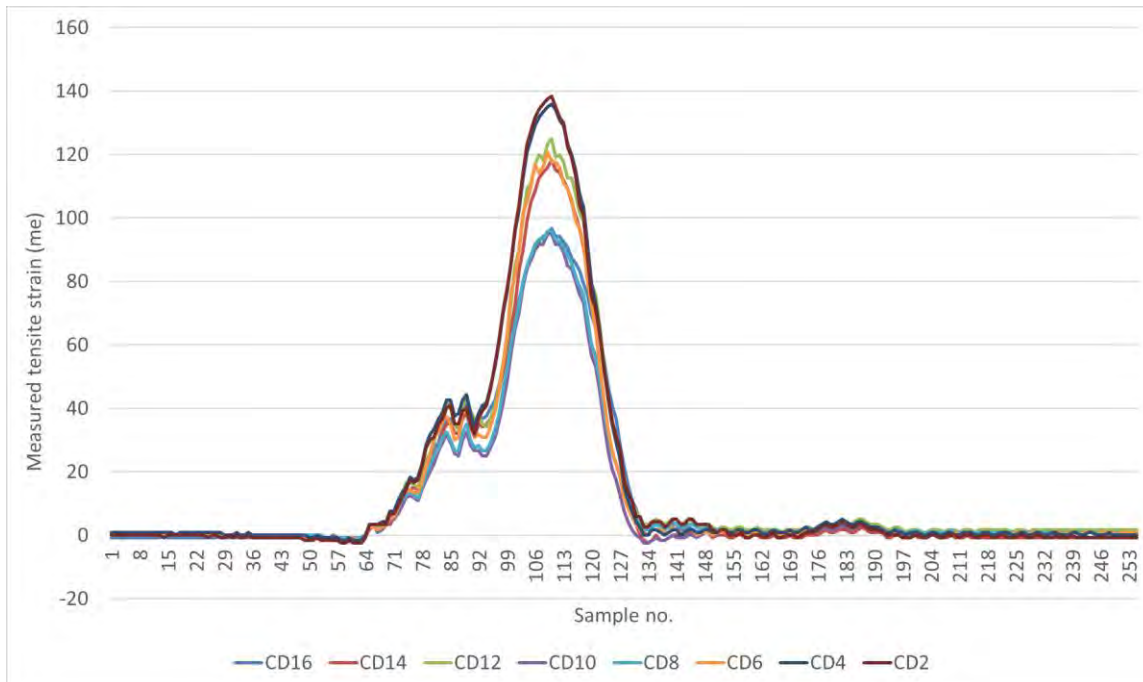
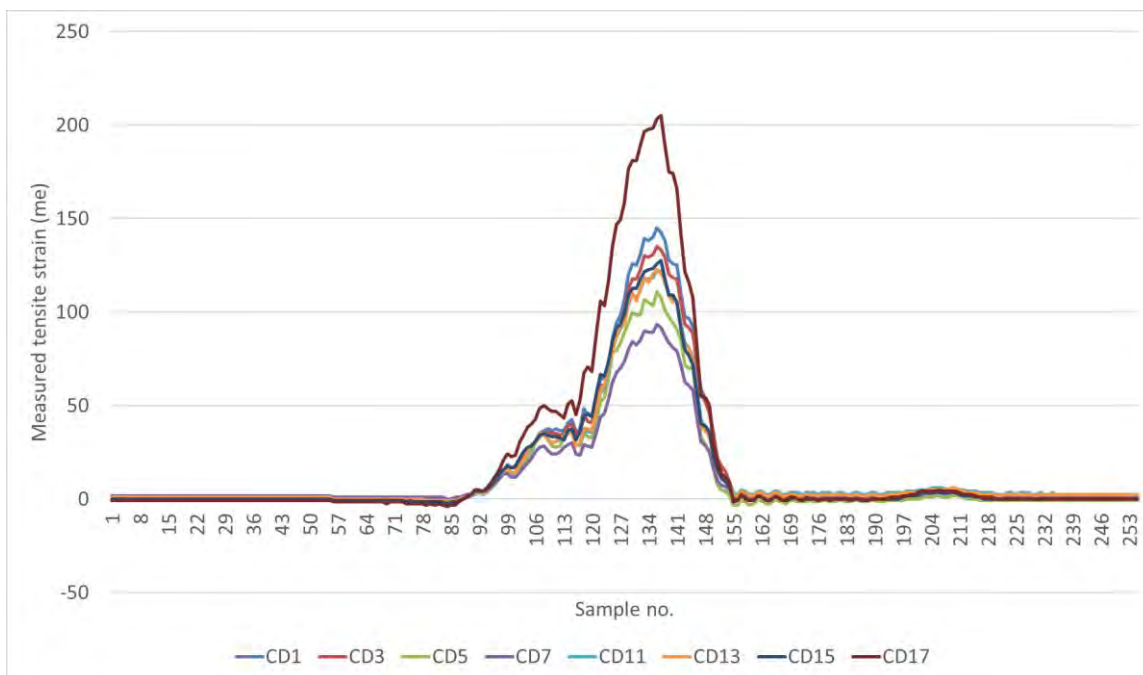
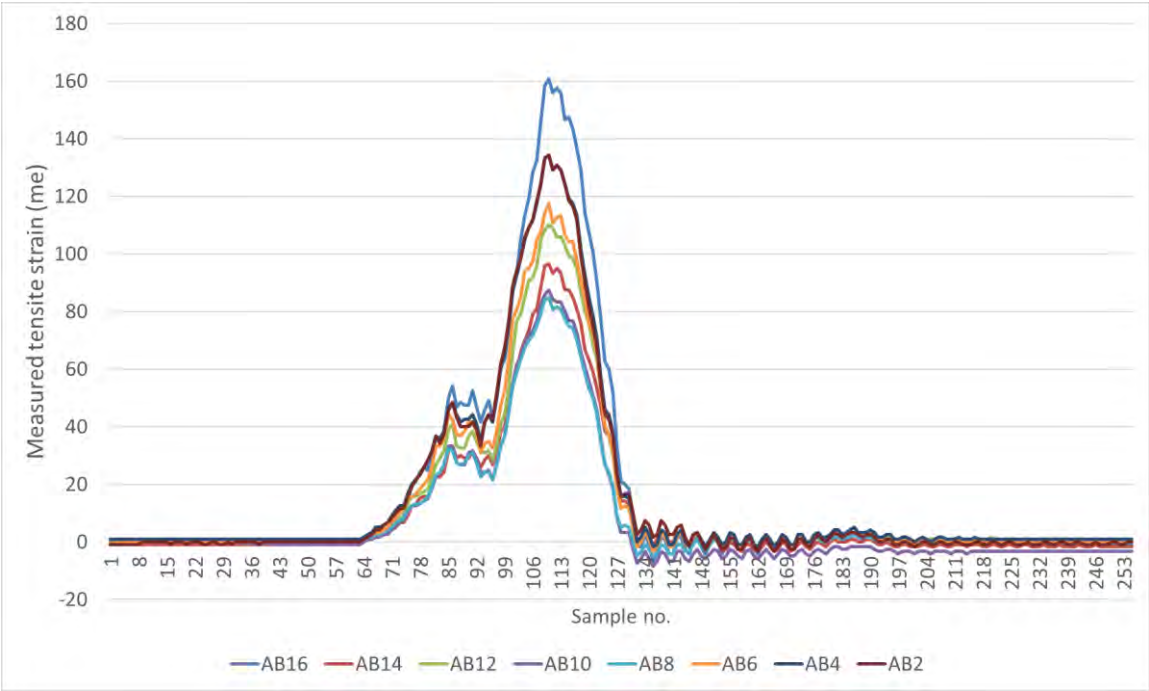
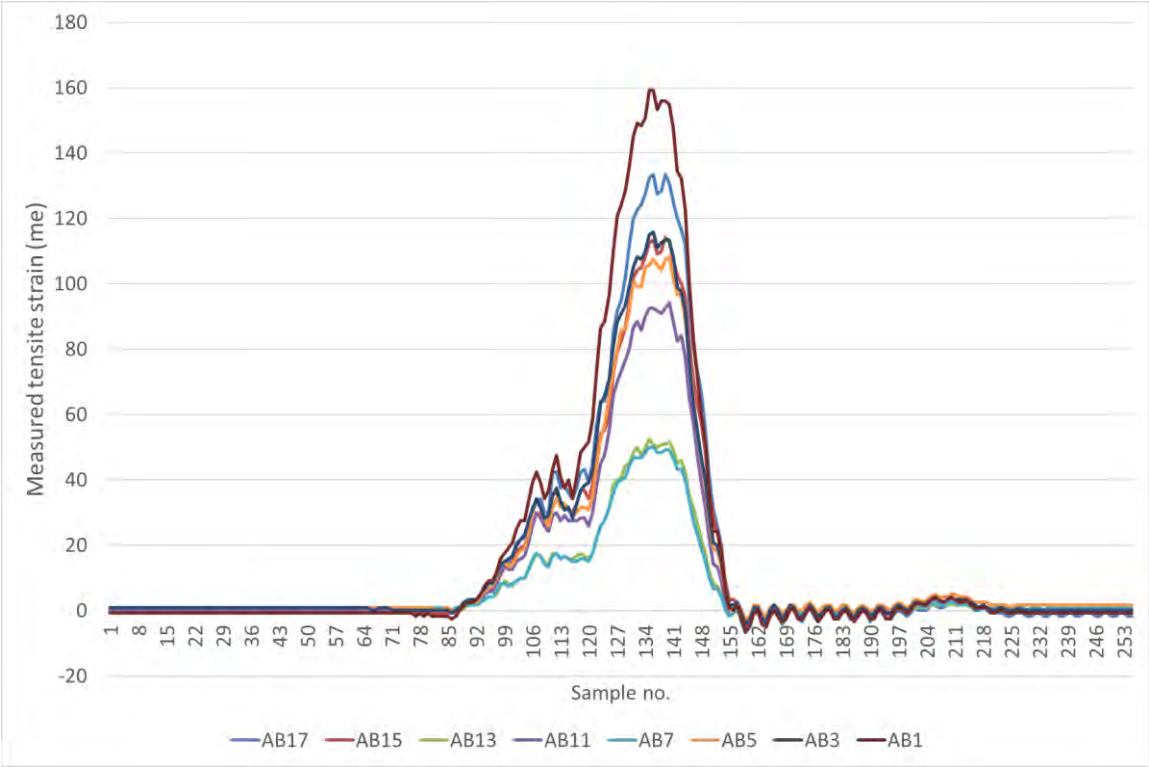
strain sensors on the bridge for the selected event. The events are split into plots for each span. The temperature sensor has been omitted from these summaries. Images of these particular heavy vehicle passing the bridge were also extracted as shown in Figure 3.6.

While data processing continues, it is clear from the above Figures that the response of each span to the same vehicle varies. While the response of each span compared with the others is generally similar, Sensor CD17 (Figure 3.3) is clearly an outlier (significantly larger than its equivalent sensors) on other spans (Sensors CD2, AB2, AB1). The reason for this is unclear. While the lateral position of the vehicle will not necessarily be identical on each span, it is likely to be very similar, so these variances may be indicative of differences in structural behaviour between spans. There are a range of potential explanations for these observations, and further investigation will take place as part of the TMR/ARRB NACoE S59 project. Given that this sensor output is approximately 25% above equivalent sensors in other spans, it should be a key focus over time because it may provide early indication of deterioration.

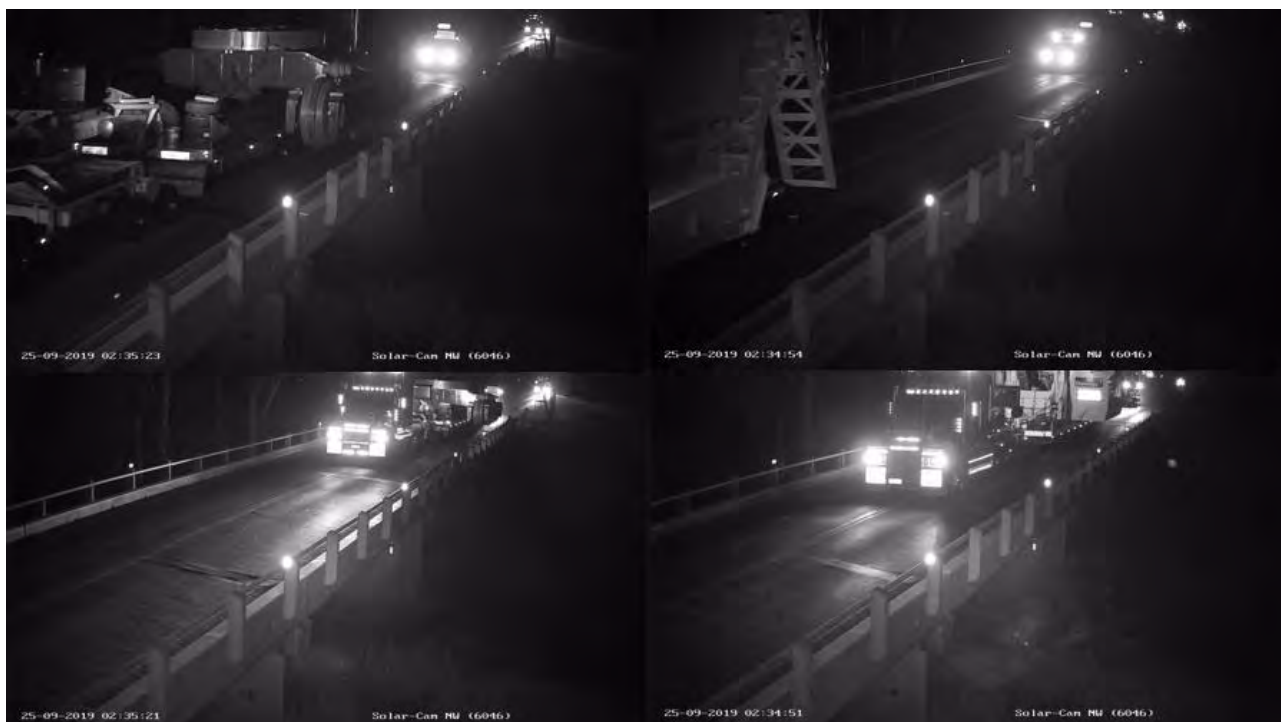
Figure 3.6 Images of the 25 September 19 at 2:35 am event

Based on the photos, the vehicle generating this event was part of a 2 vehicle OSOM “convoy” transporting a large piece of earthmoving/mining equipment on 25 September 2019, carrying the machinery deck, and undercarriage separately.

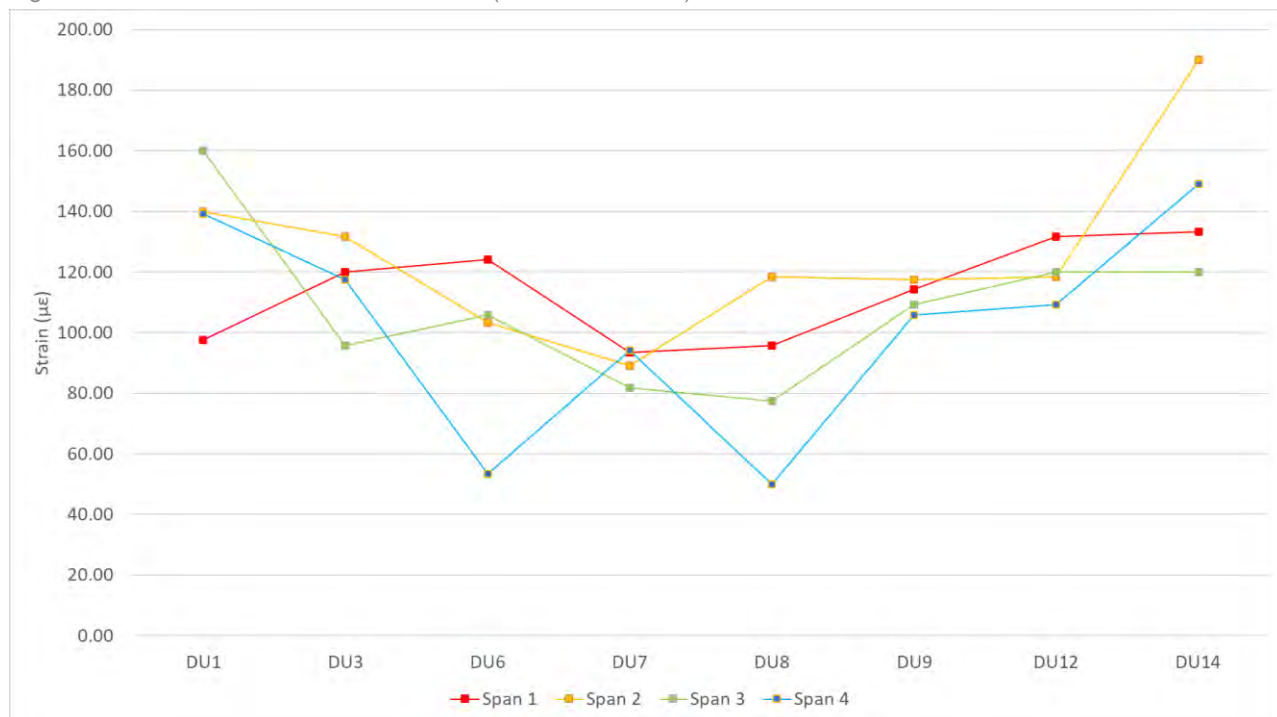
Figure 3.8 Live load distribution – event 2 (centreline OSOM)

The results shown on Figure 3.8 are for a nominally centreline OSOM event, and the following should be noted:

1. The relative variance between spans 1 to 3 have become more pronounced (compared with Figure 3.7). This is not surprising from a structural behaviour perspective but somewhat concerning from an asset integrity perspective, in that it suggests inelastic behaviour. This raises concerns that over time, repeated large OSOM events may cause incremental damage.
2. DU14 on Span 2 is an outlier consistent with previous observations.

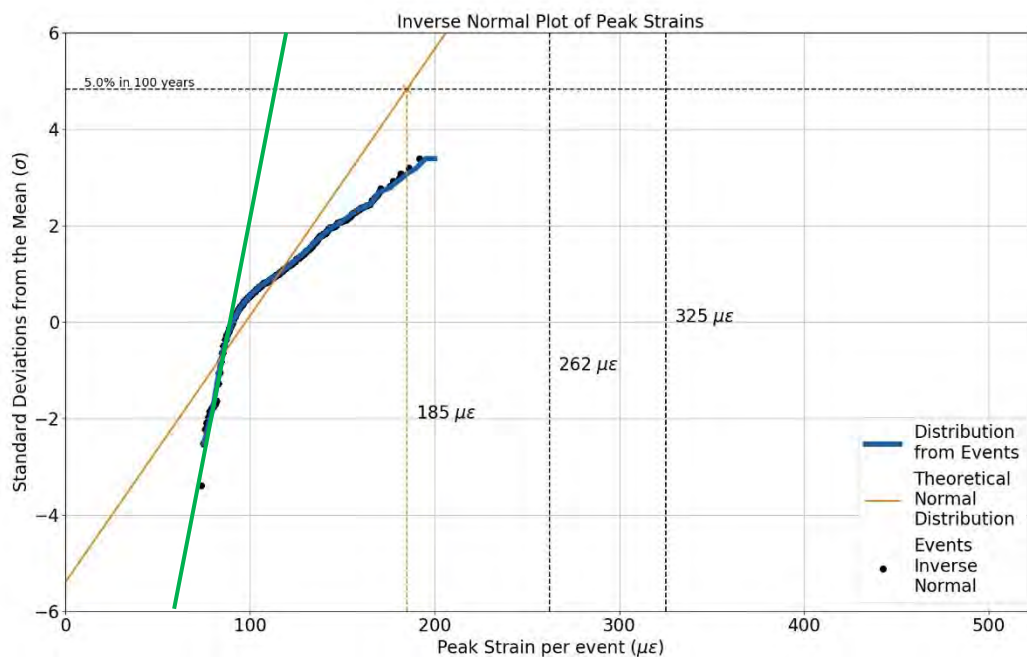
Figure 3.9 Inverse normal plot of peak strains for all events and all sensors

The green line in Figure 3.9 represents the population of "normal" freight vehicles. This vehicle population is likely to be more consistent, so the slope and intercept of this population should form the primary basis for comparison in future deterioration investigations.

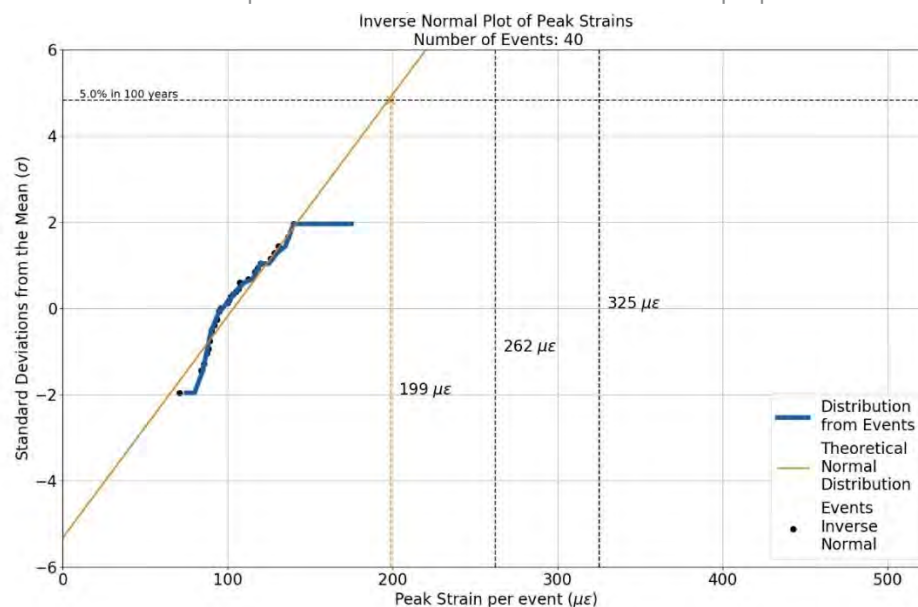
Figure 3.12 Inverse normal plot for kerb unit with maximum strains: multiple presence

Multiple presence of freight vehicles generates higher loading events compared to single presence since the load effects from the two vehicles superimpose upon each other. The multiple presence distribution of events for the kerb unit that experienced maximum strains is shown in Figure 3.12. Figure 3.13 shows the histogram

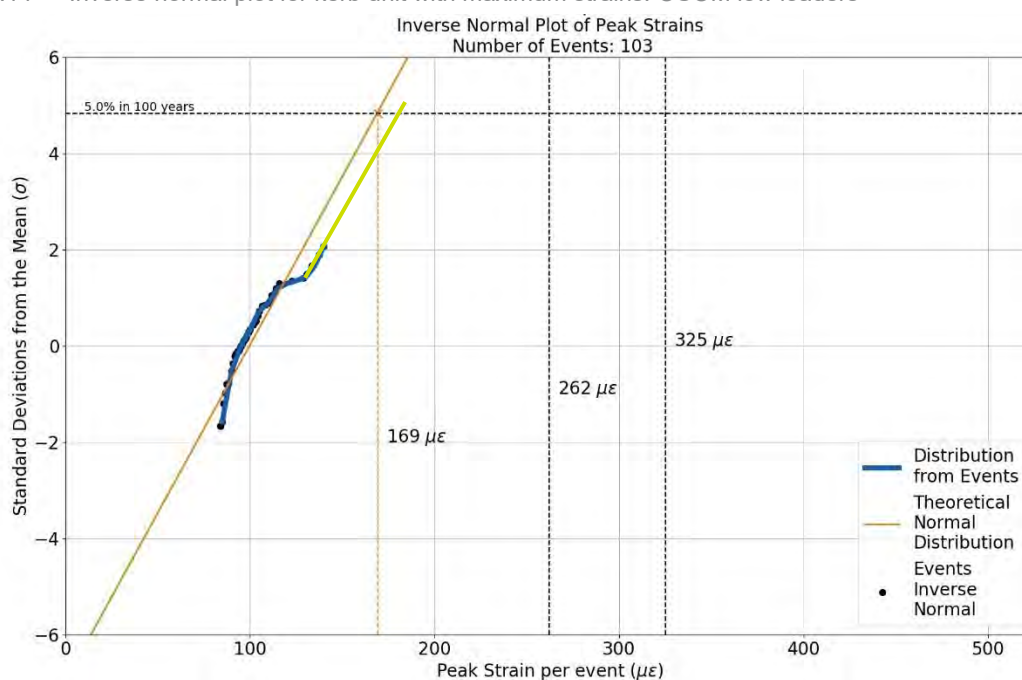
Figure 3.14 Inverse normal plot for kerb unit with maximum strains: OSOM low loaders

The OSOM vehicle analysis was split into low loaders and load platforms. Low loaders will generally have up to four axles on the trailer and may include a dolly with up to two axles. Conversely, load platforms will have 8-10 axles on the trailer and again may include a dolly with up to two axles. Consequently, the two OSOM vehicle types have different loading patterns and have been treated separately for extrapolation of maximum load. Figure 3.14 shows the empirical data and extrapolation for OSOM low loaders. A single theoretical normal distribution does not completely describe the dataset, with a shift to the right occurring for the peak events. This means that the predicted 2000-year strain shown on the plot may be non-conservative for low loaders, but given that the shift to the right is small for the peak events, the 2000-year strain value would still fall well below the tensile strain and cracking thresholds based on events captured during the six month period. This effect is demonstrated by the second yellow line on the plot, extending from the peak events. Figure 3.15 shows the histogram of actual events and the theoretical normal distribution, showing the poor fit to the lower magnitude and peak magnitude events.

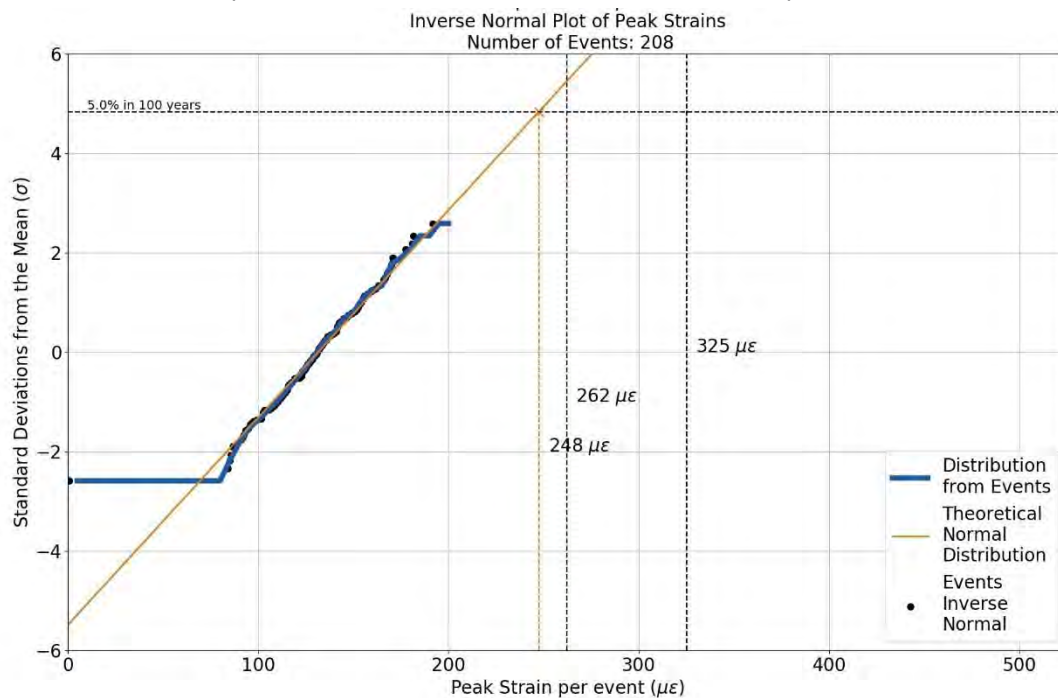
Figure 3.16 Inverse normal plot for kerb unit with maximum strains: OSOM load platforms

The largest strain events recorded have been induced by OSOM load platforms which is not unexpected since load platforms are generally used for the largest indivisible loads that need to travel on the network. The theoretical normal distribution (Figure 3.16 and Figure 3.17) provides a good fit to the captured data and while the predicted 2000-year strain magnitude is close to the tensile strain threshold, it is still below the predicted cracking threshold for the kerb units. This indicates that the load platforms captured to date are working the bridge hard but are unlikely to cause cracking of the units and impact upon durability or structural integrity based on current trends. It must be recognised however that there is some uncertainty associated with statistical projection and probability. Given the key project objective of detecting deterioration, it will be important to continue monitoring the strain events captured by the bridge to determine whether peak strains are increasing and whether the predicted maximum strains are increasing.

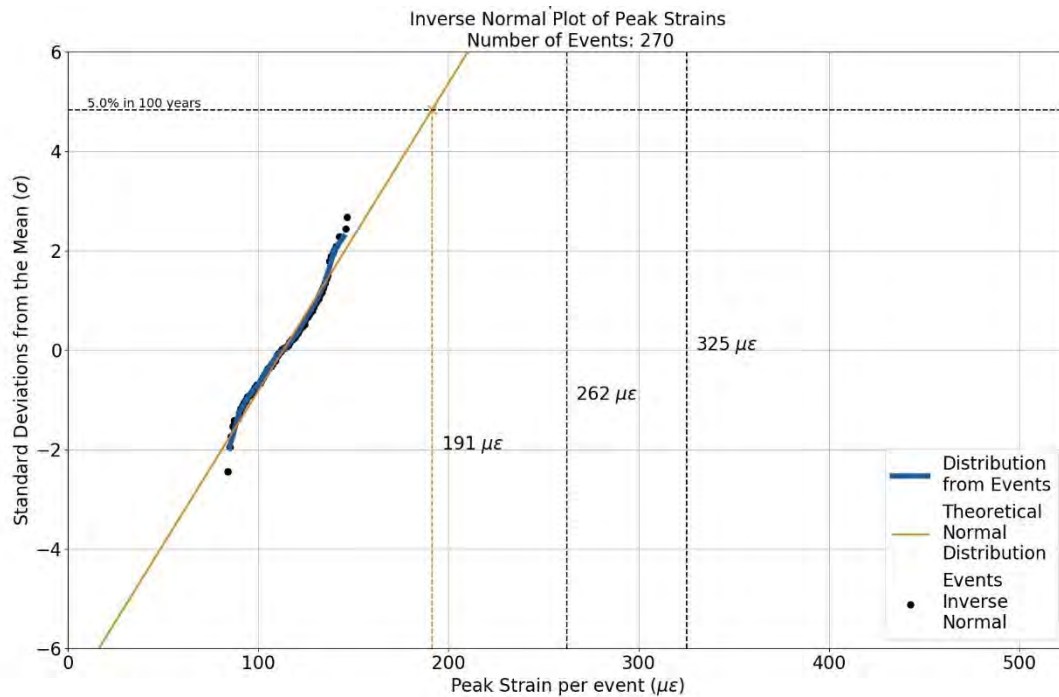
Figure 3.18 Inverse normal plot for kerb unit with maximum strains: all-terrain cranes

The loads allowable on cranes are generally tightly controlled, and the strain event magnitudes induced by cranes are largely determined by the axle configuration of the crane (e.g., 4-axle, 5-axle, boom dolly configurations). This means that the prediction of maximum event magnitudes through extrapolation may be unrealistic, as increasing strain magnitudes should not occur due to heavier loads. The inverse normal plot and histogram are included below.

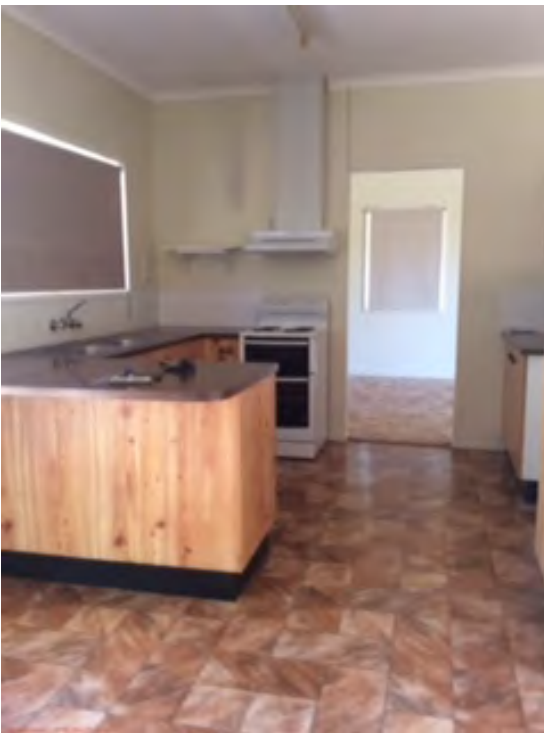
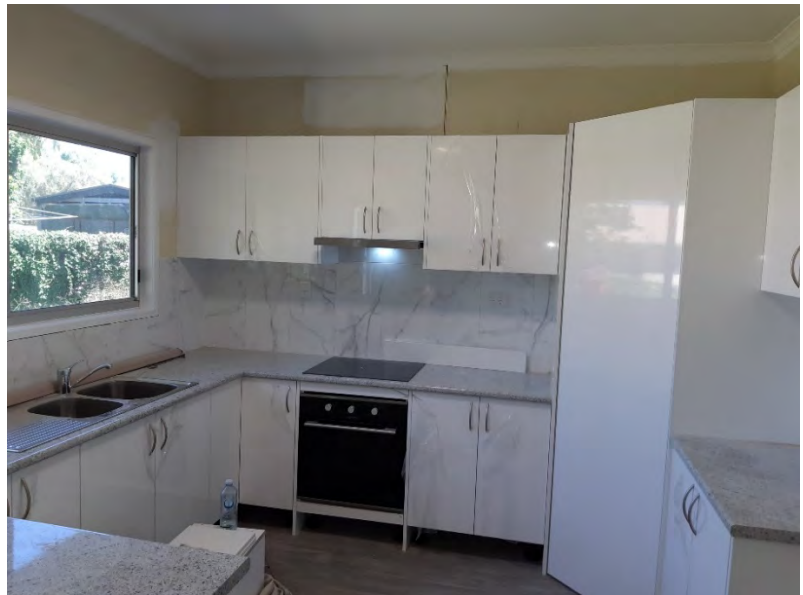
#### Before & In Progress - 13 Samson St, Kitchen

Capital works nearing completion at 11A Archer Drive and 23 Barraclough Crescent, Moranbah, 13 Samson Street, Clermont, 8 Bovey Street, 3 Bovey Street. Capital works has commenced on 10 Kemmis Street Nebo with the fitting of new stairs, kitchen and bathroom renovation. Trades teams are also addressing BMR's (Building Maintenance Requests) at various locations throughout the region. 26 Norton Street underpinning and renovations are completed ready for new tenant on the 30th April. The 16-person fatigue accommodation project at 12 Acacia Street is well into the planning stage with the purchase of the land complete and the Development Application has been submitted to Planning for approval.
