# DRINKING WATER QUALITY MANAGEMENT PLAN

2021

Presented by: Water & Waste Directorate

This Drinking Water Management System document was compiled for Isaac Regional Council by project consultants:

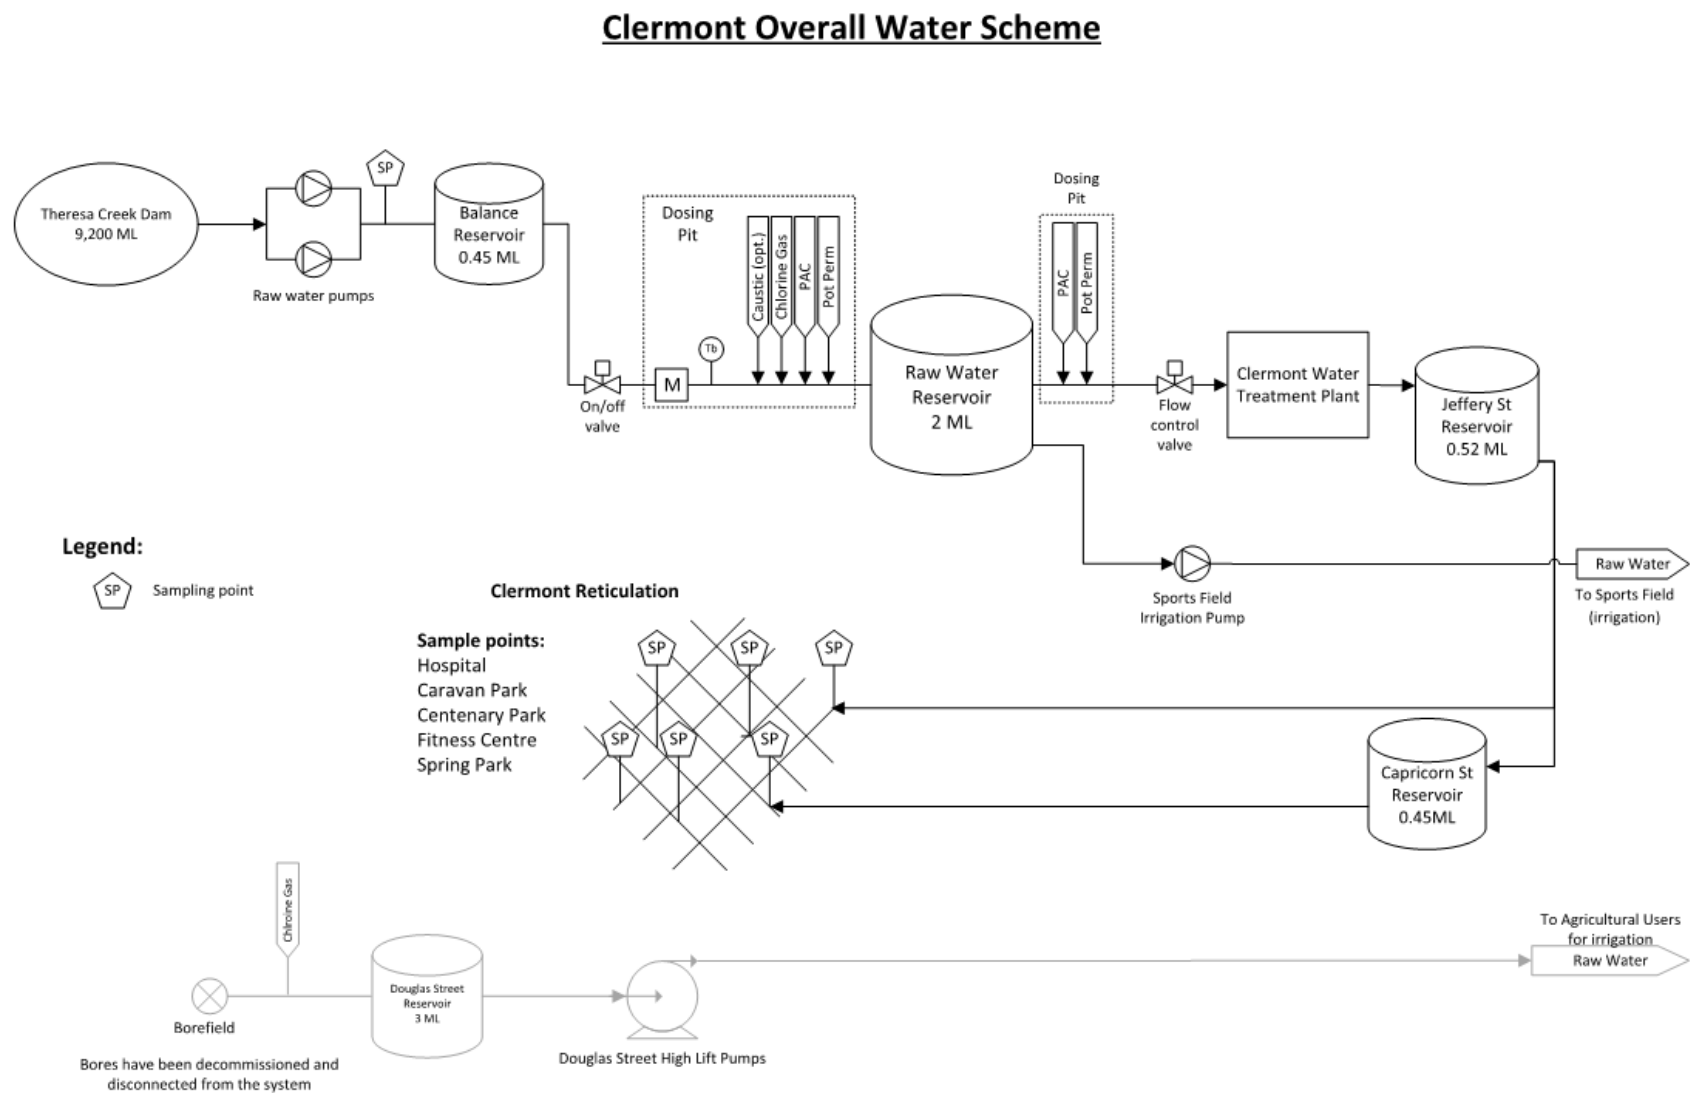
Figure 0-1: Clermont Overall Water Supply System

It should be noted that the bore fields and Douglas Street reservoir have not been used for many years. This infrastructure has been included in the diagram as the pipework has not been demolished. However, the pumps are electrically disconnected, hence it is not possible for water from the Douglas Street bores to enter the Clermont water supply network. The Capricorn St reservoir is being reinstated to increase treated water storage capacity. New pipework will be installed for the new configuration.

System Component	Description
	<ul style="list-style-type: none"> <li>• Sand filtration;</li> <li>• Disinfection with chlorine gas;</li> <li>• pH correction with sodium hydroxide; and</li> <li>• Trim chlorine gas dosing to maintain a residual in the reticulation.</li> </ul> <p>The wastewater system comprises of:</p> <ul style="list-style-type: none"> <li>• Backwash holding Tank;</li> <li>• Sludge and Backwash water sent to Sludge Lagoons (x4); and</li> <li>• Supernatant used for onsite irrigation or returned to the Raw Water Reservoir.</li> </ul>
Water Storage (After Treatment)	<ul style="list-style-type: none"> <li>• 3.0 ML and 5.0 ML Clearwater Tanks located onsite and hydraulically linked0.52 ML Jeffrey Street Reservoir</li> <li>• 0.45 ML Capricorn Street Reservoir</li> <li>• Douglas Street Reservoir (not in use)</li> </ul> <p>All treated water storages are roofed, and vermin proofed.</p>

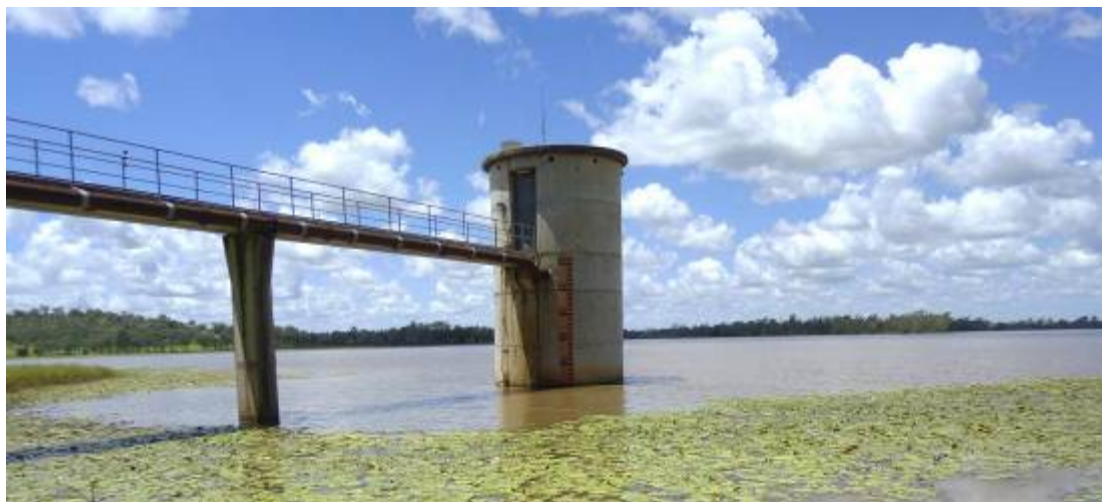
*Figure 0-3: Theresa Creek Dam Intake Tower*

A raw water intake tower constructed from reinforced concrete is located in the dam. This tower has four intake levels which can be opened and closed manually depending on the level of water in the dam. The intake levels of the tower are at two, four, six and eight metres. There is a screen located on the intake which protects the pumps from debris. This screen is manually lifted and cleaned by the operators when required. Water is pumped from the dam to the Raw Water Balance Reservoir by a set of two identical centrifugal high lift pumps arranged in a duty/standby configuration. The intake is 300 mm in diameter and the pumps can each provide 112 L/s at 78 m head.

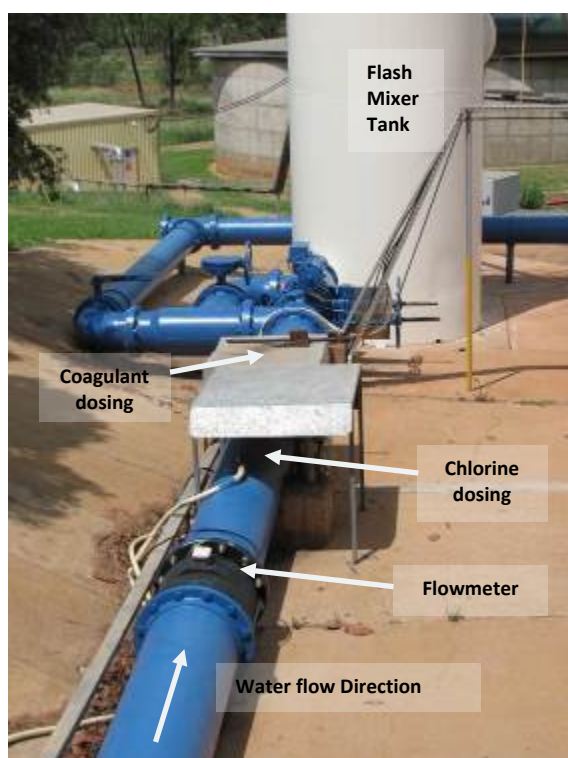
Figure 0-4: WTP Inlet

The first raw water dosing point at Clermont WTP is a pit just prior to the plant flow control valve where PAC and potassium permanganate can be dosed if required. From this pit, the raw water main from the Raw Water Reservoir continues to the flash mixer via a magnetic flowmeter as shown in the photograph in Figure 0-4. Sodium hydroxide is dosed into the raw water main on the outlet of the dosing pit as required to adjust the pH for coagulation. Chlorine and alum are dosed just after the flowmeter at the inlet to the flash mixer. The first dose point is chlorine which is dosed at this point to oxidise any residual iron and manganese. The second dose point is for alum which is added for coagulation.

All chemical dosing setpoints are selected when required by the operators and flow paced to the WTP flow. The chemical dosing stops automatically when no flow is detected in the WTP.

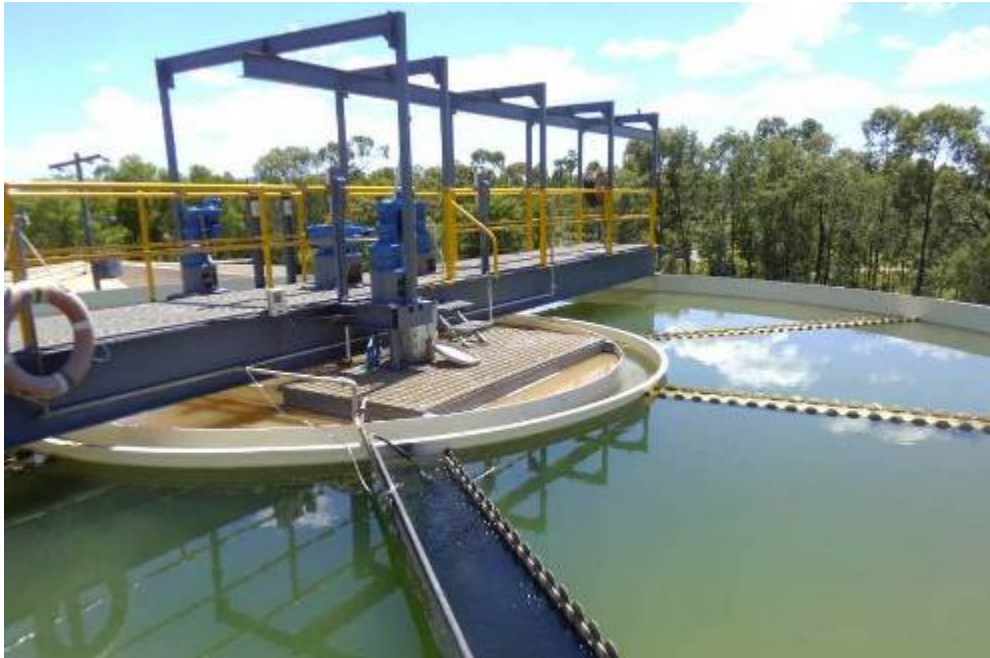
*Figure 0-5: Clarifier with Central Flocculation Chamber*

The clarifier is a reactor-type clarifier with a central flocculation zone as described in Section 0.

The floc that has formed during flocculation settles to the bottom of the clarifier. Clarified water flows out via the launders and to the filters via the outlet channel. PAC, when required, is dosed into the settled water in the clarifier outlet channel. PAC is dosed to prevent the taste and odour issues caused by cyanotoxins created by algal growth in the Theresa Creek Dam. Figure 0-5 shows the PAC slurry being dosed into the clarifier outlet channel.

The clarifier's shell is constructed from steel and appears to be in good condition with no observed deterioration on its external surface. The mechanical mixers also appear to be in good working order.

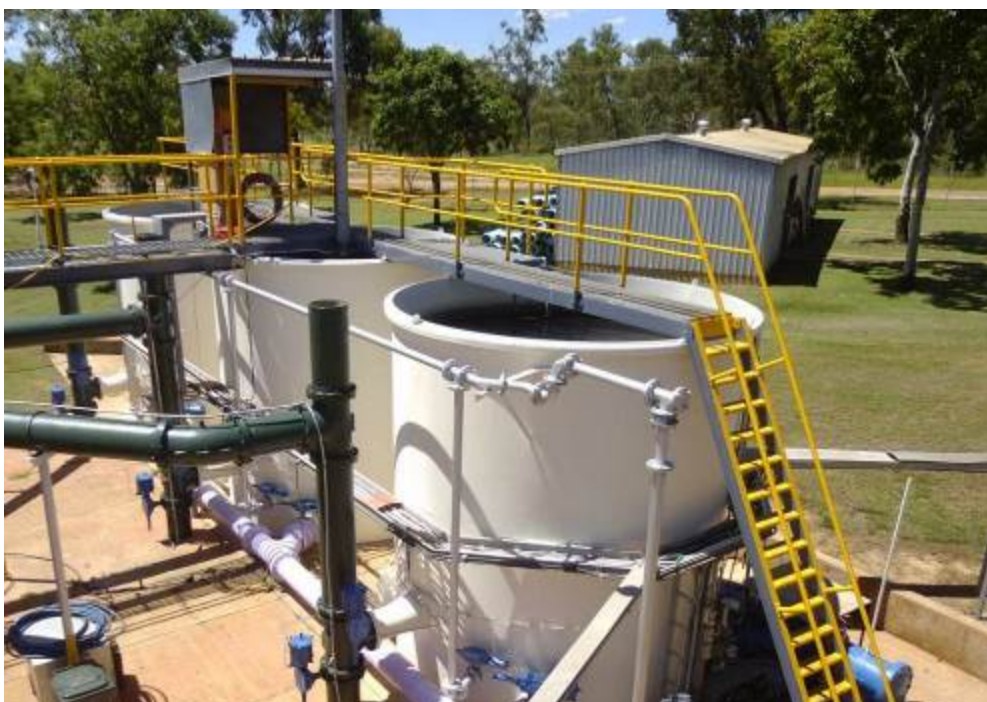
*Figure 0-6: Rapid Sand Filters*

Filter backwash is manually initiated but the sequence is automatically controlled through SCADA. The operator normally watches the backwash and only returns the filter to service once the water is visually clear. The dirty backwash water flows from the filters into a dedicated backwash holding tank.

The filter backwash pumps have a capacity of 148 L/s at a total head of 10 m. The air scour blowers have a capacity of 5.3 m<sup>3</sup>/min against a pressure of 3.5 m of water. The filter tank surface and associated mechanical equipment appear to be in good condition. The filters are shown in Figure 0-6.

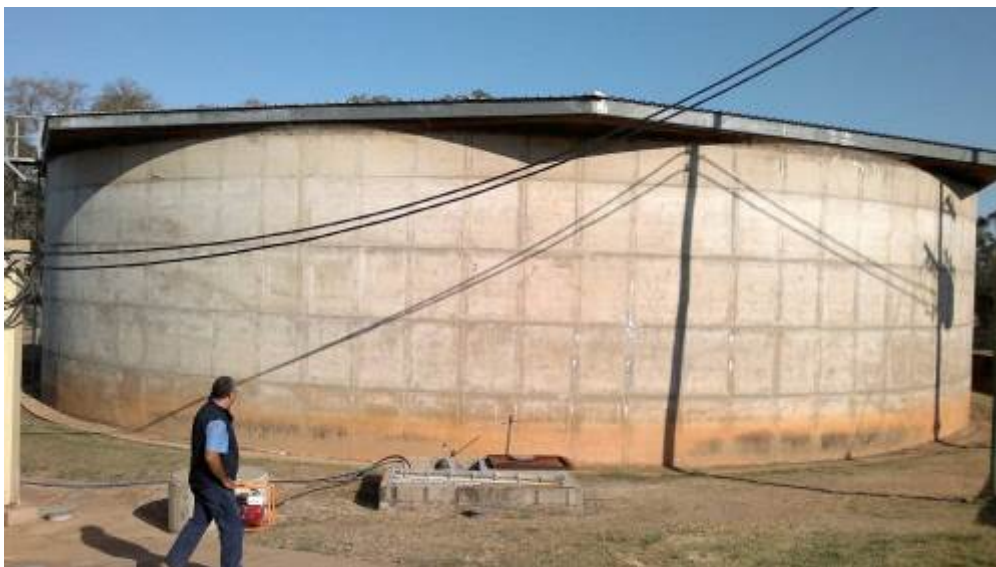
*Figure 0-7: 3 ML Treated Water Reservoir (Clearwater Tank)*

The WTP is operated at an operator selected flow setpoint and is stopped and re-started based on the level in the 3 ML Treated Water Reservoir.

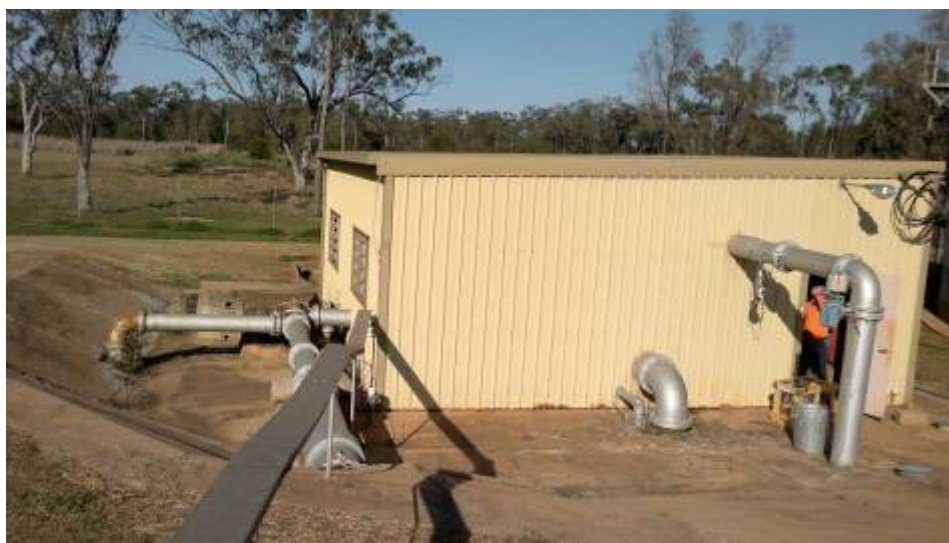
*Figure 0-8: High-lift pump rising main (left) and filter backwash line (right)*

Two high lift pumps transfer water from the 3 ML Treated Water Reservoir to the Jeffrey Street reservoir. These pumps start and stop based on the measured level in the Jeffrey Street Reservoir. The pumps are arranged in a duty/standby configuration and have a capacity of 100 L/s at a head of 48 m. Treated water is dosed with a chlorine trim dose prior to the high lift pumps if required to boost the residual in the reticulated water. The high lift pumps are located within a pump house as shown in Figure 0-8.

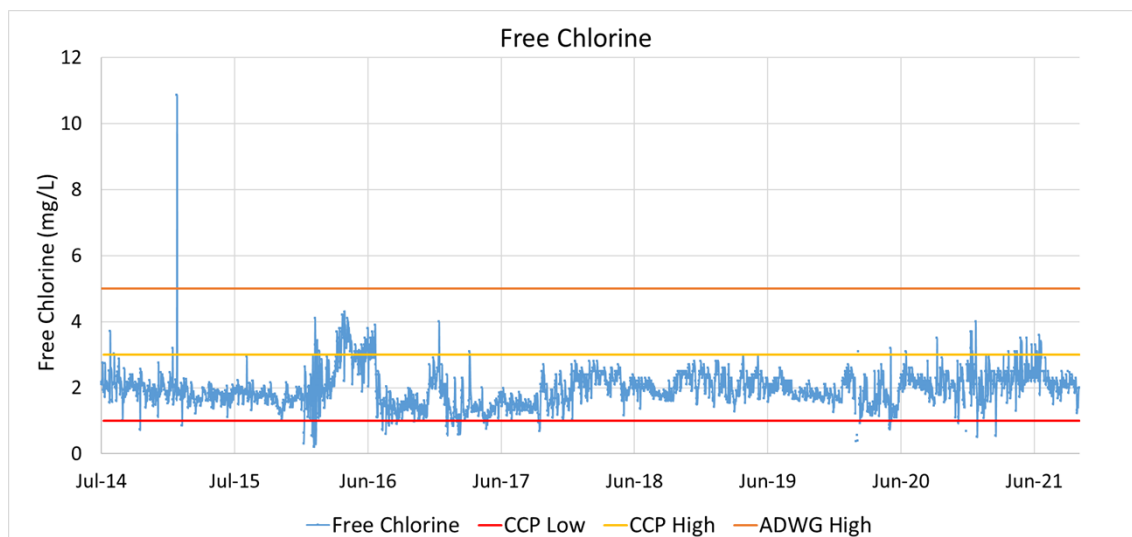
Figure 0-1: Treated Water Free Chlorine

Chlorine needs to be present in the treated water for sufficient time to ensure disinfection takes place. Chlorine residual also needs to be maintained throughout the reticulation to prevent re-contamination. The results in [Table 0-4: Clermont Treated Water Quality \(July 2014 - October 2021\) table](#) and Figure 0-1 show that there is high fluctuation in total and free chlorine concentration in the treated water. A chlorine analyser which provides continuous readings and alarms, or control actions has been installed to assist the operators in keeping the chlorine levels in the treated water more stable. The figure below presents the level of free chlorine in treated water between July 2014-October 2021 with relevant limits. Chlorine levels are seen to fluctuate the most in late 2015, the first 6 months of 2016, and, again more prominently, from July 2020 onwards.

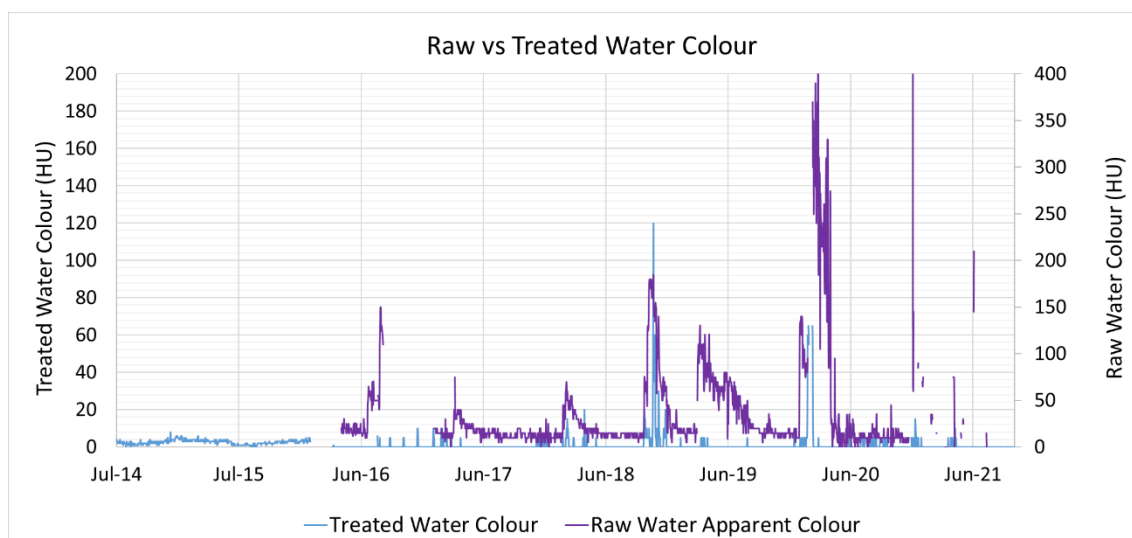
Figure 0-2: Colour in the Raw and Treated Water

Figure 0-2 and Figure 0-3 present the variation in colour and turbidity in the treated water as compared with the colour and turbidity of the raw water. The turbidity levels are shown on a logarithmic scale and colour is shown on a separate axis. The charts confirm that high levels of colour and turbidity occur in the treated water when the raw water has high levels of colour and turbidity. A filtered water turbidity meter with alarms has been installed to assist operators in ensuring compliant turbidity levels and timely response to any exceedances.

There was also a dramatic spike in raw water colour (>2,000 HU) beginning in March 2020, though this had minimal impact on treated water colour.

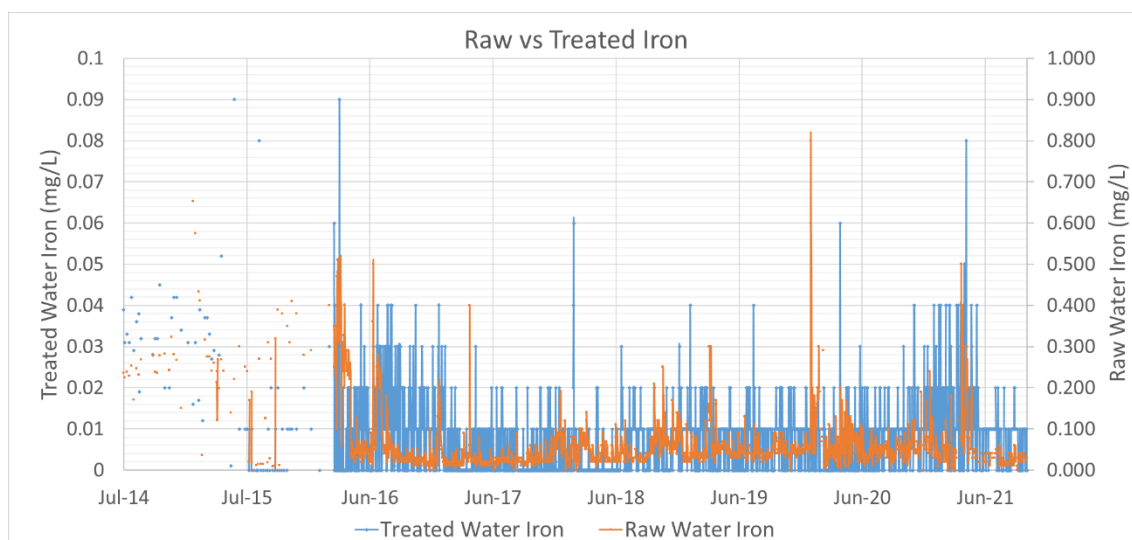
Figure 0-4: Iron Concentration in Raw and Treated Water

Figure 0-4 and Figure 0-5 below show the variation in iron and manganese in the treated water for the period July 2014 – October 2021. CCP limits are not shown on the graphs as all treated water results are well below the limits. The graphs show sufficient removal of iron and manganese, even with increased levels. There are 2 instances of treated manganese exceeding the ADWG aesthetic threshold, but concentrations were never detected above the health threshold.

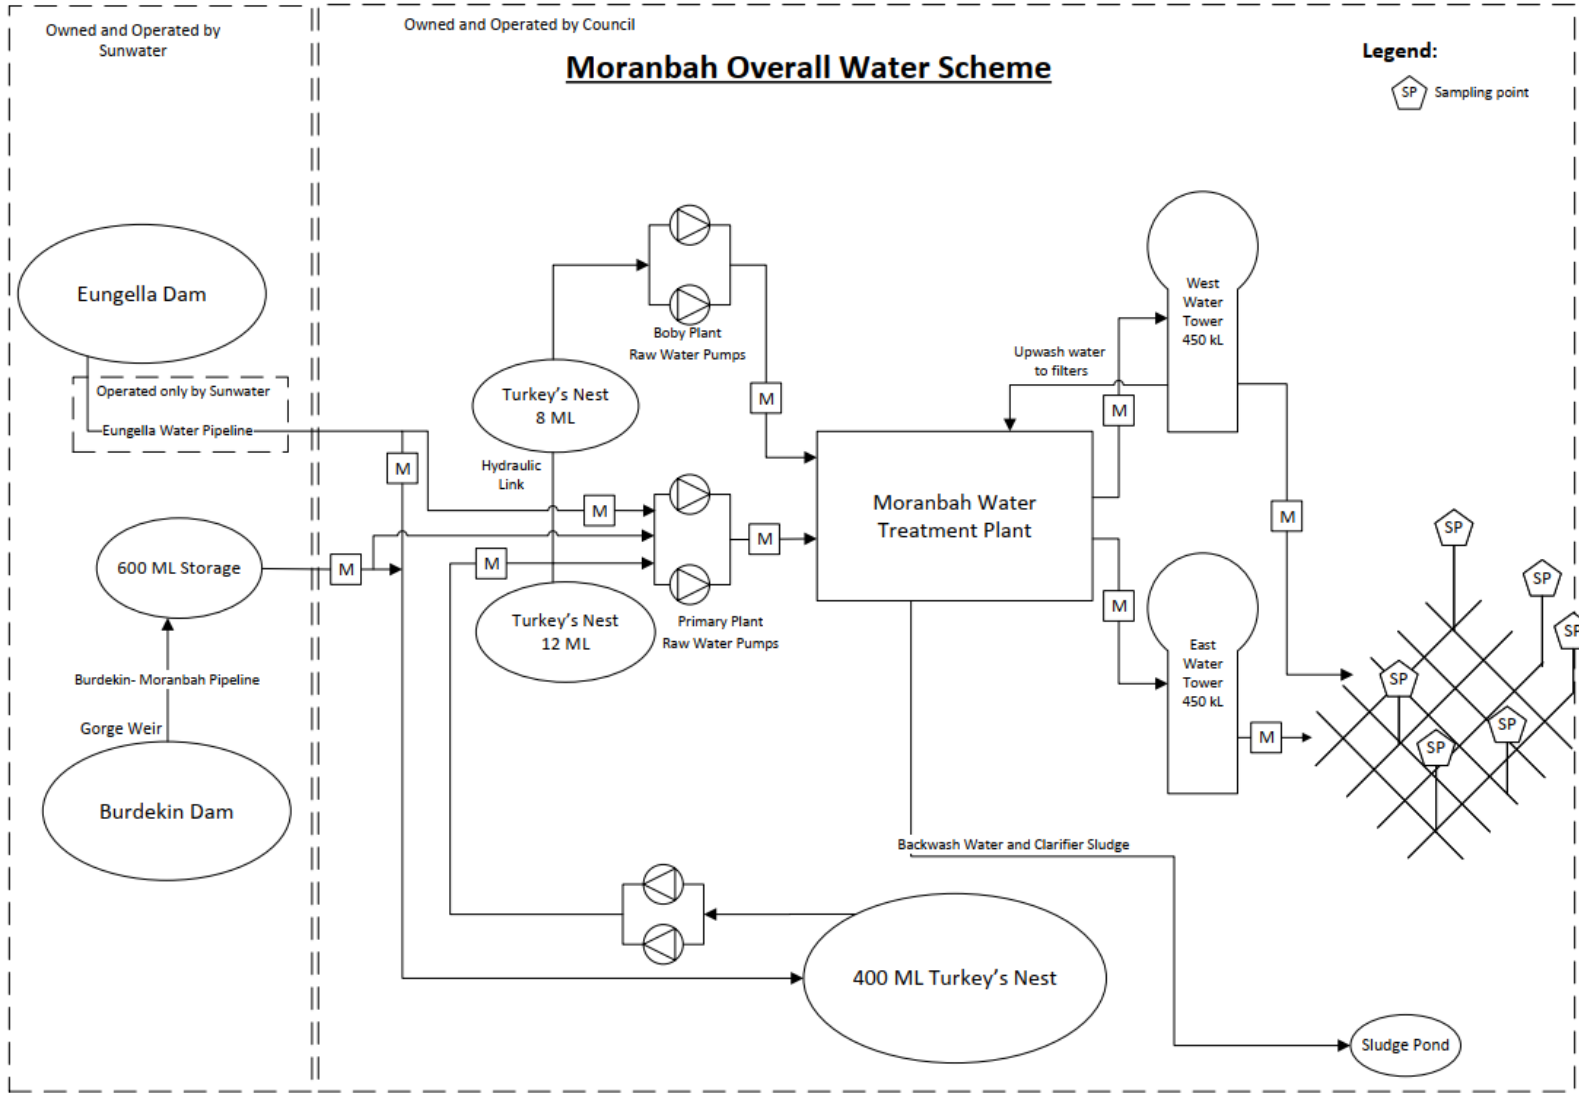
Figure 0-1: Moranbah Overall Water Supply System

<b>System Component</b>	<b>Description</b>
	<ul style="list-style-type: none"> <li>• PAC for taste and odour removal;</li> <li>• Coagulation with ACH;</li> <li>• Polymer dosing for flocculation aid;</li> <li>• Flocculation;</li> <li>• Clarification;</li> <li>• Dual media filtration;</li> <li>• Sodium hydroxide dosing for post-pH adjustment;</li> <li>• Disinfection with chlorine gas; and</li> <li>• Fluoridation with sodium fluoride.</li> </ul> <p>The wastewater system comprises of:</p> <ul style="list-style-type: none"> <li>• Wastewater Holding Tanks</li> </ul>
<b>Water Storage (After Treatment)</b>	<p>Moranbah has 3 treated water reservoirs onsite, totalling 27.1 ML of storage:</p> <ul style="list-style-type: none"> <li>• 5.3 ML Treated Water Reservoir 1</li> <li>• 8.0 ML Treated Water Reservoir 2</li> <li>• 13.8 ML Treated Water Reservoir 3</li> </ul> <p>There are also 2 additional treated water storages that gravity feed the reticulation network:</p> <ul style="list-style-type: none"> <li>• 0.45 ML West Water Tower</li> <li>• 0.45 ML East Water Tower</li> </ul> <p>All treated water storages are roofed. The inlet weirs to Treated Water Reservoir 1 are not fully enclosed, vermin proofed or secure.</p>

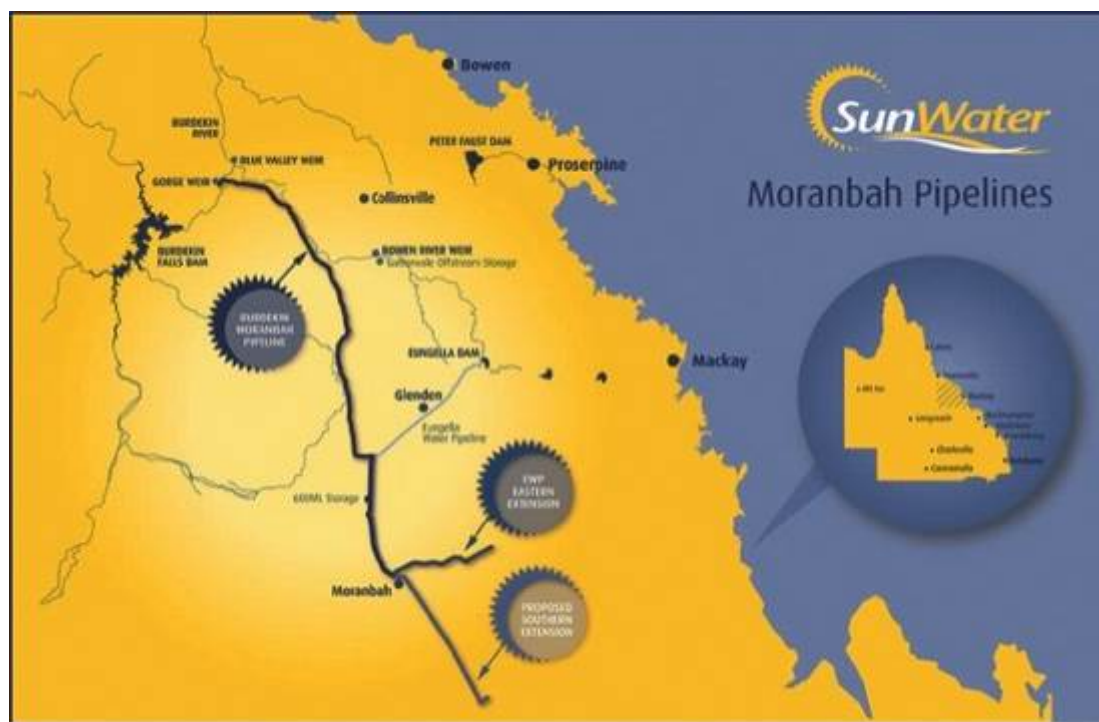
Figure 0-3: Water Supply Pipelines to Moranbah

The main raw water sources for Moranbah are presented below in Figure 0-3.

Source	Owner	Pipe Diameter	Pipe Length (km)
Eungella Pipeline	BMA	450-600mm	119
Eungella	Eungella Pipeline Co	450-700mm	238
Burdekin Pipeline	Sunwater	750-813mm	217

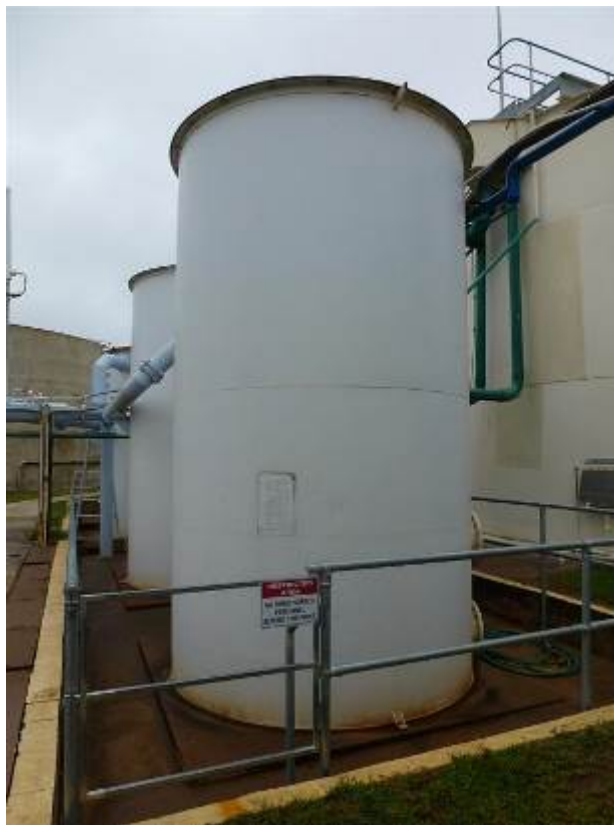
*Figure 0-4: Moranbah Bobby Plant Filters*

The clarified water flows into fifteen sand filters (six for Bobby Plant and nine for the Main WTP) by gravity. The diameters of the filters are 2.7 m for Bobby Plant and 3.3 m for the Main WTP. The filter backwash sequence is started and controlled manually each day for the Bobby Plant and triggered automatically based on head loss for the Main WTP filters.

The filter tank surfaces appear to be in good working condition. Backwash valves and actuators on the Bobby Plant filters have been replaced to prevent leaks and reduce reliance on manual operation. Each WTP has its own air compressor which provides air to the filter valve actuators. The compressors can also be cross connected thereby providing duty standby in case of equipment redundancy.

When a filter in the Bobby Plant starts a backwash, the filtered water from the other operating Bobby Plant filters becomes the upwash water instead of flowing to the treated water tanks. Upwash water for the WTP filters flows from the East Water Tower. The filter media in the Bobby Plant filters is 1,000 mm sand and in Main WTP the filter media has a depth of 1,250 mm of multimedia. The Main WTP filters have recently been refurbished (completed October 2017), including new media, painting, nozzles, underdrains (including Plenum Floor) and valves.

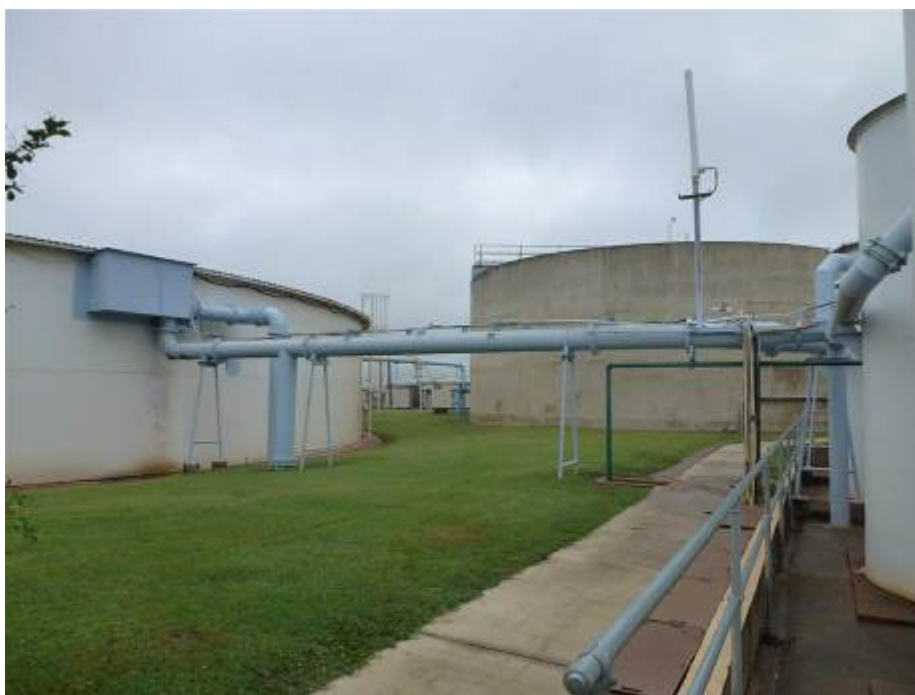
*Figure 0-5: Moranbah Filtered Water Line from Bobby WTP into Treated Water Res 1*

Sodium hydroxide, chlorine and fluoride are injected into the filtered water mains leading to the treated water reservoir. Each WTP has its own pipe into Treated Water Reservoir 1. The inlet weir boxes to the reservoir were previously open to the air and showing signs of corrosion, risking contamination of treated water from vermin or corrosion. These have now been refurbished and enclosed to minimise the risk of contamination.

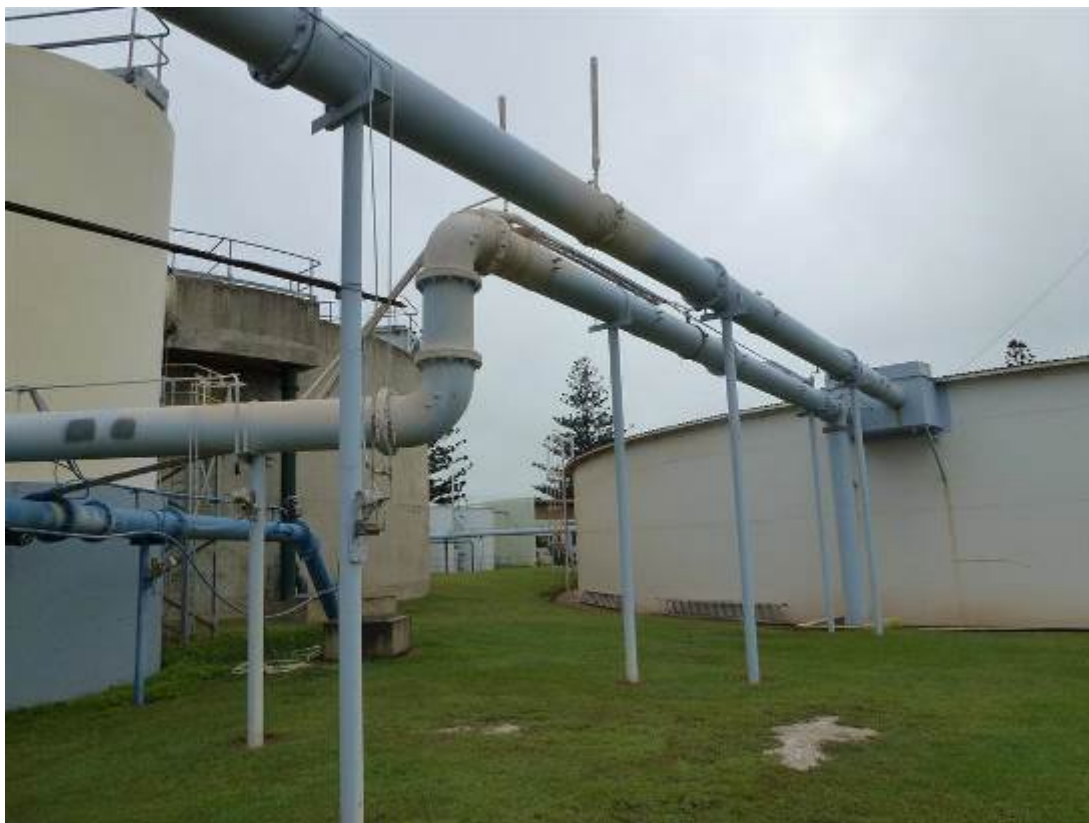
Figure 0-6: Moranbah Filtered Water Pipeline from WTP into Treated Water Reservoir 1

The treated water reservoirs provide more than the 30 minutes of chlorine contact time required for disinfection.

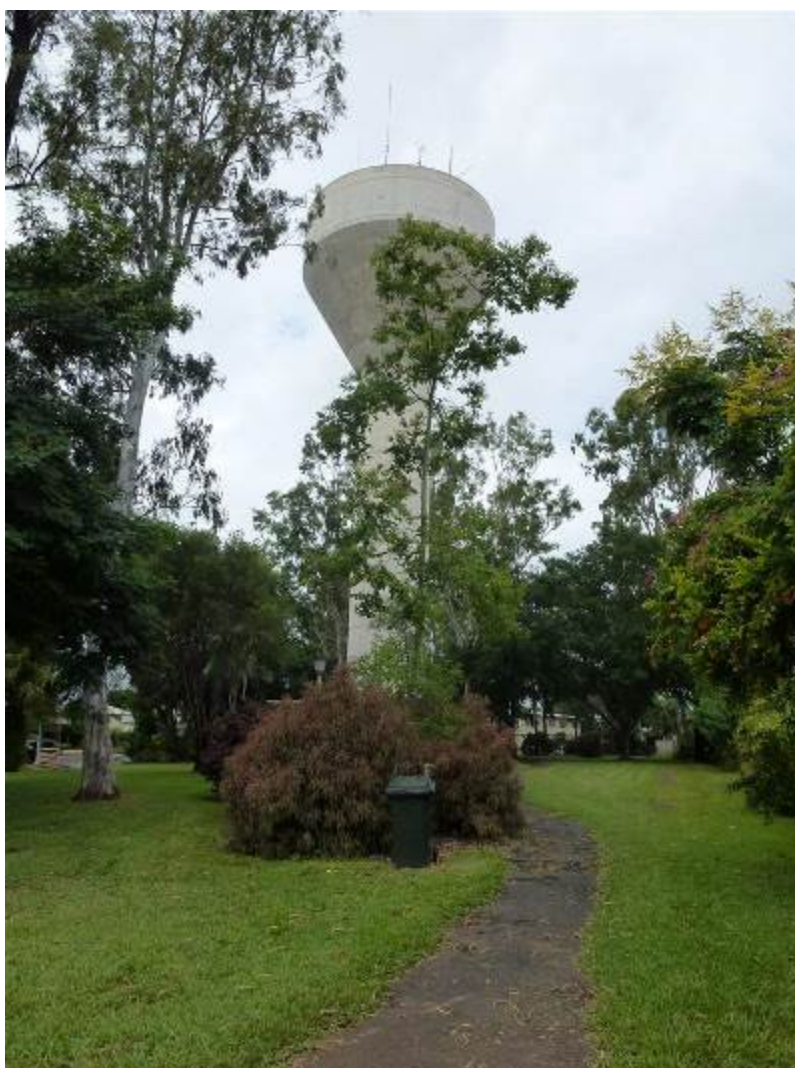
*Figure 0-7: Moranbah Eastern Water Tower*

There are two water towers for Moranbah, the Western Tower located at the WTP and the Eastern Tower located at the corner of Clements Street and Mills Avenue in Moranbah East. The Western Tower is constructed of steel with corrugated tin roof and the Eastern Tower shown in Figure 0-7 is constructed of reinforced concrete with a corrugated tin roof. Each of the towers has a storage capacity of 0.45 ML (total capacity of 0.9 ML).

Water from the treated water tanks is pumped into the towers by two sets of high lift pumps. The pumps start and stop based on the water level in the water towers. Each set of high lift pumps has three pumps arranged in duty/standby configuration. One of the standby pumps is a diesel-powered pump which can be operated in the event of power failure. The pump duty is alternated regularly by the operator.

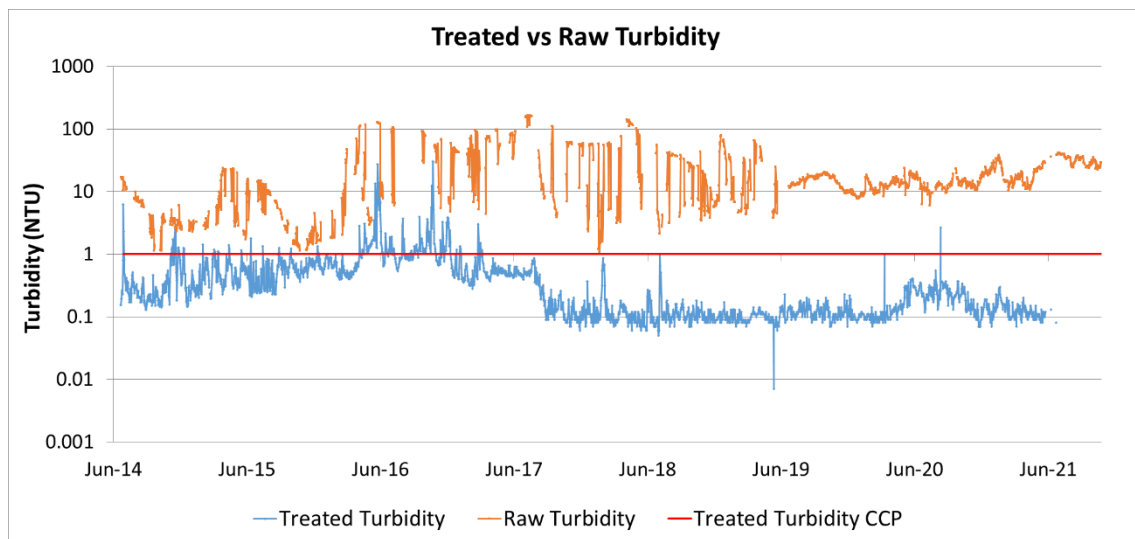
Figure 0-1: Moranbah Raw and Treated Water Turbidity

As shown in the following graphs, treated water turbidity and colour have significantly improved since early 2017. Note that only true colour is available for raw water from June 2017 onward. There was also a short-lived spike in treated water colour in July-September 2020, which has since been resolved.

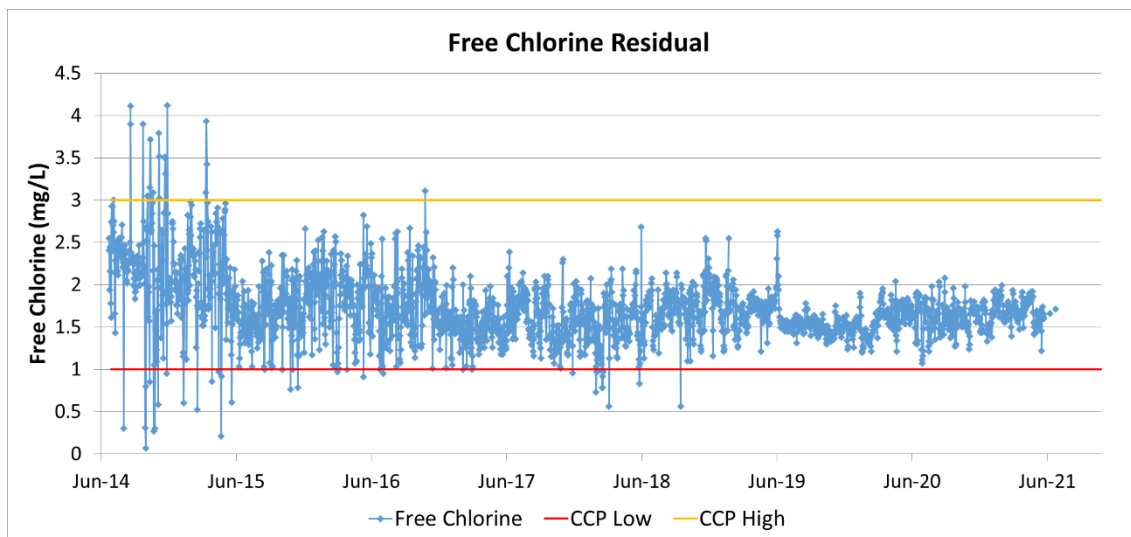
Figure 0-3: Moranbah Free Chlorine Residual in treated water

Figure 0-3 below depicts the free chlorine residual in the treated water for the period July 2014 – June 2021. Compliance with the Chlorine CCP limits are seen to improve with fewer values outside of the CCP limits from 2016 onwards.

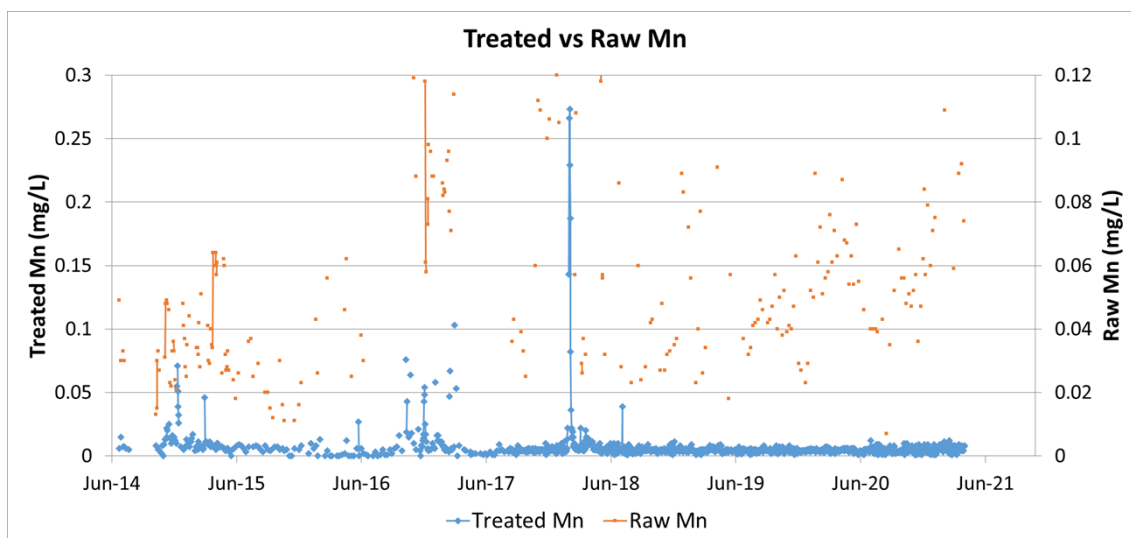
Figure 0-4: Moranbah Raw and Treated Water Manganese

Figure 0-4 and Figure 0-5 present the iron and manganese concentrations in the treated water at Moranbah.

The health limit for manganese is 0.5 mg/L and the aesthetic limit is 0.1 mg/L. The aesthetic limit for iron is 0.3 mg/L. Figure 0-5 shows that iron concentrations have never exceeded the ADWG aesthetic limit. Figure 0-4 shows that manganese concentrations exceeded the ADWG aesthetic guideline during one week in February 2019 only but has never exceeded the health limit.

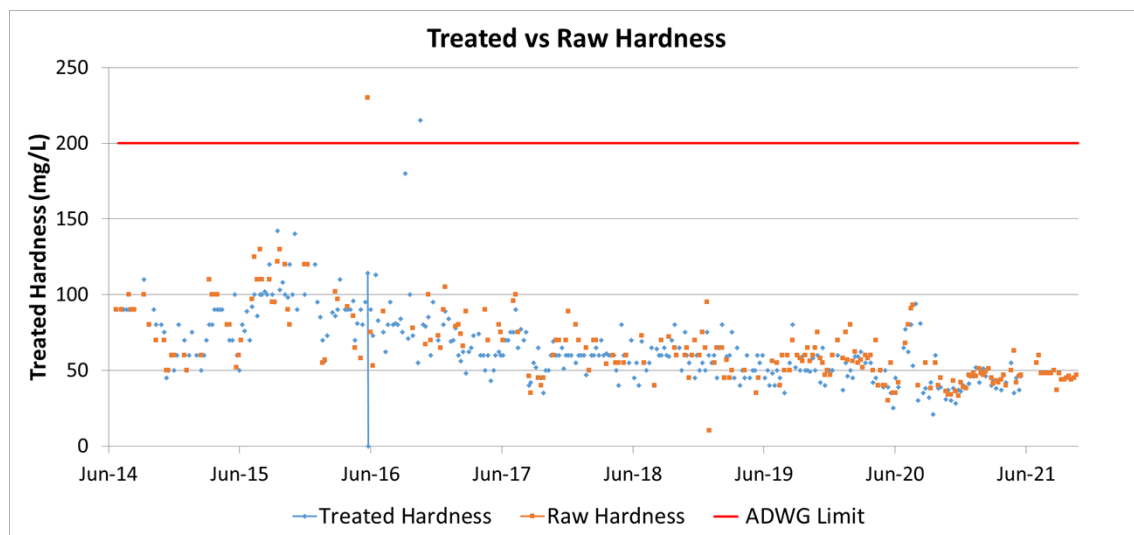
*Figure 0-6: Moranbah Treated Water Hardness*

Figure 0-6 below indicates that the WTP does not have much effect on the hardness of the raw water. This is not considered a problem as the hardness is generally within ADWG aesthetic guidelines, although sometimes potentially corrosive.

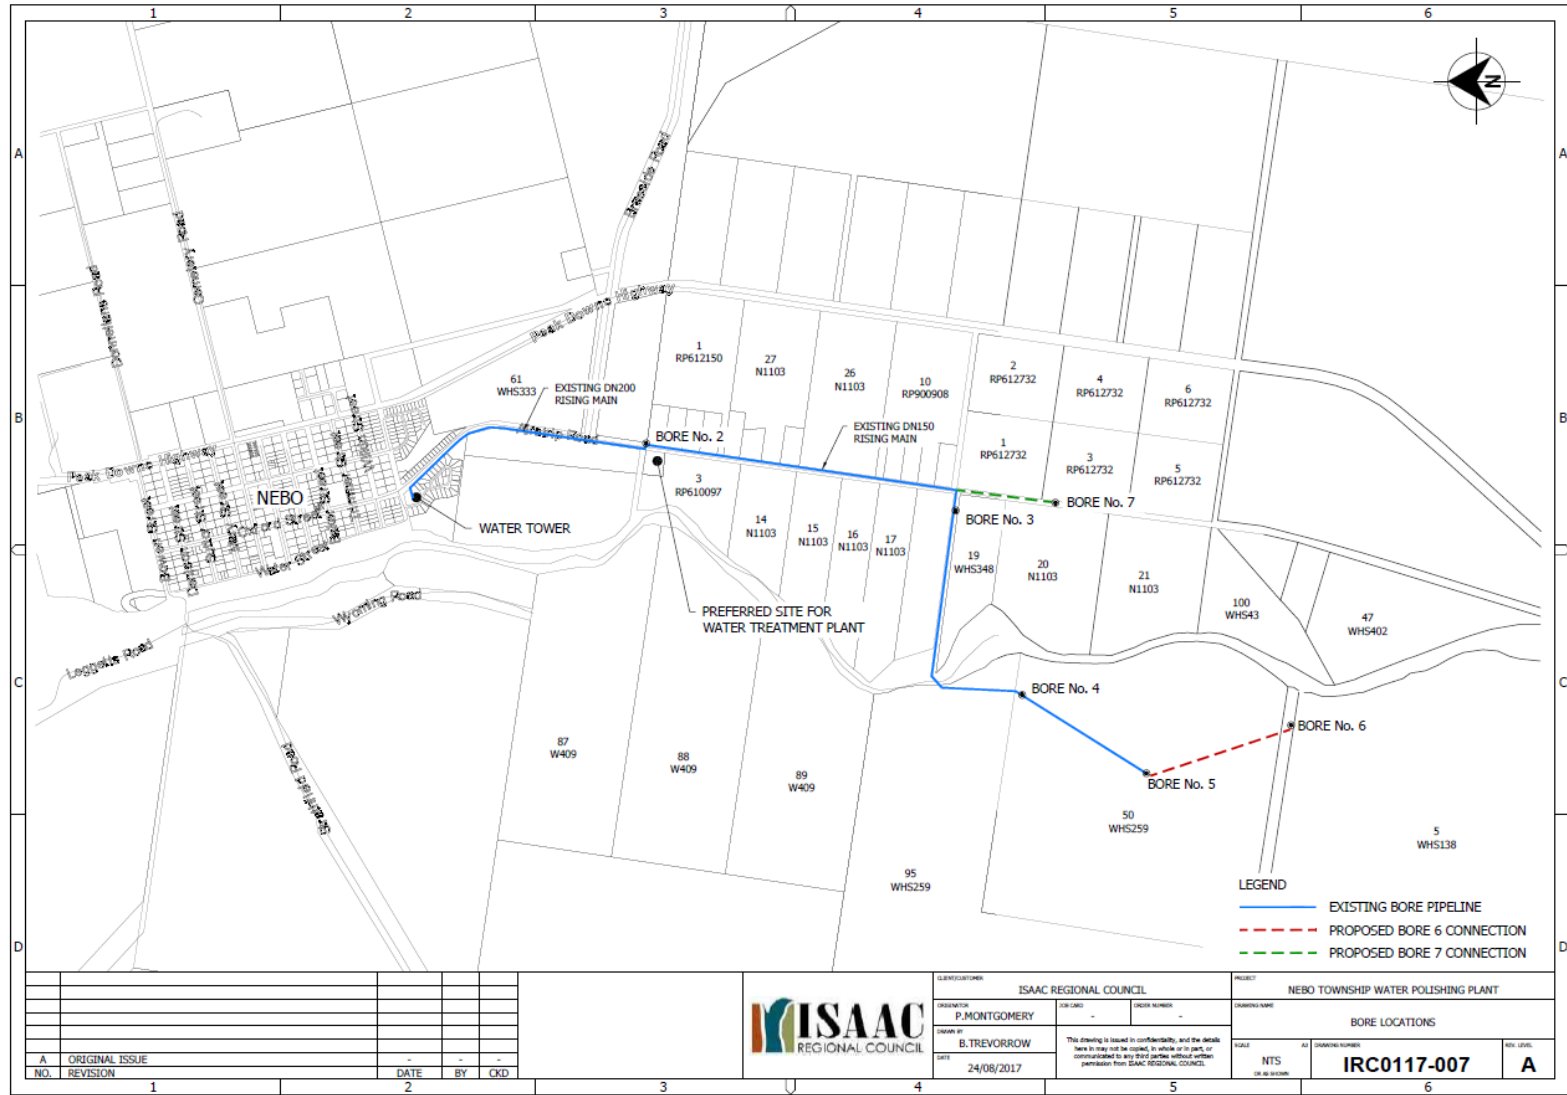
Figure 0-4 : Nebo Bore Locations

The locations of the Nebo bores are shown in [Figure 0-4 : Nebo Bore Locations](#). As shown, all five bores are located south of the township. The current total annual allocation for the bores is 250 ML/year. Bores 2, 3 and 7 are located on the eastern side of Nebo Creek and the other bores, 4, 5, and 6 are located on the western side. During the wet season, the creek level can rise and cut-off access to Bores 4, 5 and 6 so inspection checks and maintenance cannot be performed

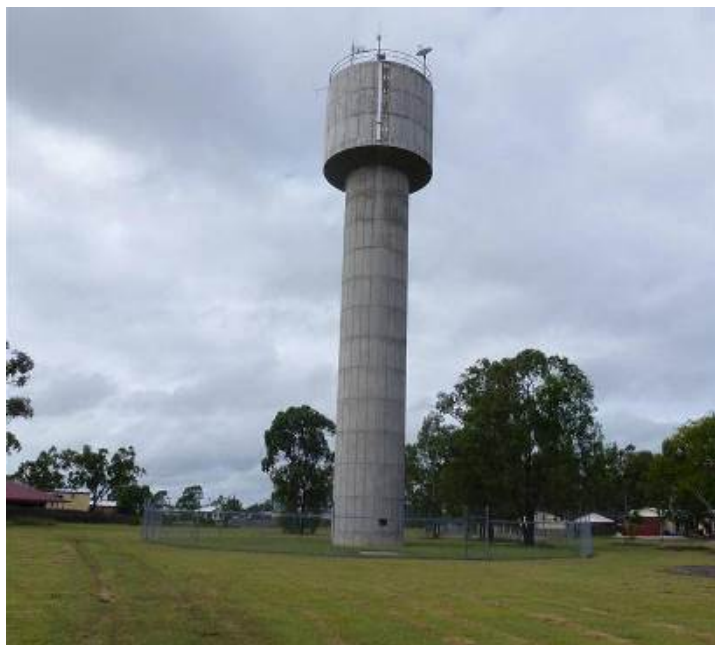
Figure 0-5: Nebo Water Tower

The treated water is pumped from the 2 ML Treated Water Storage Tank to the 250 kL water tower via a DN200 line. The water tower is fully enclosed and made of reinforced concrete.

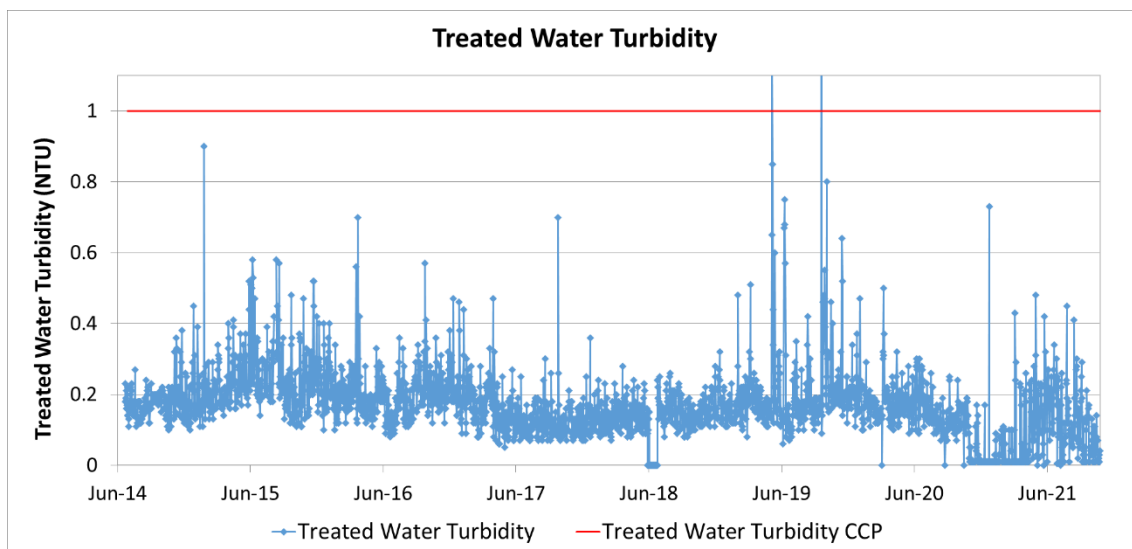
Figure 0-1: Nebo Treated Water Turbidity

Figure 0-1 and Figure 0-2 below show the recorded turbidity and colour data for the Nebo scheme. Both parameters have mostly been within the compliance limits set out in the ADWG (5 NTU and 15 HU respectively) in the past three years, with the exception of 2 turbidity exceedances and 5 colour exceedances, respectively. The results are variable with occasional spikes and do not appear to follow a seasonal pattern, with a slight increase in colour spike incidences in recent years.

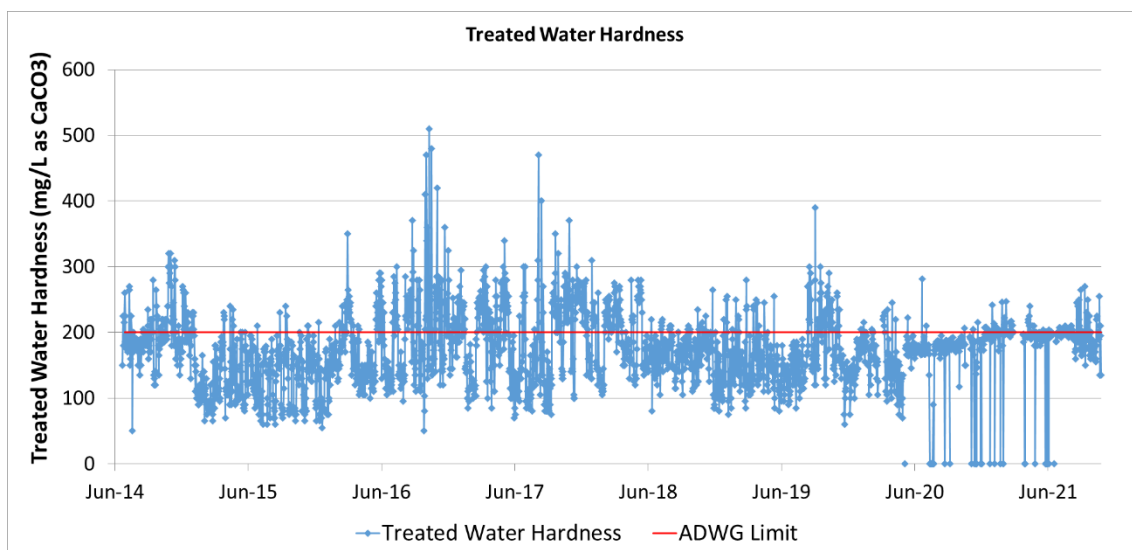
Figure 0-3: Nebo Treated Water Hardness

Figure 0-3 below shows that hardness often exceeds the ADWG limit of 200 mg/L. The results are variable and there does not appear to be a seasonal pattern. A new softening plant has been commissioned at Nebo to address issues with hardness. Hardness levels have since lowered but still consistently straddle the ADWG aesthetic threshold. Further WTP optimisation works are scheduled for early 2022 to improve performance of the treatment process.
