# DRINKING WATER QUALITY MANAGEMENT PLAN

2021

Presented by: Water & Waste Directorate

This Drinking Water Management System document was compiled for Isaac Regional Council by project consultants:

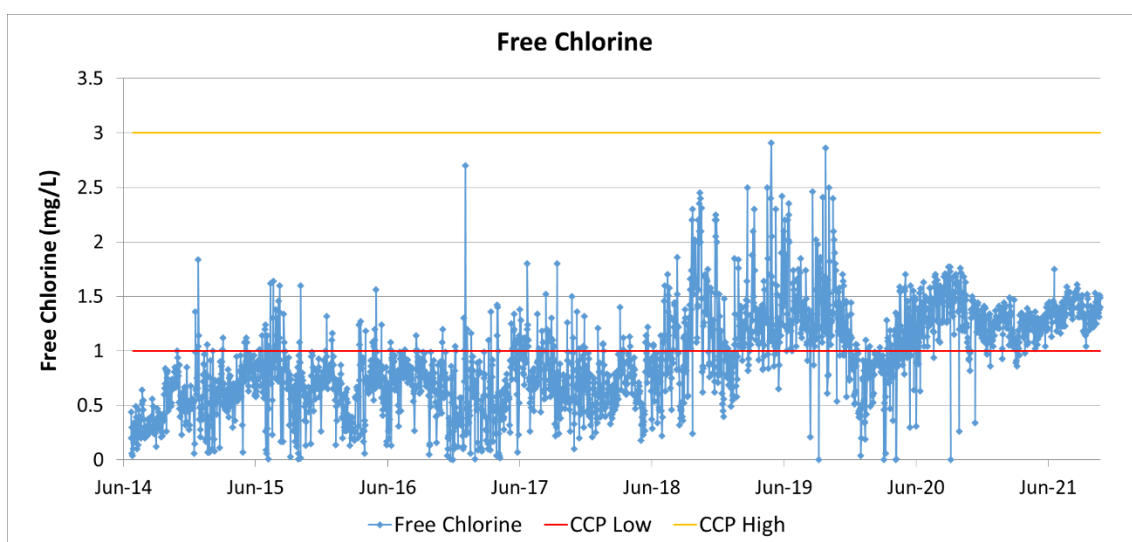
Figure 0-4: Nebo Treated Water Free Chlorine Concentration

Figure 0-4 below shows the free chlorine concentration of the treated water for Nebo. The residual was often below the CCP limit of 1 mg/L however there was significant improvement from 2018. Chlorine residuals again dipped below 1 mg/L for a period around December 2019 but have since stabilised to high levels. It is important to maintain an adequate free chlorine residual to provide evidence of initial disinfection and prevent recontamination in the reticulation.

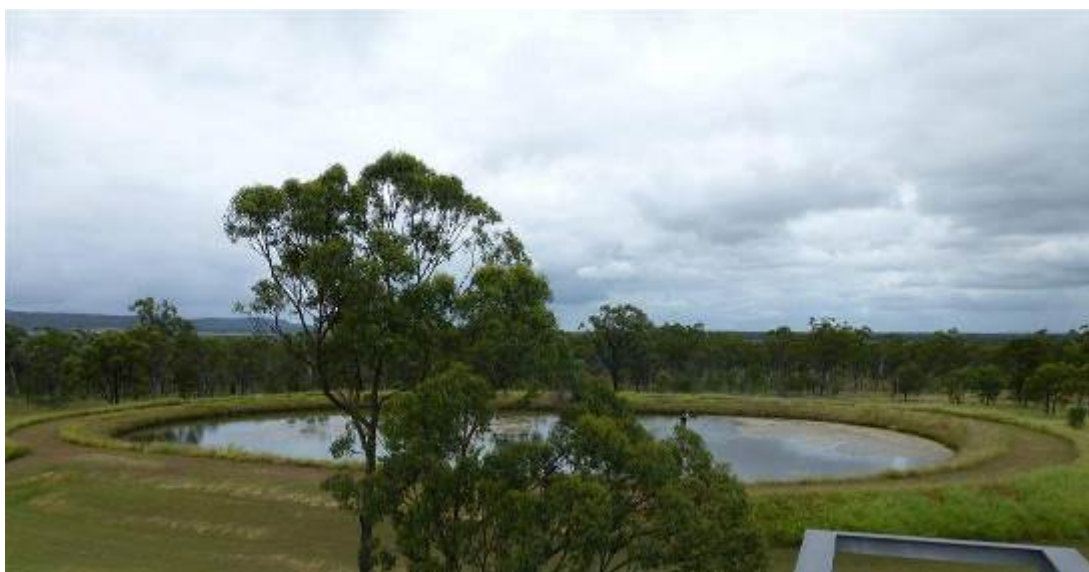
Figure 0-2: Glenden Raw Water Turkeys Nest

Raw water for the Glenden Water Scheme is taken from Bowen River Weir (and the Gattonvale off-stream storage) via the Newlands pipeline to a 100 ML storage lagoon at Newlands Coal Mine (Xstrata), which is then pumped to the raw water turkeys nest at Glenden WTP. The storage lagoon at Newlands coal mine along with the pipe and pump station is currently operated and maintained on behalf of Xstrata by SunWater. The turkey's nest at the WTP has storage of 6 ML. From the turkeys nest onwards, the equipment is owned and operated by Council.

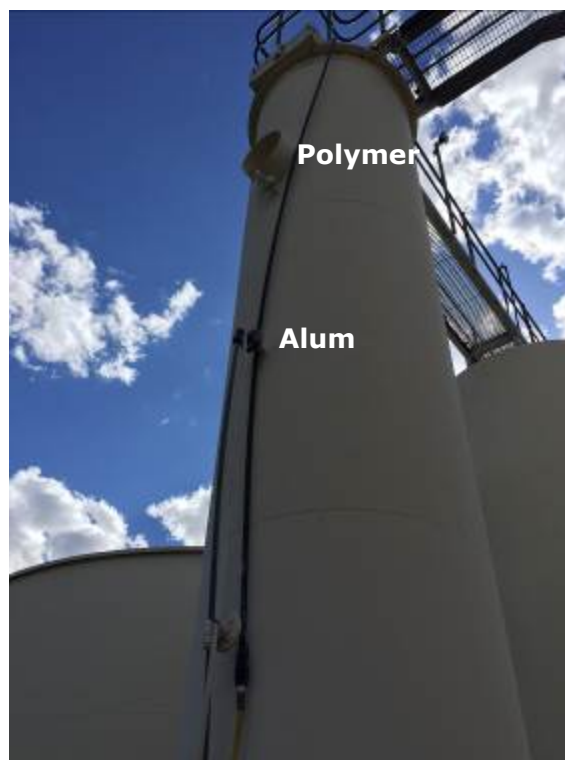
The first dose point is PAC which is dosed when algae and/or taste and odour compounds are detected in the raw water. This is followed by liquid alum dosing for coagulation and then polymer which is dosed into the flash mixer as a flocculation aid. Each chemical system has two dosing pumps which operate in a duty/ standby configuration. The pump duty is changed over manually by the operators. Mixing occurs hydraulically in the flash mixer tank.

*Figure 0-3: Flash Mixer and Dosing Points*

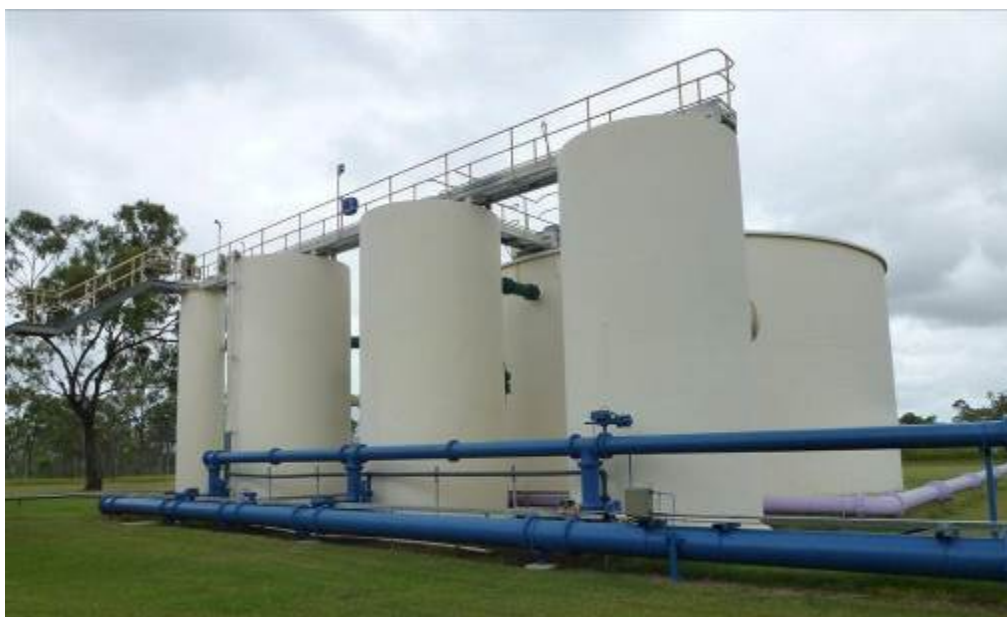
All chemical dosing pumps are interlocked with the flow to the treatment plant and the dosing rates are manually adjusted. No dilution water is available for chemical dosing. The treatment plant is pictured in Figure 0-4.

*Figure 0-4: Glenden WTP*

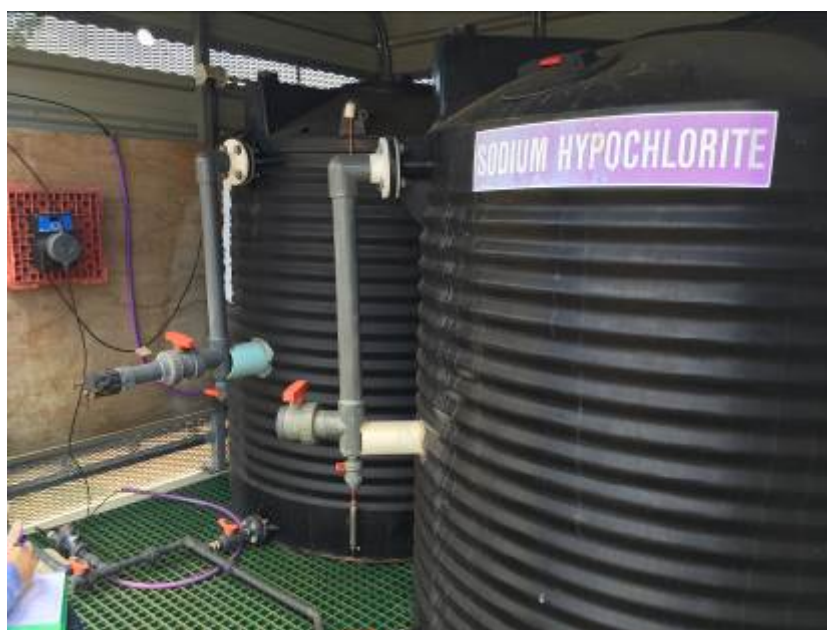
Figure 0-5: Sodium Hypochlorite System

Sodium hypochlorite is stored in black chemical tanks in an outdoor enclosed and ventilated shed. A single duty dosing pump is installed for the disinfection system.

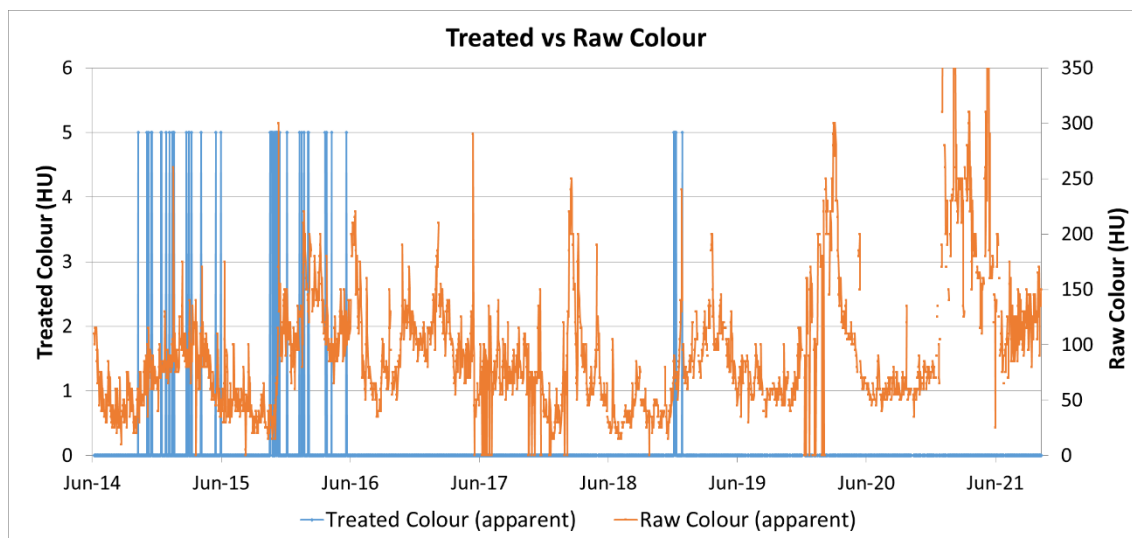
Figure 0-1: Glenden Raw and Treated Water Colour

The chart below shows raw and treated water colour for Glenden WTP. There have been times in the past (December 2015, July 2017 and December/January 2019) when colour has been high. However, treated water colour has not exceeded 5 HU, but this could potentially be as a result of the current testing equipment and/or program. Regardless, treated water colour has remained low since January 2019 irrespective of raw water colour spikes.

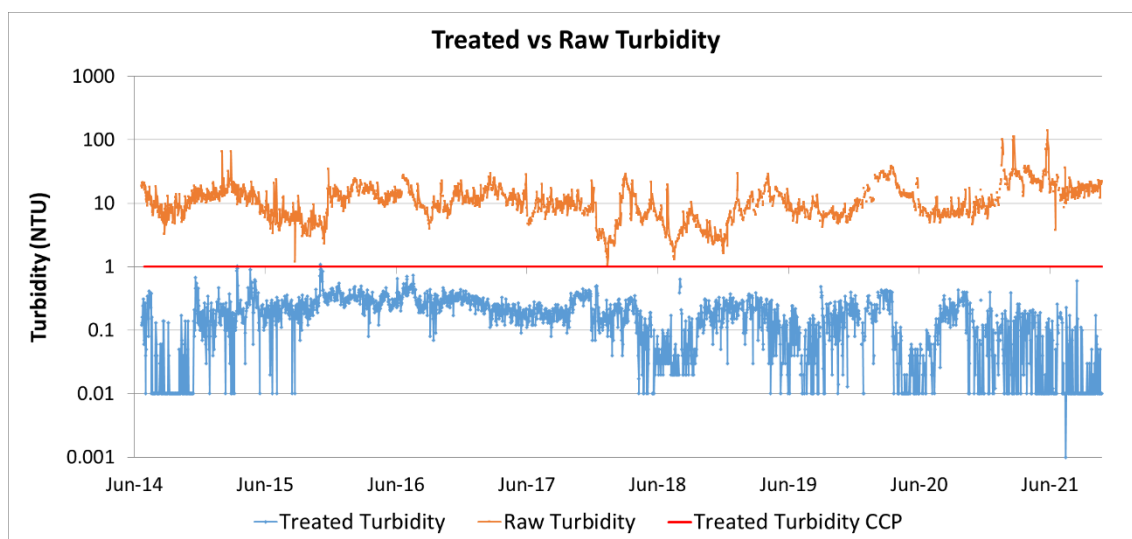
Figure 0-2: Glenden Raw and Treated Water Turbidity (In-house Results)

The graph below shows raw and treated water turbidity on a logarithmic scale. This graph shows that there have been no spikes in treated water turbidity, regardless of raw water turbidity since November 2015.

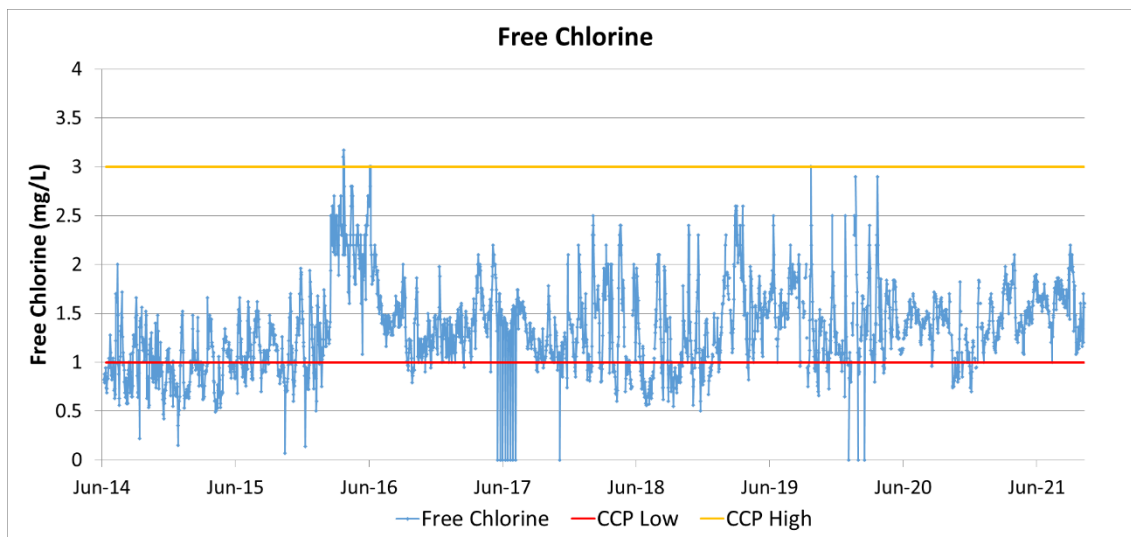
Figure 0-3: Glenden Treated Water Free Chlorine Residual

Figure 0-3 shows free chlorine residual of the treated water leaving Glenden WTP. From July 2014 until February 2016 there are large fluctuations in the free chlorine residual indicating the dosing system was not well controlled. Since this time there has been increased monitoring and the chlorine residual has stabilised, with fewer samples below the CCP limit of 1 mg/L. Chlorine residuals do still fluctuate, however, with a period of heightened variation occurring in early 2020.

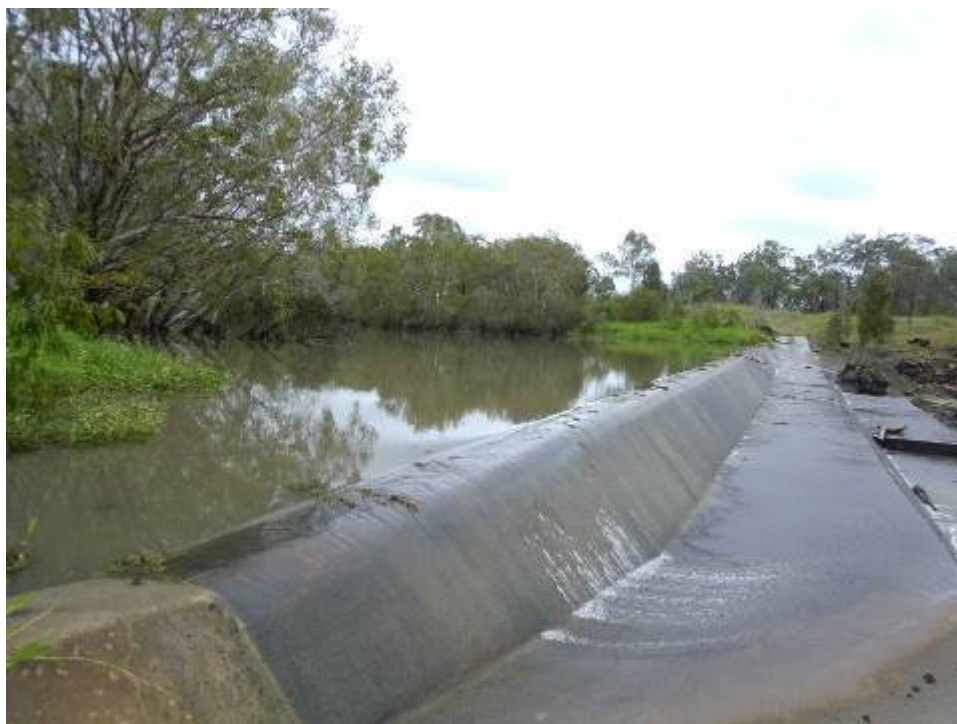
Raw water for the St Lawrence Water Scheme is taken from the St Lawrence Creek approximately 500 m upstream from the St Lawrence Creek Weir. The Weir acts as a tidal barrier and provides a total storage capacity of 210 ML<sup>17</sup>. The operational staff noticed that when the water level in the St Lawrence Creek was low there was a decrease in quality of the raw water. This is possibly due to water becoming saline as saltwater seeps through the Weir.

*Figure 0-3: St Lawrence Creek Weir*

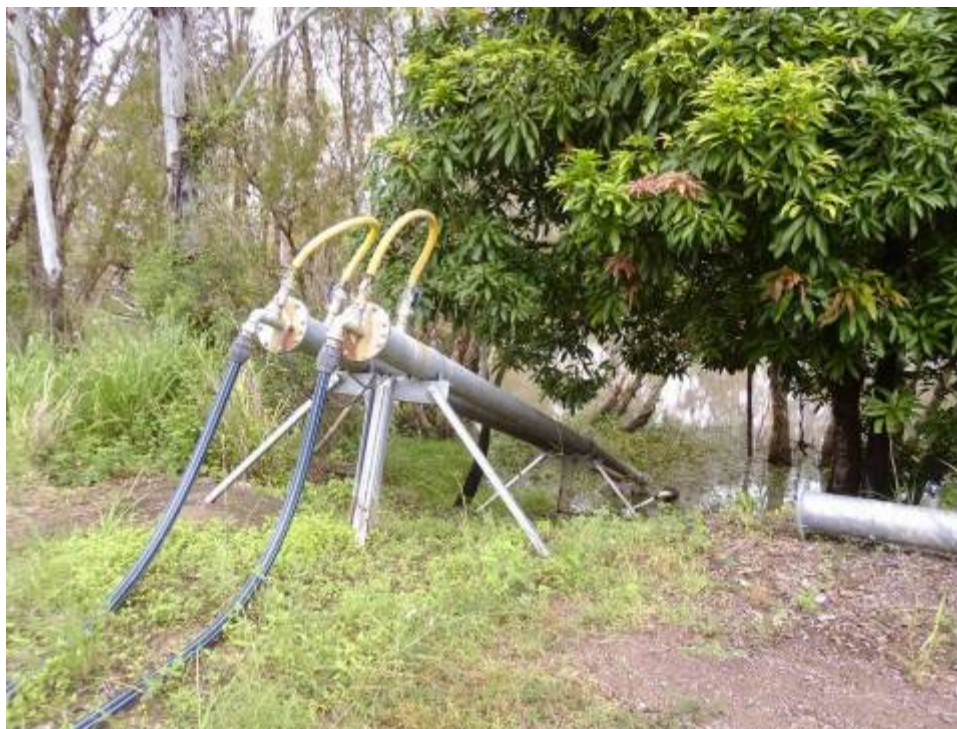
Two high lift pumps are used in a duty/standby arrangement to pump the raw water from St Lawrence Creek Weir to the WTP. The pumps are submersed with one reaching deeper into the creek. The pump set at a higher position is generally the duty pump. This mitigates elevated levels of turbidity, iron and manganese content found in the raw water deeper in the creek. Pumps are equipped with call out alarms on failure.

A 100 mm diameter rising main constructed from AC and uPVC pipe connects the raw water pump station to the St Lawrence WTP. The raw water pumps are presented below in Figure 0-4.

*Figure 0-4: Raw Water Pumps at St Lawrence Weir*

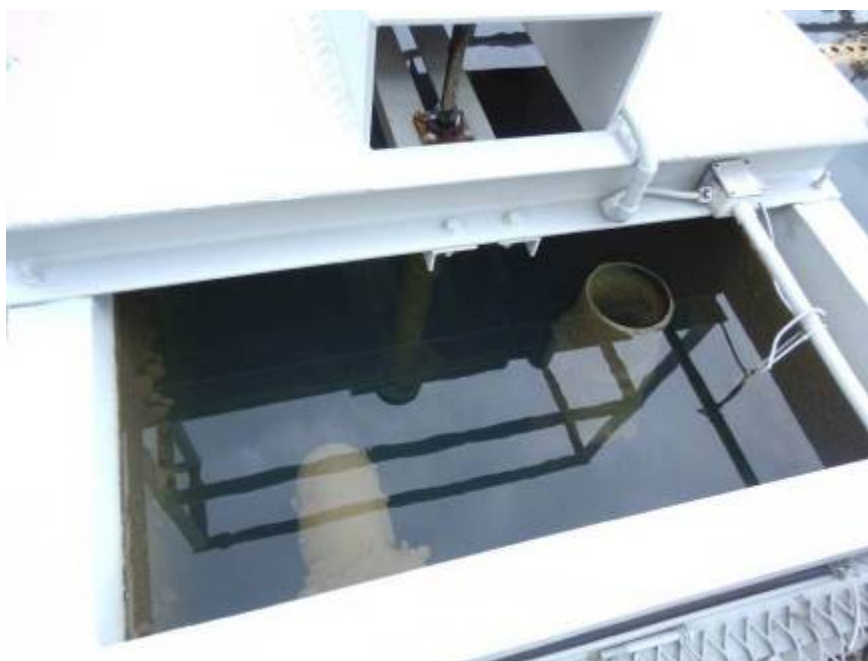
After raw water dosing the water flows into the flash mixer. The flash mixer has one mixer and a volume of 6 kL.

*Figure 0-5: Flash Mixer/Flocculation Chamber*

Some corrosion was evident in the flocculation chamber. The external structure is in good condition.

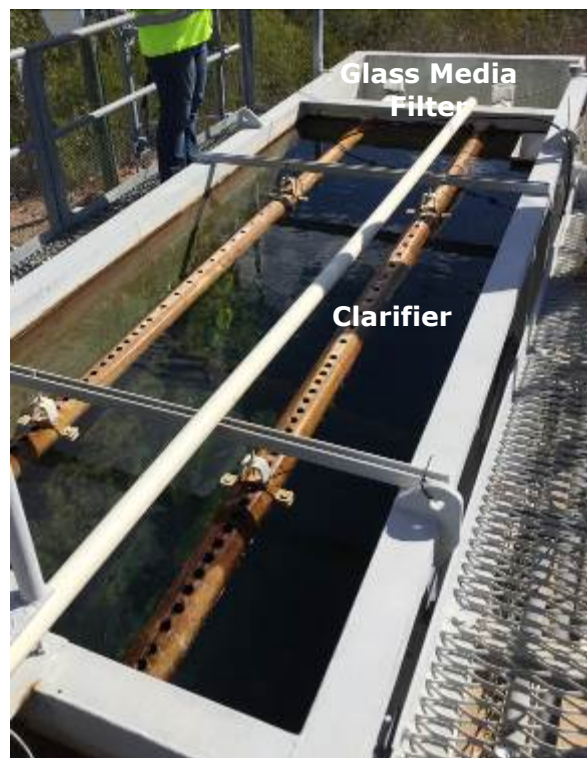
Sludge is released automatically by opening a de-sludge valve at the bottom of the clarifier. This de-sludge valve is set to a timer, the frequency of which is determined by the operator depending on the quality and quantity of the raw water. The sludge is released to sludge settling ponds.

*Figure 0-6: Clarifier and Glass Media Filter*

Corrosion and significant iron sediment was present in the clarifier, sand blasting and refurbishment was completed in 2017 to address this. External surfaces were in good condition and recently repainted.

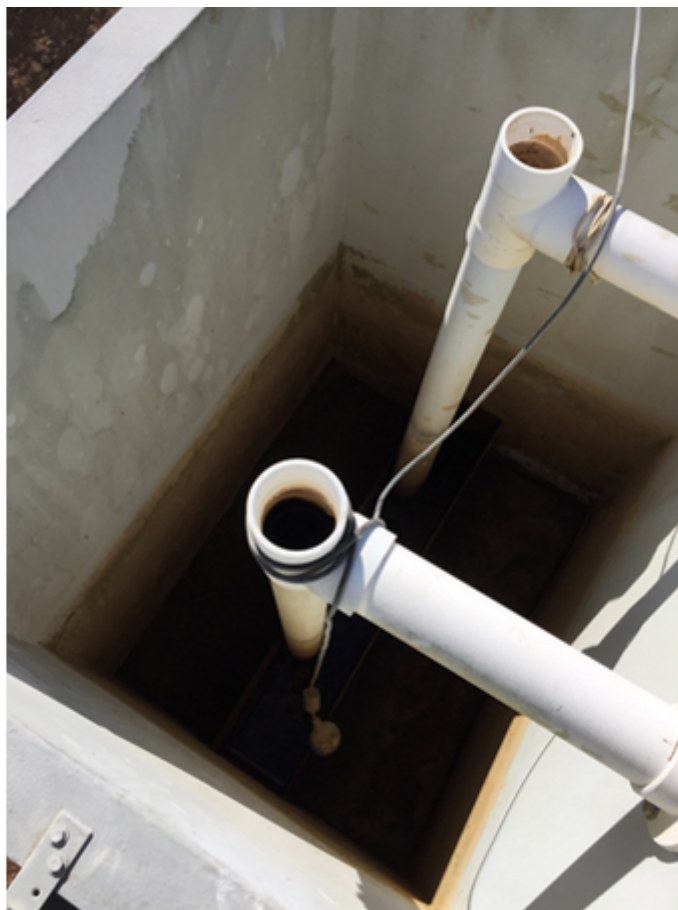
Filter backwash is triggered automatically when headloss across the media bed increases and the water level rises. A primitive level float sensor is installed in the filter (Figure 0-7) to trigger backwash initiation.

*Figure 0-7: Primary Filter Level Float Sensor*

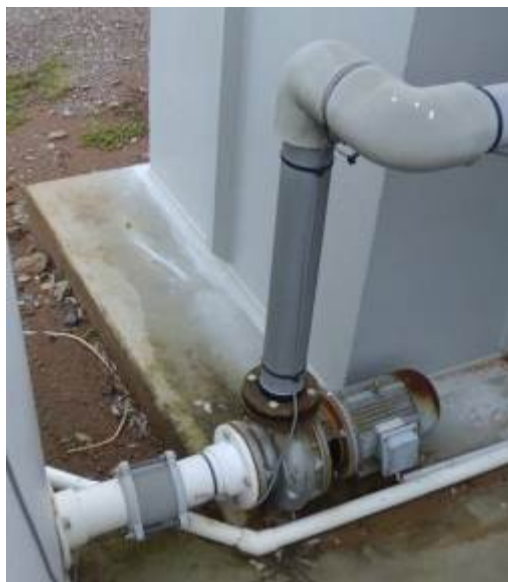
*Figure 0-8: Backwash Pump*

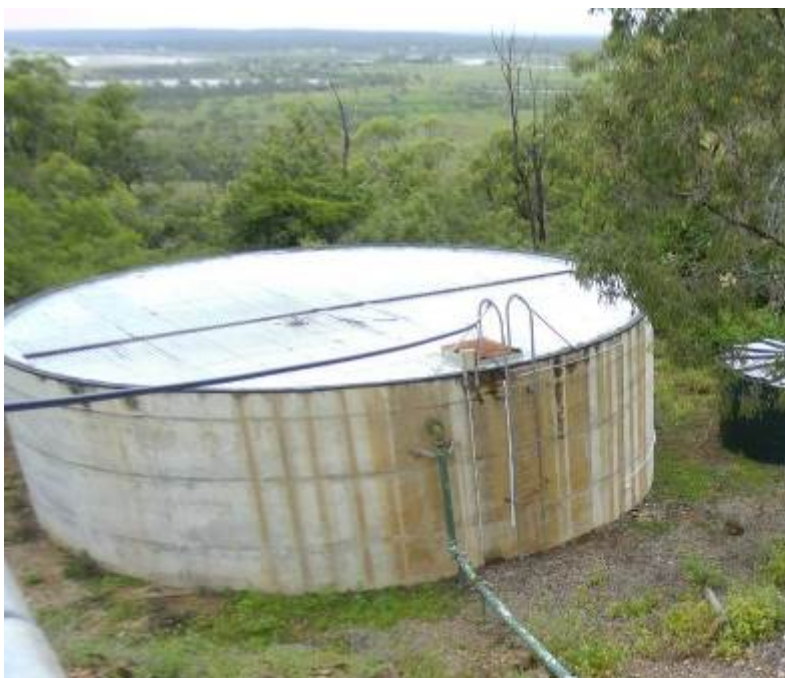
The treated water from the St Lawrence WTP is gravity fed through a 100 mm diameter line to the treated water reservoir. It is constructed of concrete and has a capacity of 300 kL as is shown below in Figure 0-9. The reservoir is located at the WTP and the connecting pipe is approximately 25 m in length.

*Figure 0-9: Treated Water Reservoir*

The reservoir roof has been replaced to prevent recontamination of treated water. Planning for a new WTP in a new location is currently being considered in line with assessment of asset condition and requirements of population growth in the area.

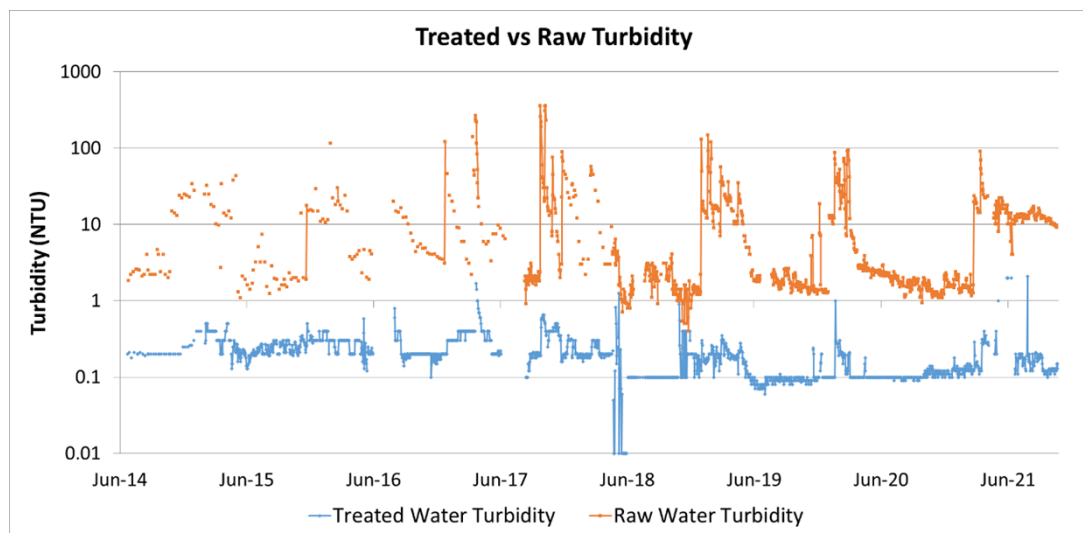
Figure 0-1 shows raw and treated water turbidity for St Lawrence WTP on a logarithmic scale. Increasing raw water turbidity can be seen to have a minor impact on treated water turbidity, however, the treatment process is usually sufficient to maintain turbidity at acceptable levels. The two exceedances seen in March 2017 correspond to increased raw water turbidities of over 150 NTU. More recently, 4 exceedances were seen in March – August 2021 and also appear to coincide with raw water turbidity spikes.

Figure 0-1: St Lawrence Raw and Treated Water Turbidity

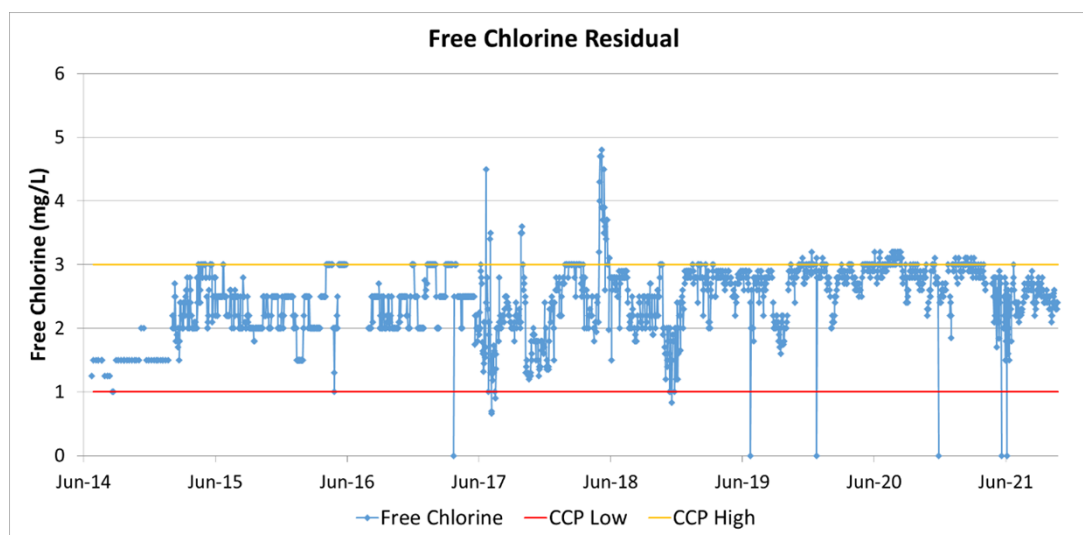
The figure below shows free chlorine residual for treated water at St Lawrence. Large fluctuations in free chlorine residual are seen from May – August 2017 and again in May 2018. Lower turbidity seen in August 2017 (around 2 NTU) corresponds with a stabilisation of the free chlorine residual. Chlorine residuals have remained stable and slightly high since December 2020, often exceeding the upper CCP limit of 3 mg/L, however these have recently been trending downwards.

Figure 0-2: St Lawrence Treated Water Free Chlorine Residual

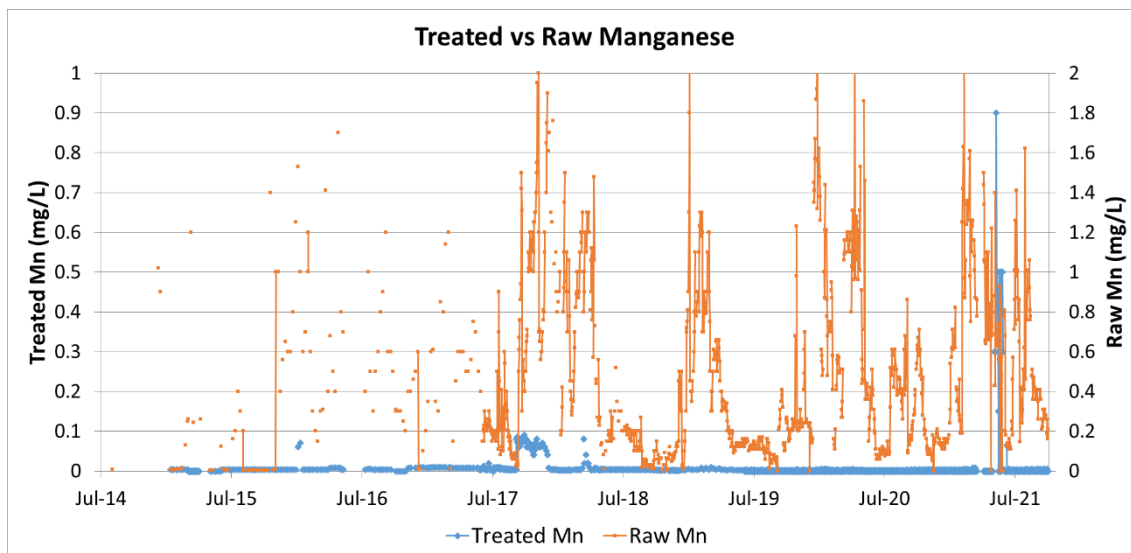
Figure 0-3 and Figure 0-4 show raw and treated water, manganese and iron levels (respectively). Both parameters experience some spikes iron and manganese, however, all treated water samples have historically fallen well below the ADWG recommended limits. Both treated water manganese and iron spiked above ADWG guidelines in June 2021, coinciding with spikes in raw water concentrations.

Figure 0-3: St Lawrence Raw and Treated Water Manganese

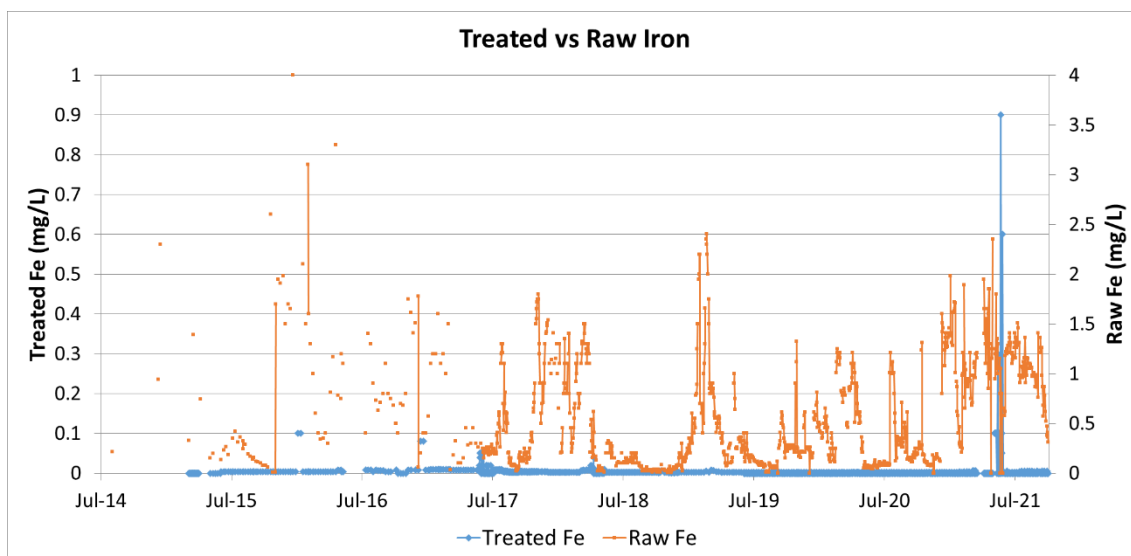
Figure 0-4: St Lawrence Raw and Treated Water Iron

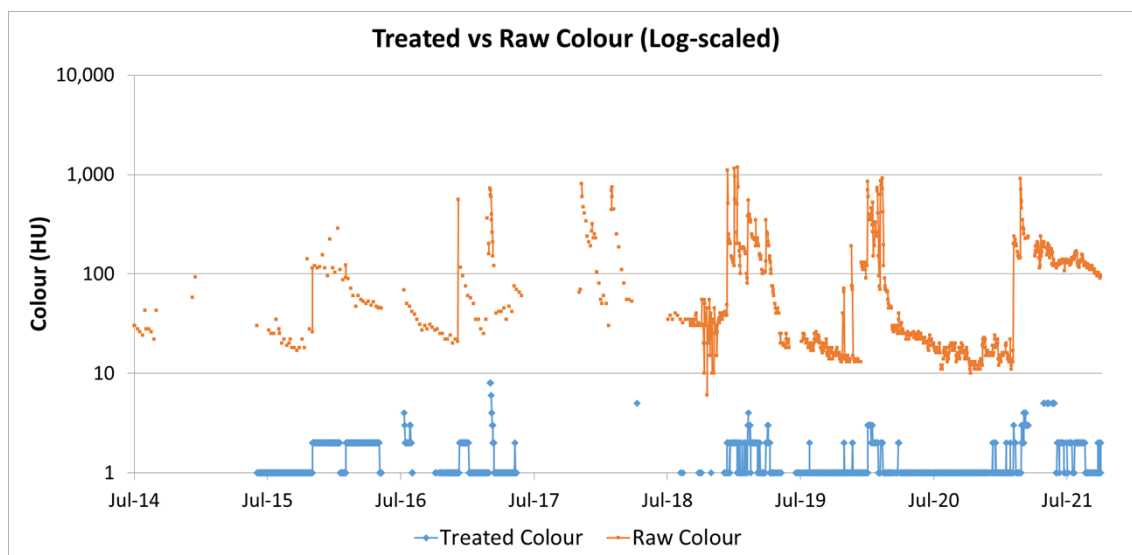
The figure below shows raw and treated water colour on a logarithmic scale. St Lawrence experiences some spikes in raw water colour, however the graph shows there have been no exceedances of the ADWG limit (15 HU) for treated water colour.

Figure 0-5: St Lawrence Raw and Treated Water Colour

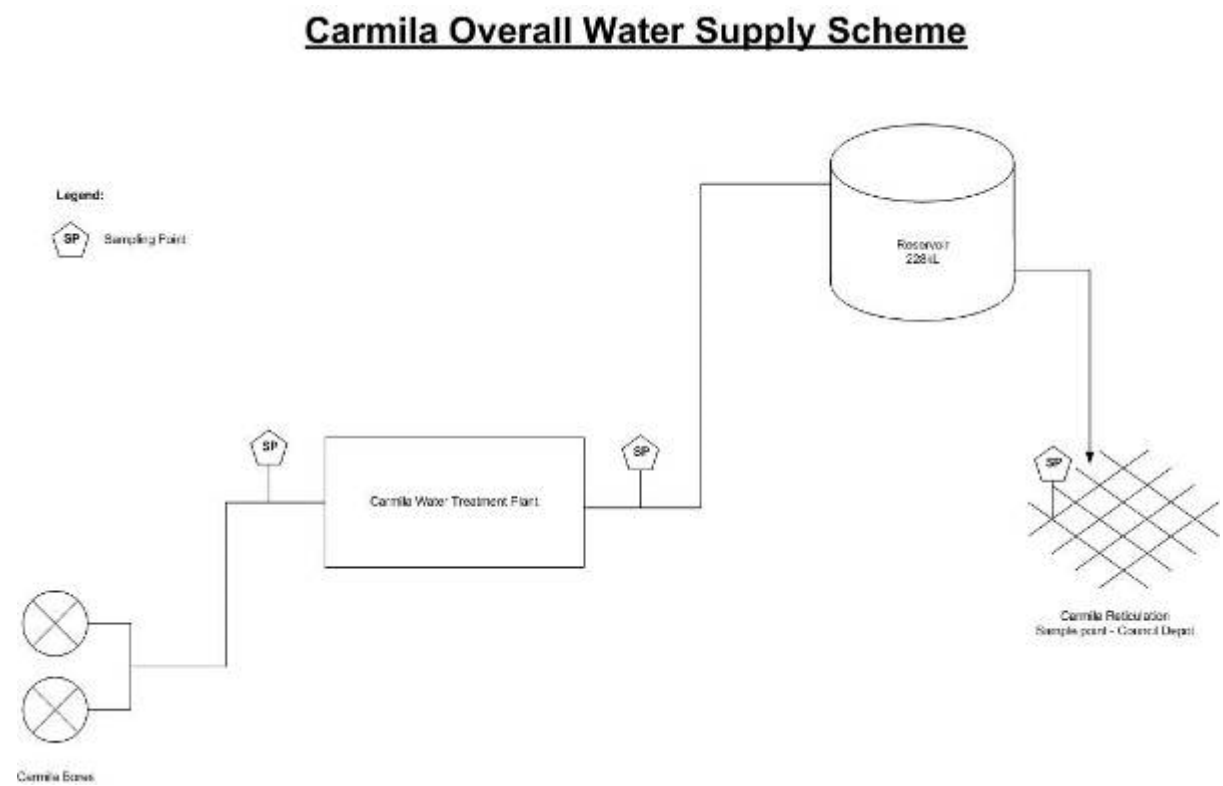
Figure 0-1: Carmila Overall Water Supply Scheme

System Component	Description
<b>Population Supplied</b>	Total connections of approximately 71 comprising approximately 333 persons.
<b>Water Sources</b>	Raw groundwater is taken from two shallow raw water bores near Carmila Creek.
<b>Water Treatment</b>	<p>Raw Water from the bores is treated at Carmila WTP as follows:</p> <ul style="list-style-type: none"> <li>• Coagulation with alum;</li> <li>• Calcium hypochlorite dosing for iron and manganese oxidation and final disinfection;</li> <li>• Polymer dosing as a flocculation aid;</li> <li>• Flocculation;</li> <li>• Clarification; and</li> <li>• Media filtration.</li> </ul> <p>The wastewater system comprises:</p> <ul style="list-style-type: none"> <li>• Sludge drying beds (x3).</li> </ul>
<b>Storage After Treatment</b>	<ul style="list-style-type: none"> <li>• 16 kL Clearwater Tank onsite</li> <li>• 228 kL Elevated Treated Water Reservoir</li> </ul> <p>Both are roofed and vermin proofed.</p>

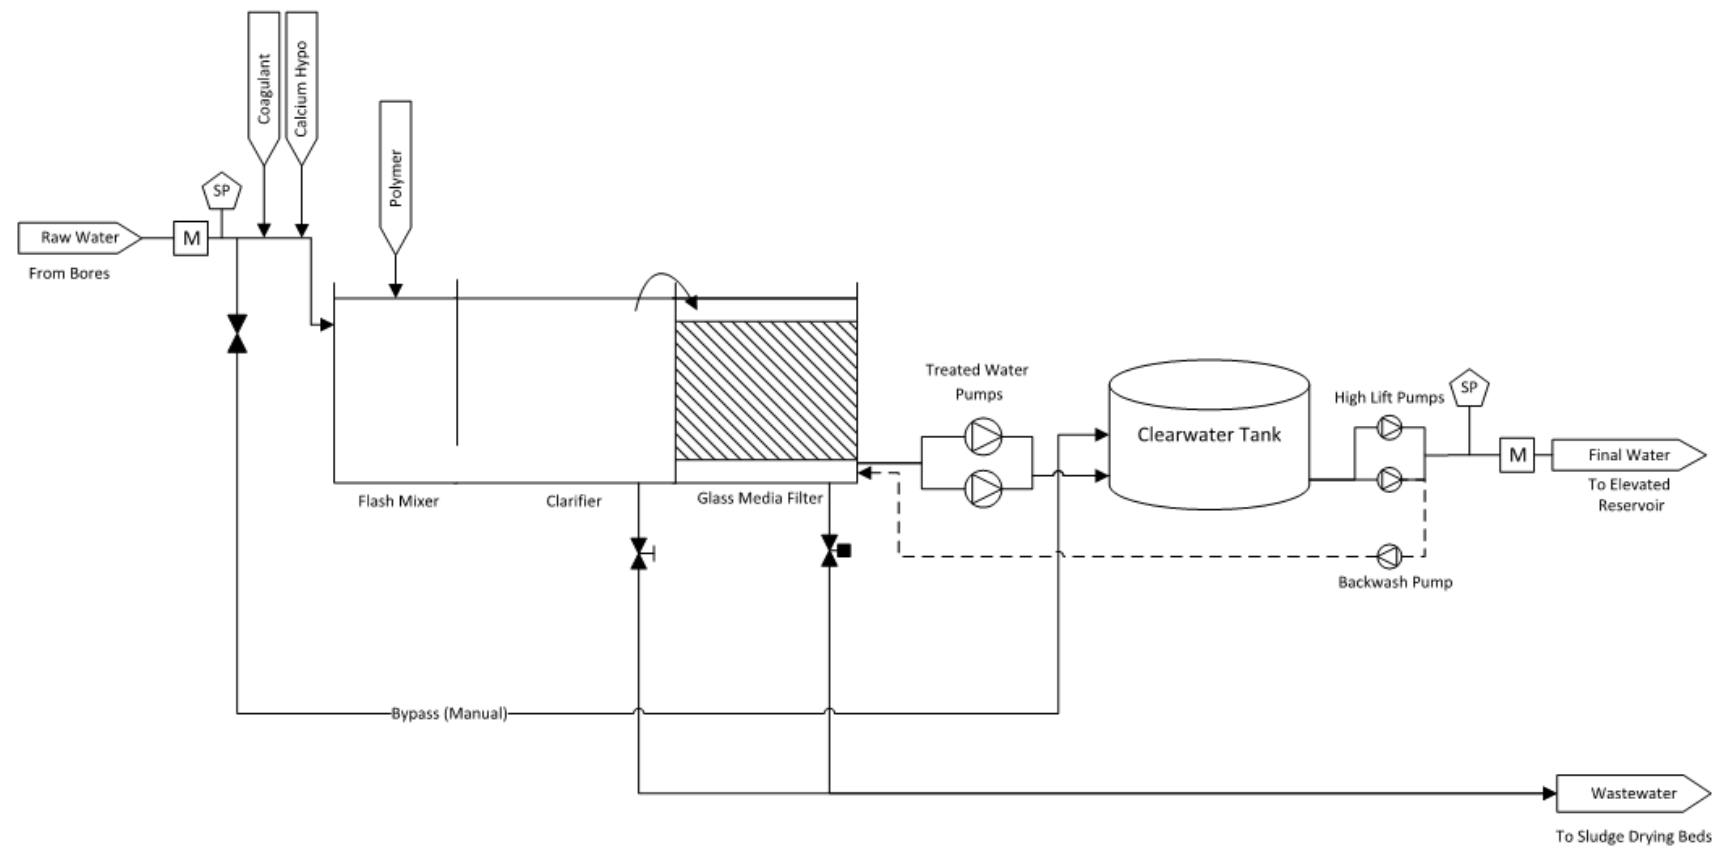
Figure 0-2: Carmila Water Treatment Plant

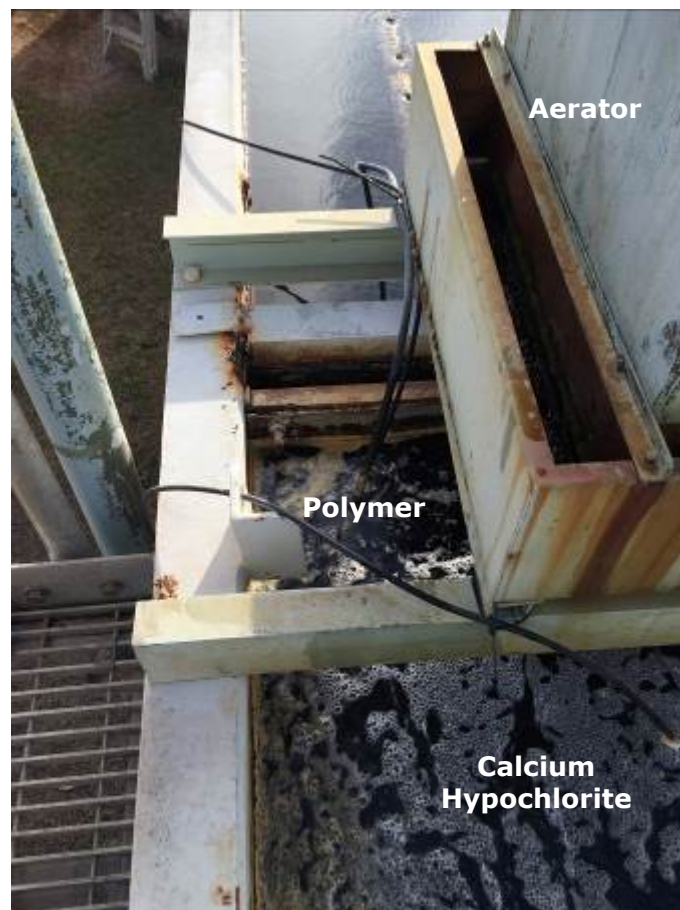
Alum for coagulation and calcium hypochlorite for iron and manganese oxidation are added prior to the flash mixer. Polymer is dosed as a flocculation aid directly into the flash mixer. The operator advised that calcium hypochlorite dosing at this location is usually sufficient to provide primary kill and an appropriate chlorine residual at the ends of the reticulation.

*Figure 0-3: Chemical Dosing into Flash Mixer*

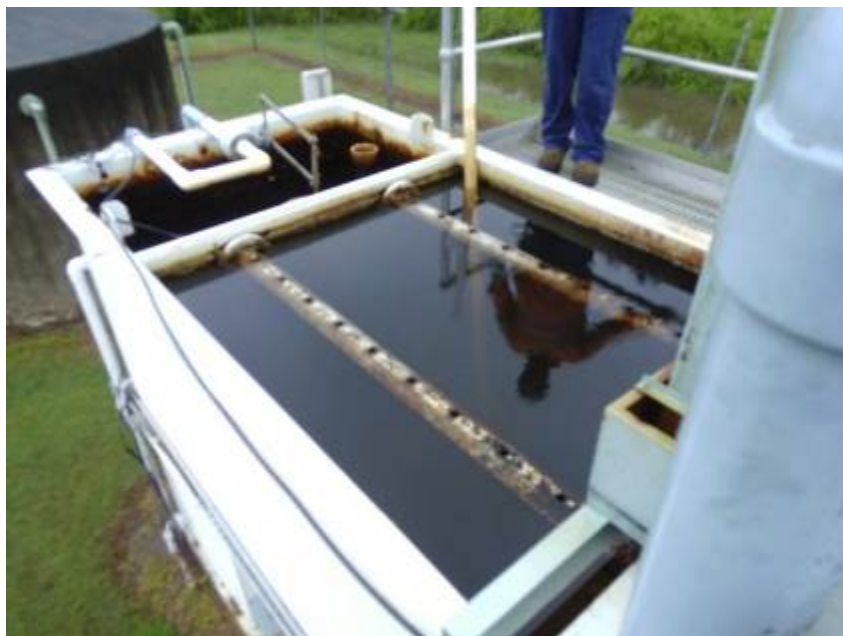
Sludge is released by manually opening a de-sludge valve at the bottom of the clarifier. The frequency of this is determined by the operator depending on the quality and quantity of the raw water being treated. This process is generally conducted on a weekly basis with the sludge released to one of the three sludge drying beds.

*Figure 0-4: Clarifier*

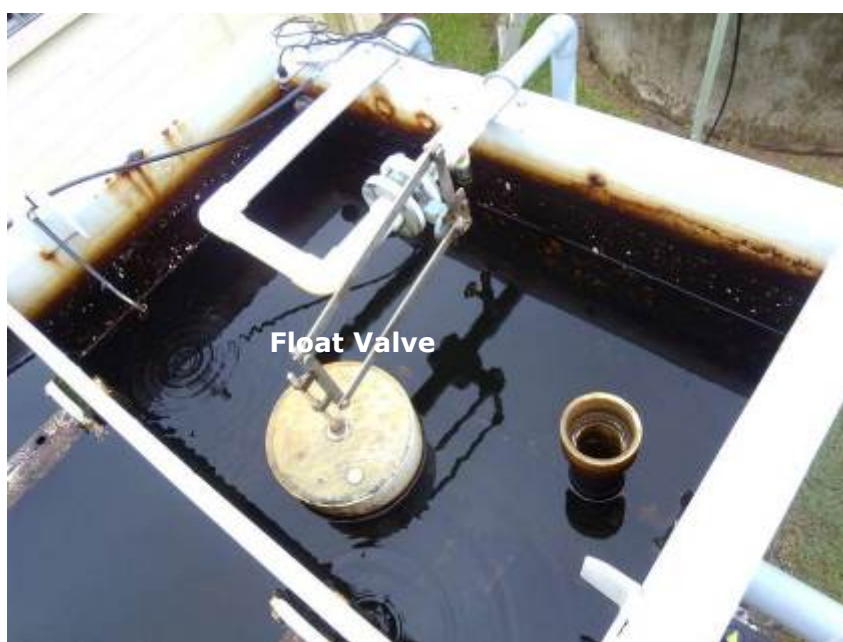
The media filter has a filtration area of 1.5 m<sup>2</sup> and rate of approximately 7.2 m/h. The filter is pictured in Figure 0-5.

*Figure 0-5: Filter*

Filter backwash is initiated when the filter has operated for 12 hours and the sequence is automatically activated by a timer. The backwash sequence is automatic and consists of draining the filters to a pre-set level, starting the backwash pump, and running the backwash pump before re-commencing filtration. Air scour is not included in the backwash sequence even though polymer is dosed.

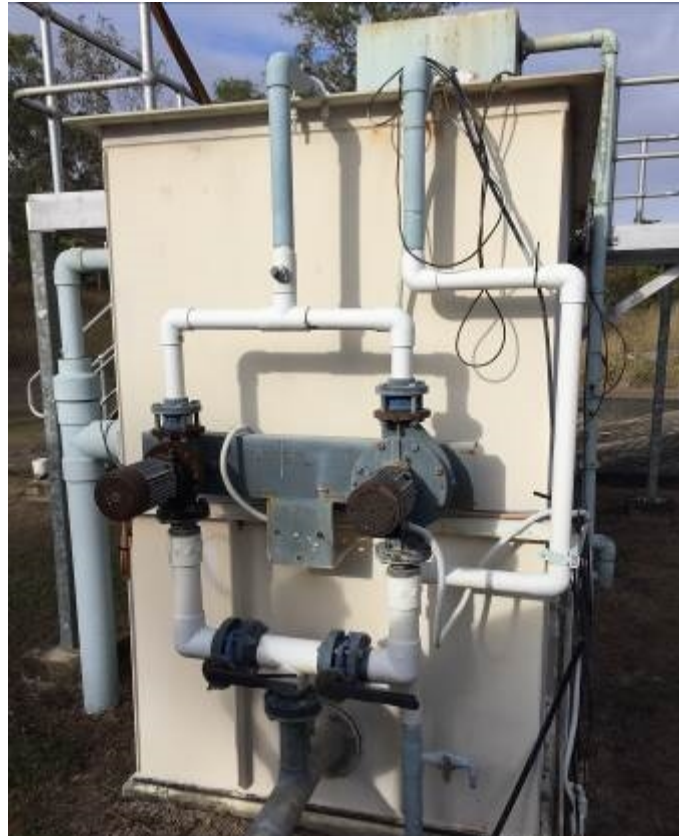
The treated water is pumped by two pumps in a duty/standby arrangement from the filter to the clearwater tank.

*Figure 0-6: Treated Water Pumps*

The clearwater tank is constructed from concrete and has a volume of 16 kL. The water is pumped from the clearwater tank to the treated water reservoir via two high lift pumps operating in a duty/standby arrangement. The treated water pumps, clear water tank, high lift pumps and backwash pumps are pictured in Figure 0-6 and Figure 0-7.

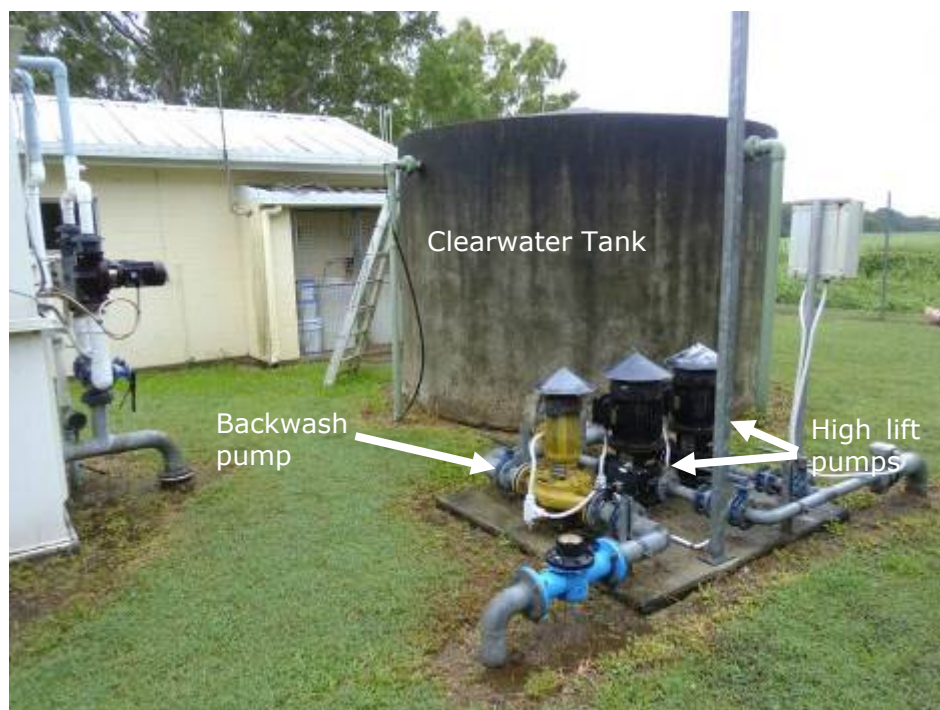
*Figure 0-7: Clearwater Tank, High Lift Pumps and Backwash Pump*

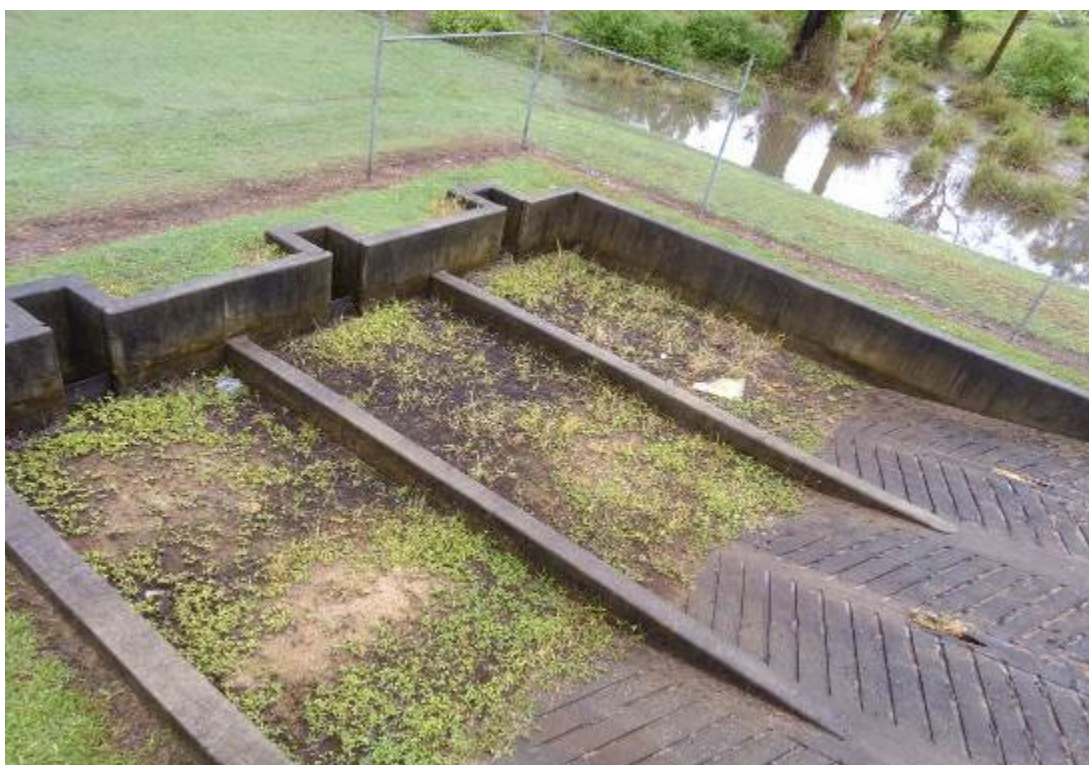
There are three sludge drying beds which receive the clarifier sludge and waste backwash water. The drying beds operate in parallel and the operator manually directs the sludge to the selected sludge drying bed.

The amount of sludge accumulated in the clarifier is very small. This results in infrequent sludge disposal from the drying beds.

Figure 0-8: Sludge Drying Beds

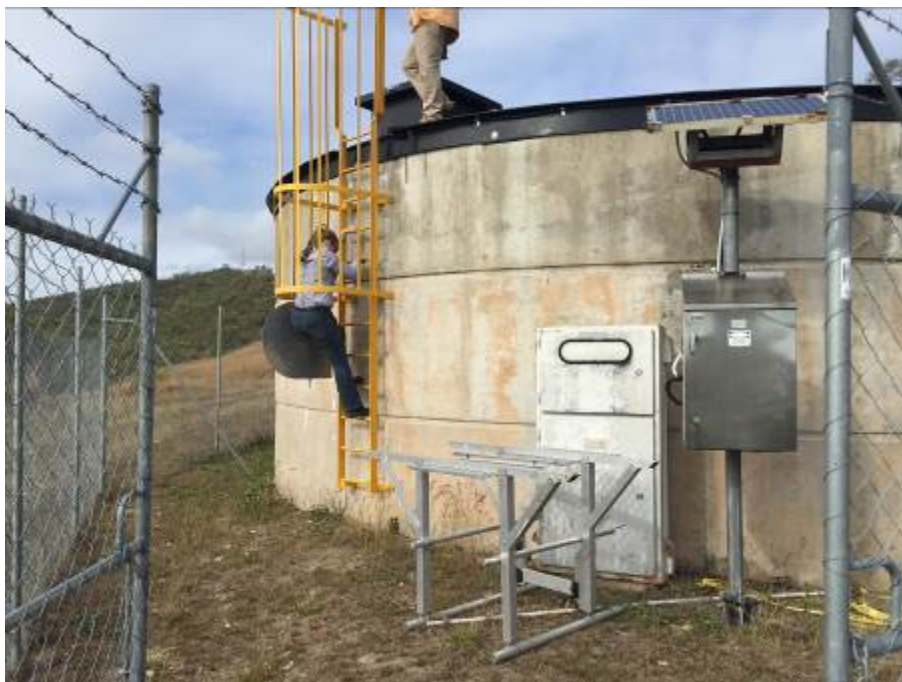
The level in the treated water reservoir controls the WTP's throughput. When the level reaches the low level setpoint, the bore pumps are triggered to start and supply raw water to the WTP. The treated water reservoir is pictured in Figure 0-9.

Figure 0-9: Carmila Treated Water Reservoir

The treated water reservoir is a 228 kL concrete tank. The original concrete roof has recently (early 2015) been replaced with a black poly roof. The reservoir is fully enclosed and secure. The transmitter at the treated water reservoir is solar powered. Table 0-3 presents a summary of the information about the treated water reservoir.

Volume	228 kL
Materials of construction	Concrete
Roof	Yes
Vermin-Proof	Yes

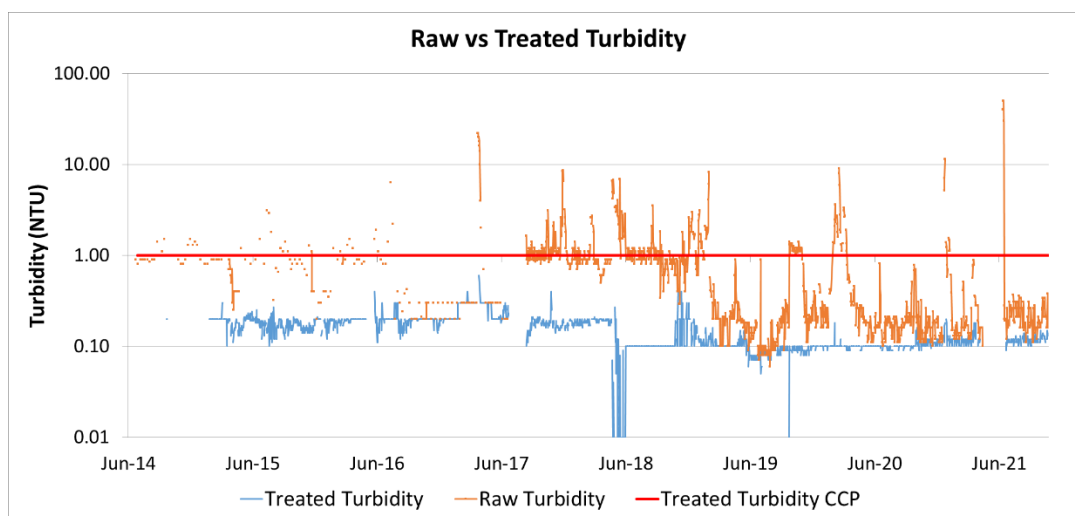
Figure 0-1 shows raw and treated water for Carmila WTP on a logarithmic scale. The red line shows the CCP limit of 1 NTU for treated water turbidity. Raw water turbidity is generally quite low at Carmila WTP, consequently treated water turbidity is also generally quite low and always below the CCP limit. There is a period in October 2016 where raw water turbidity is lower than treated water turbidity, likely due to poor coagulation and filter operation. Raw turbidity has remained generally low since February 2019 with only occasional spikes since. Despite these, treated water turbidity has remained stable and satisfactory.

Figure 0-1: Carmila Raw and Treated Water Turbidity
