# DRINKING WATER QUALITY MANAGEMENT PLAN

2021

Presented by: Water & Waste Directorate

This Drinking Water Management System document was compiled for Isaac Regional Council by project consultants:

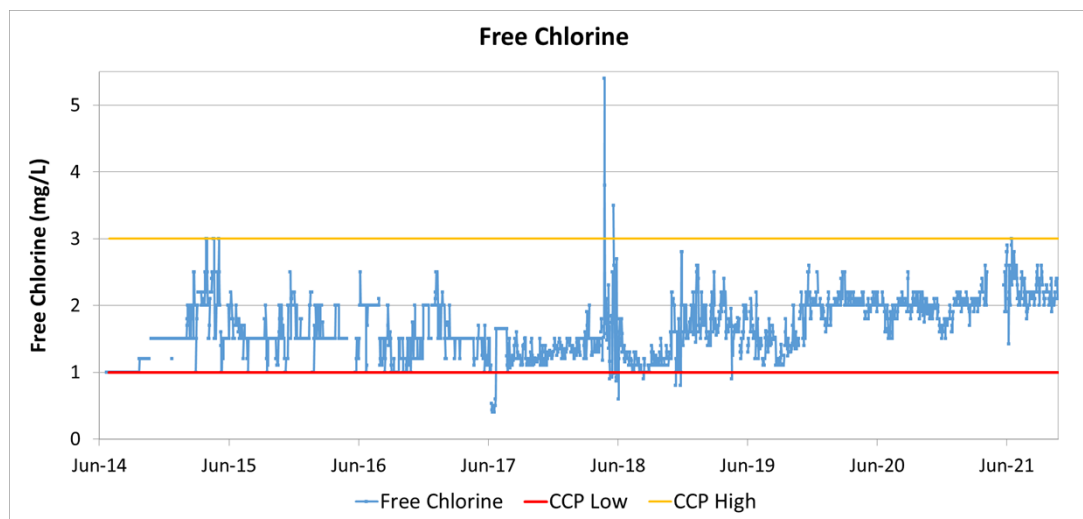
The figure below shows the treated water chlorine residual for Carmila WTP. Chlorine residual is generally maintained within the limits set out by the chlorine CCP (1-3 mg/L), however there was a number of exceptions in 2017 and 2018 and an exceedance of the ADWG health guideline value in May 2018. These results suggest there was a loss of dosing or control during these times. Chlorine has remained stable around 2 mg/L since December 2019, barring a brief period of fluctuation in June 2021.

Figure 0-2: Carmila Raw and Treated Water Free Chlorine

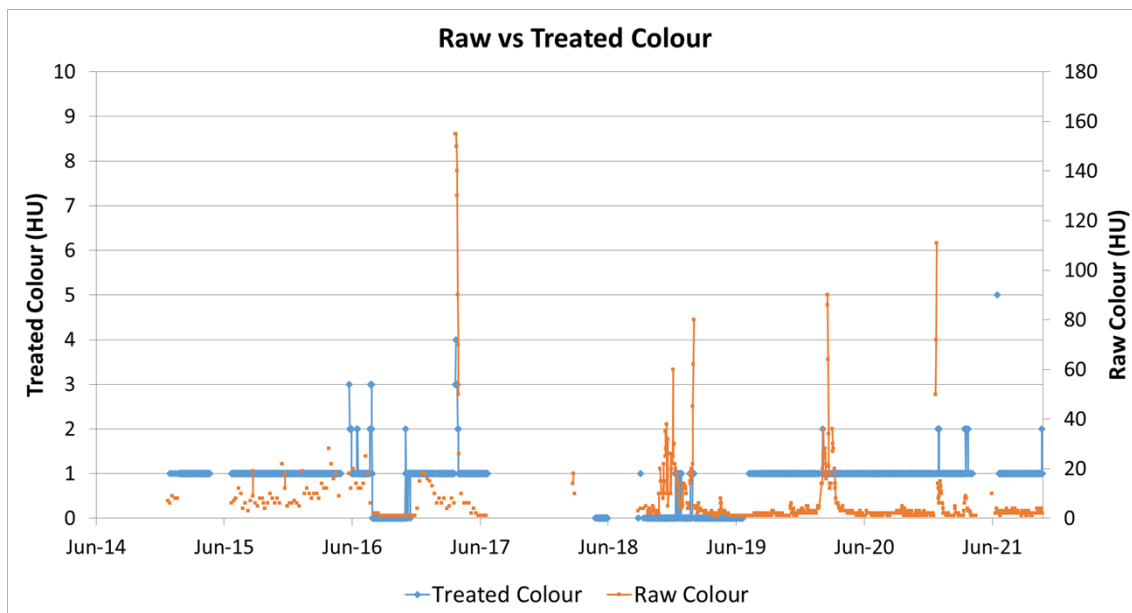
Figure 0-3, Figure 0-4 and Figure 0-5 show levels for colour, manganese and iron in the raw and treated water at Carmila. All three parameters show elevated levels in early to mid 2017. Colour falls well below the ADWG guidelines while iron and manganese experienced a brief spike above the ADWG thresholds in June 2021, seemingly independent of the raw water concentrations.

Figure 0-3: Carmila Raw and Treated Water Colour

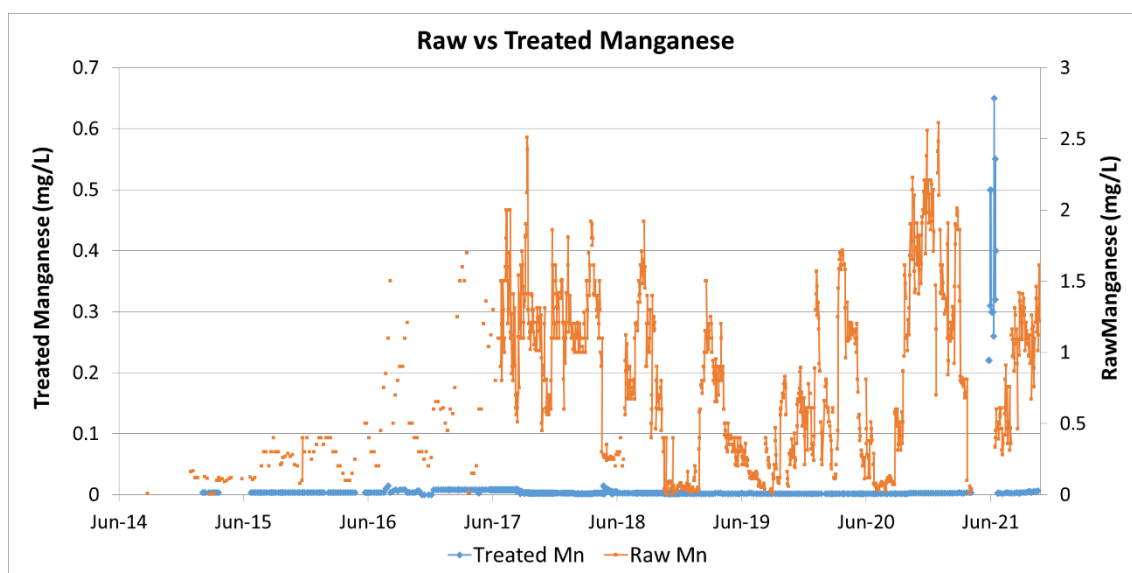
Figure 0-4: Carmila Raw and Treated Water Manganese

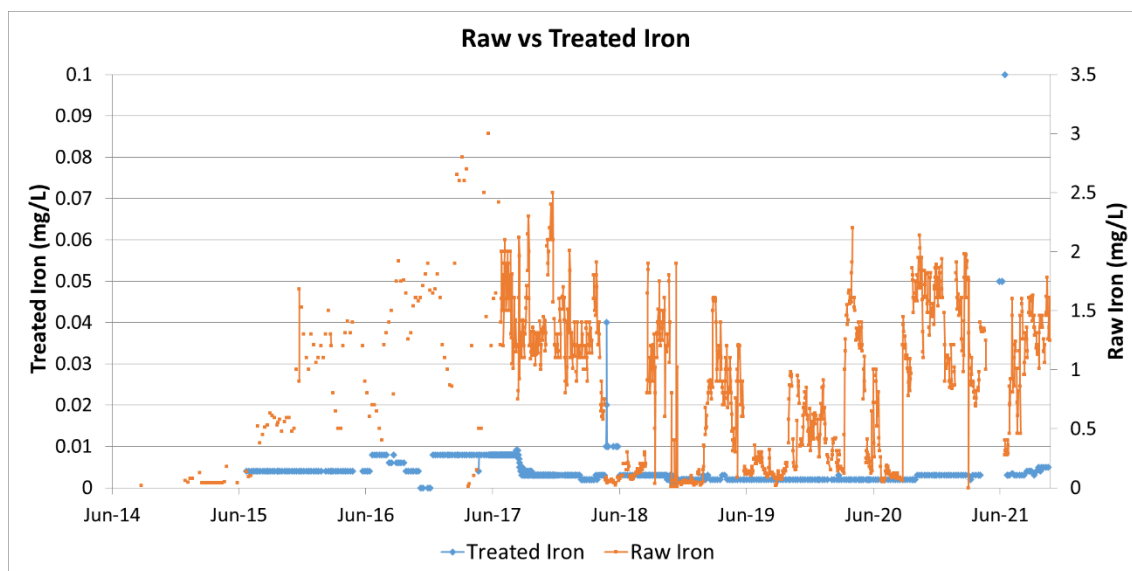
Figure 0-5: Carmila Raw and Treated Water Iron

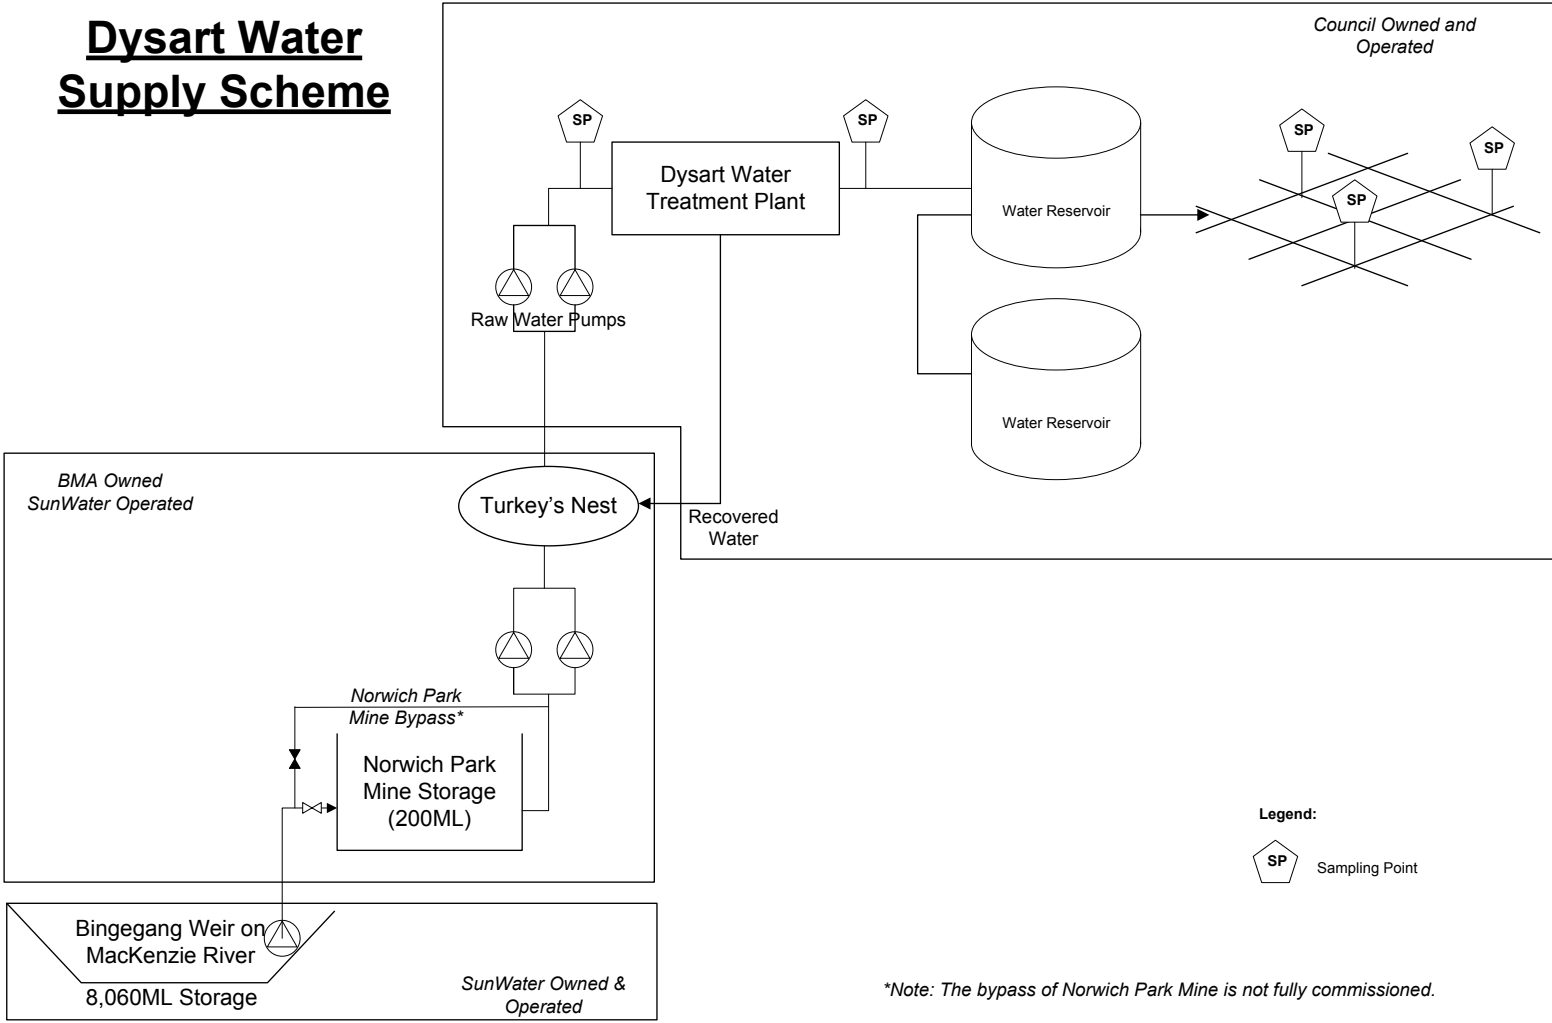
Figure 0-1: Dysart Overall Water Supply Scheme

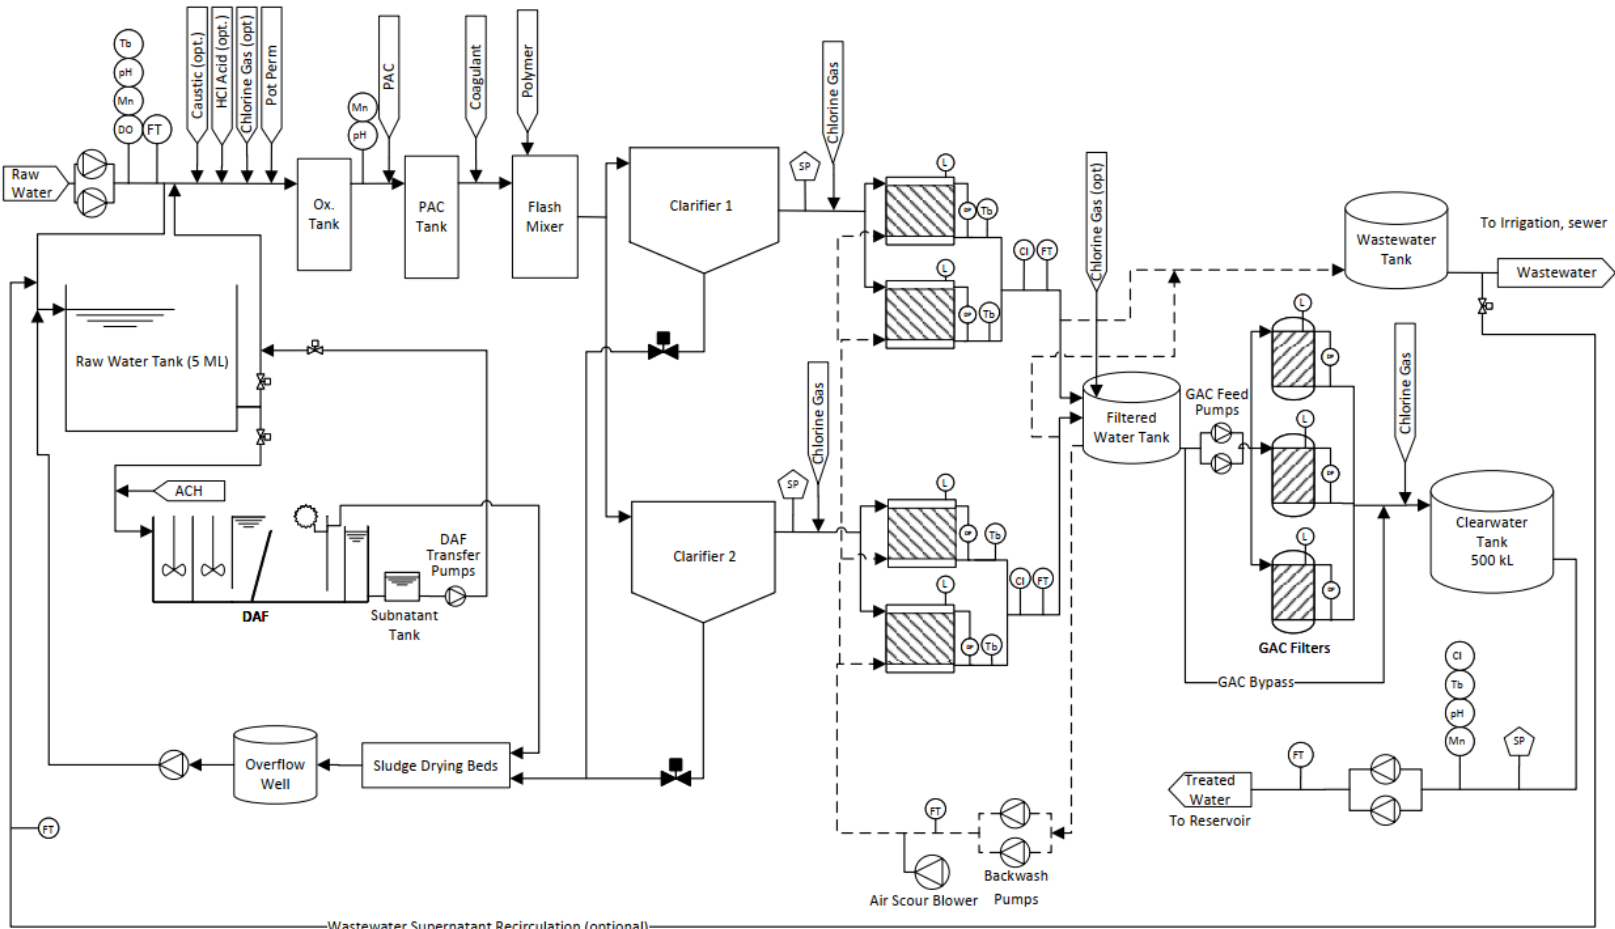
Figure 0-2: Dysart Water Treatment Plant

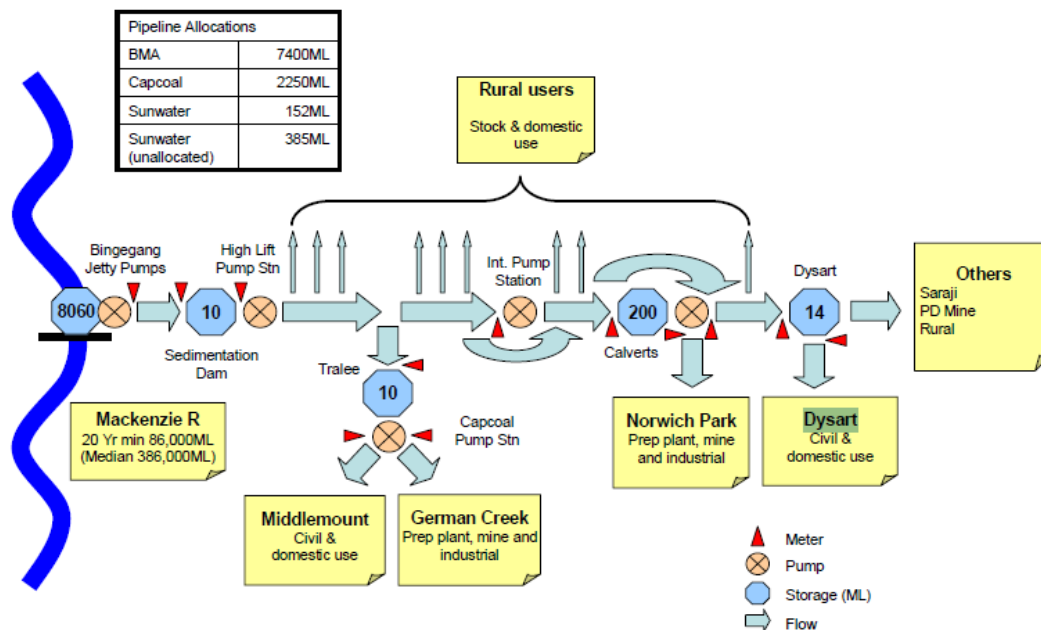
The raw water pipeline between the Binglegang Weir and BMA's Norwich Park Mine is 134 km long and has a diameter of 375-395 mm. There are six pump stations along this pipeline. This pipeline supplies various other users including mines, farms and Middlemount WTP. The diagram below is a schematic showing storage, pump and user information.

Figure 0-4: Bingegang Weir Water Allocations<sup>27</sup>

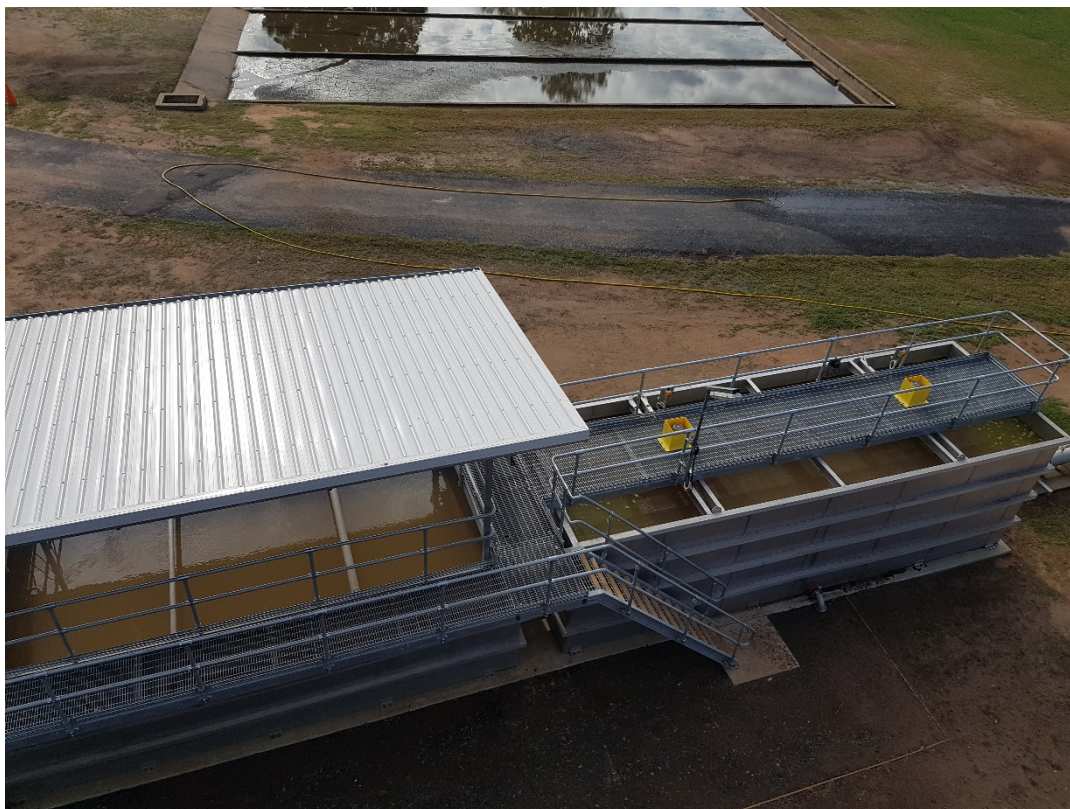
During periods of elevated algae concentrations in the raw water, DAF can be used to remove cells prior to the rest of the conventional treatment process. The DAF unit consists of 2 flocculation stages and a flotation chamber with float scraper. Raw water is dosed with ACH prior to the flocculation tank to improve float formation and integrity.

*Figure 0-5: DAF Unit at Dysart WTP*

The float is removed periodically based on a timer and drains to a sludge tank before being pumped to the sludge drying beds. DAF supernatant is pumped back into the raw water main upstream of the raw water dosing points and oxidation tank.

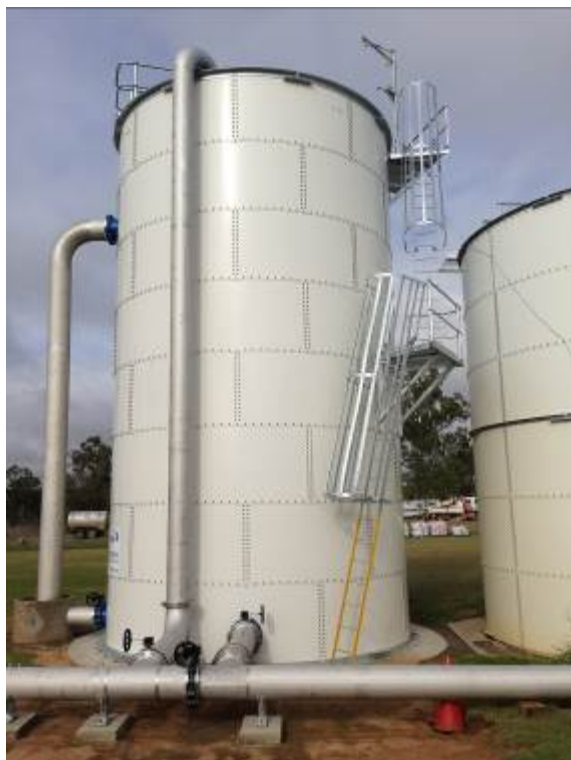
Potassium permanganate is dosed into the raw water main upstream of the new oxidation tank. Potassium permanganate is a strong oxidant dosed to oxidise any soluble metals present in the raw water, particularly iron and manganese. The oxidation tank provides 20 minutes contact time at maximum flow and employs a mechanical mixer for improved chemical distribution and contact efficiency. Potassium permanganate is part of a multi-barrier treatment approach to removing manganese.

Figure 0-6: Oxidation Tank

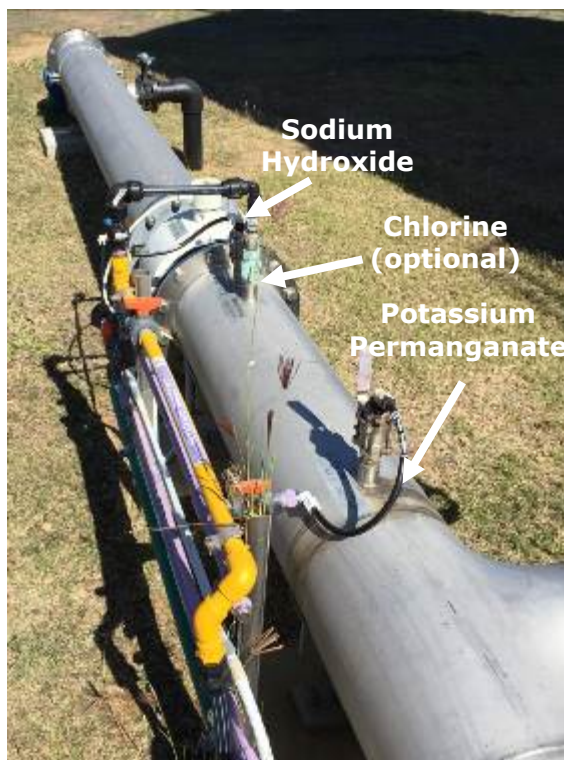
Dysart WTP also has an optional chlorine gas dose point prior to the oxidation tank for removal of iron and manganese (see Figure 0-7). This dose point is not currently used to minimise the risk of releasing cyanotoxins from the high levels of algae in the raw water or forming disinfection by-products from reaction with organics.

Figure 0-7: Potassium Permanganate Dosing Point

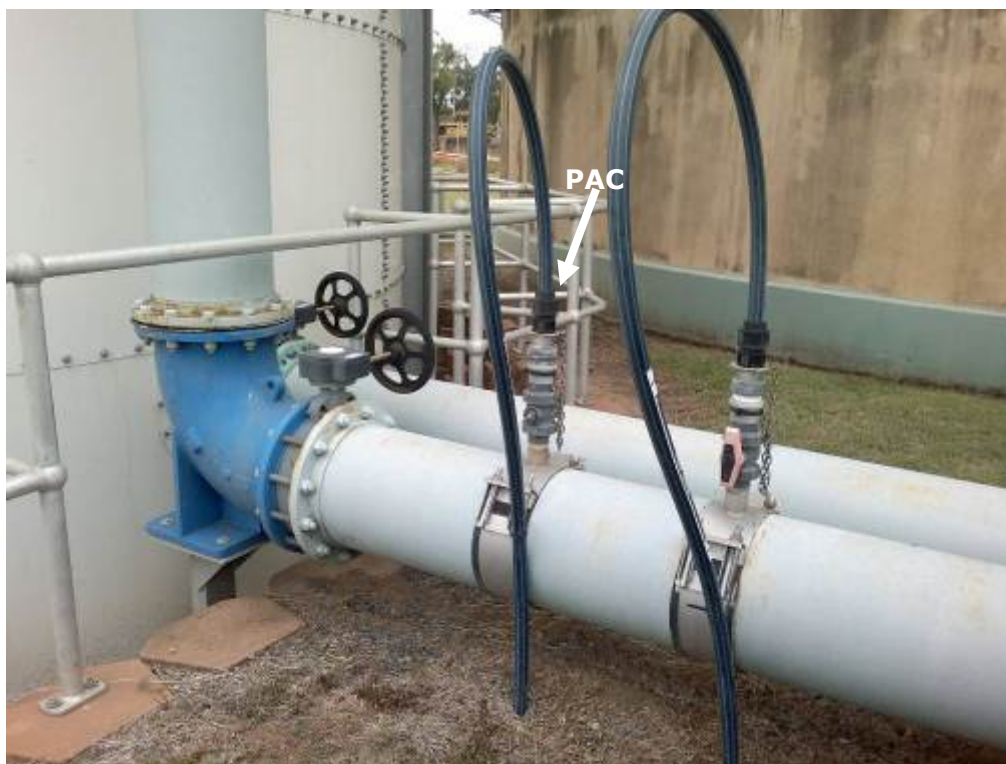
PAC is dosed into the raw water upstream of the PAC contact tower. PAC dosing is intended to prevent taste and odour issues caused by cyanotoxins, MIB and Geosmin from algal growth in the upstream dams. Dysart WTP has a PAC batching and dosing system with duty/ standby dosing pumps that are equipped with auto-changeover on fault through the plant SCADA. Two dose points are available upstream of the contact tank for PAC dosing, however the injection point closest to the tank inlet is currently used.

*Figure 0-8: Dosing Points on Contact Tank Inlet*

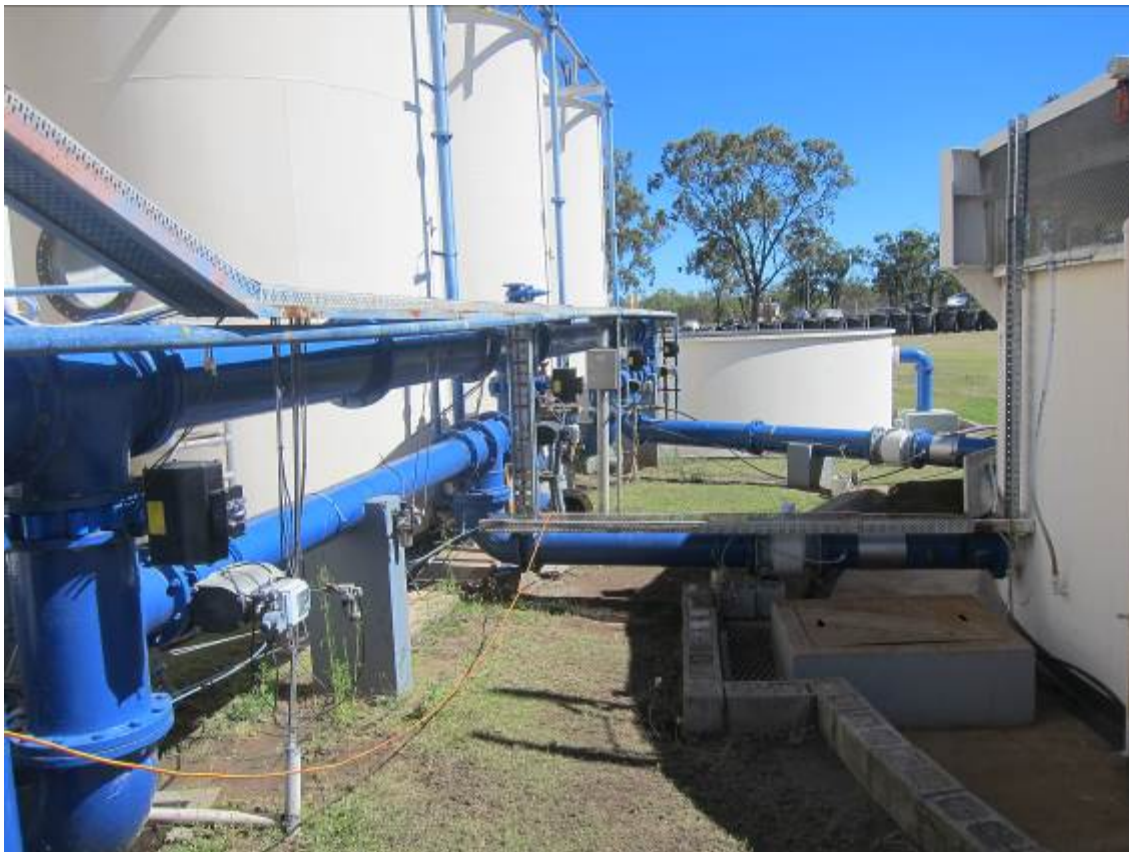
The clarified water flows into four dual media filters (two filters dedicated to each clarifier) by gravity. The filter pressure differential, level and individual outlet turbidity and chlorine residual is continuously monitored. The backwash sequence is initiated either manually by the operator or automatically based on pre-programmed set points that are operator adjustable through the SCADA system. Backwash triggers include run time, headloss and turbidity.

*Figure 0-9: Filtered Water Manifold to Clearwater Tank*

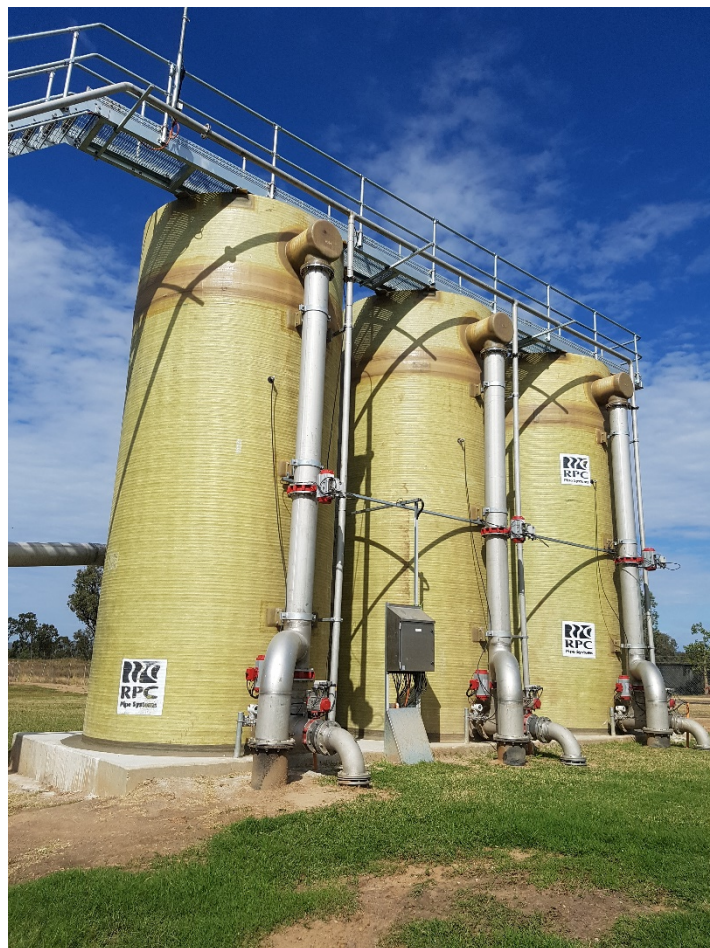
During periods of elevated algae and/or organics concentrations in the raw water, the filtered water is also passed through 3 GAC filters. Filtered water from the dual media filters is pumped from a filtered water tank to the GAC filters. GAC is used as a polishing step to remove any residual organic contaminants such as algal toxins and trace taste and odour compounds. The filter pressure differential and level are continuously monitored.

The backwash sequence is initiated either manually by the operator or automatically based on pre-programmed set points that are operator adjustable through the SCADA system. Backwash triggers include run time and headloss.

Figure 0-10: GAC Filters

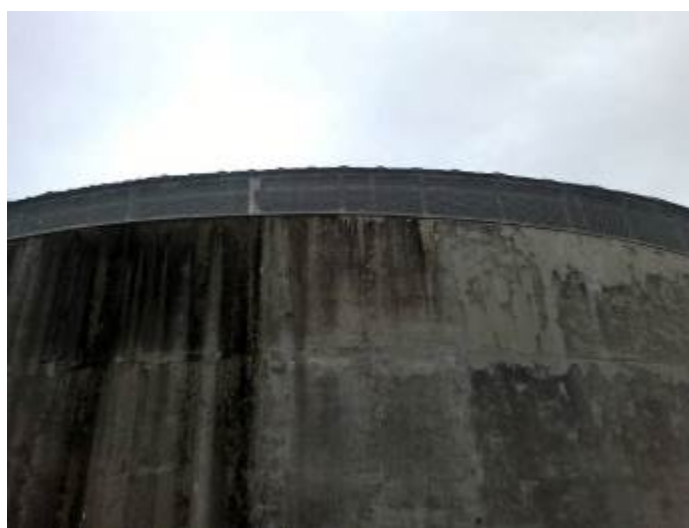
*Figure 0-11: Dysart Treated Water Reservoir*

Volume	5.25 ML	3.75 ML
Materials of construction	Concrete	Concrete
Roof	Yes	Yes
Vermin-Proof	Yes	Yes

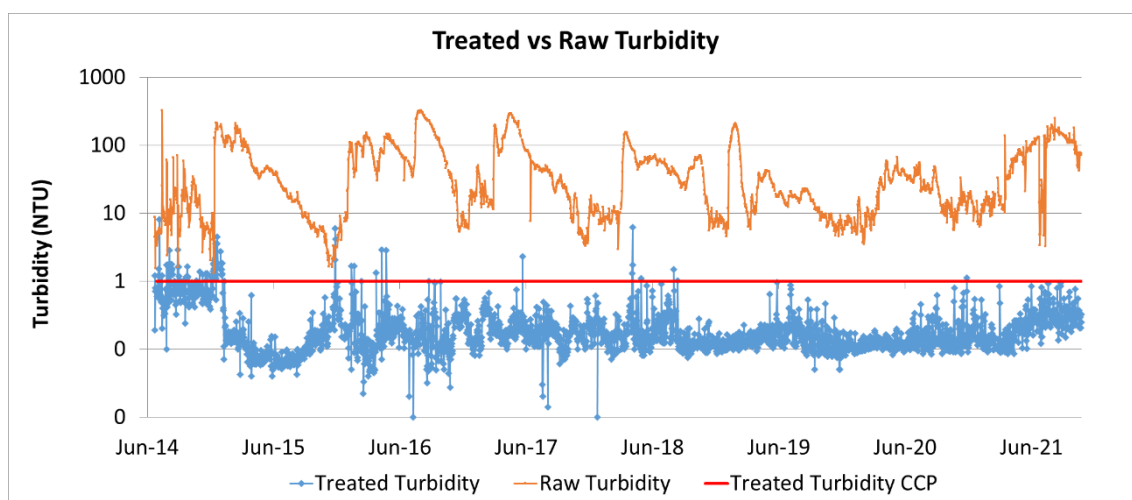
Figure 0-1: Dysart Raw and Treated Water Turbidity

The following figure shows raw and treated water data on a logarithmic scale. The turbidity in the raw water is seen to fluctuate significantly. From early 2015 a significant improvement in treated water turbidity is observed with some spikes, particularly in summer months. Improvement in treated water quality relates to the finalisation of the new filter commissioning and overall optimisation of the upgraded WTP. Spikes in treated water turbidity relate to poor water quality from significant algal blooms (2016/17 summer) and tropical cyclone and associated storms in April 2018. Raw turbidity has seen a somewhat seasonal increase in turbidity from January 2020 to present, with a corresponding effect on treated water turbidity, although this has managed to be maintained below the CCP limit.

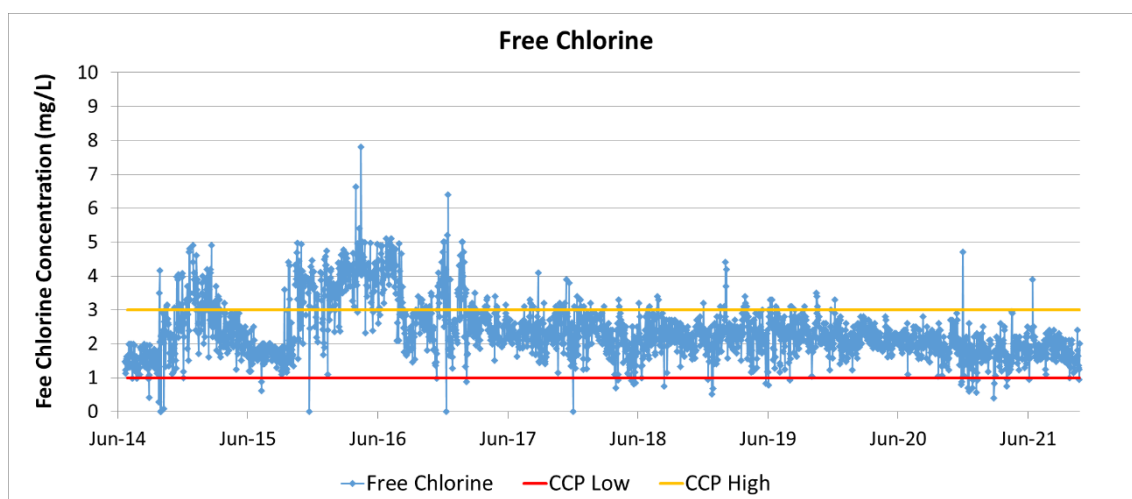
Figure 0-2: Dysart Treated Water Free Chlorine

Figure 0-2 shows free chlorine residual in treated water at Dysart. Historically there has been significant variation in residual level with a trend of very high chlorine residual observed from late 2015 to July 2017. However, free chlorine results in the reticulation for this period are all within acceptable limits suggesting that the increased chlorine dose at the WTP is to cope with higher losses in the network. Increased and formalised network flushing and reservoir desludging would help to reduce chlorine doses to achieve required residuals at the extremities of the network. Chlorine residuals have remained more stable and generally within CCP bounds from July 2017 onwards.

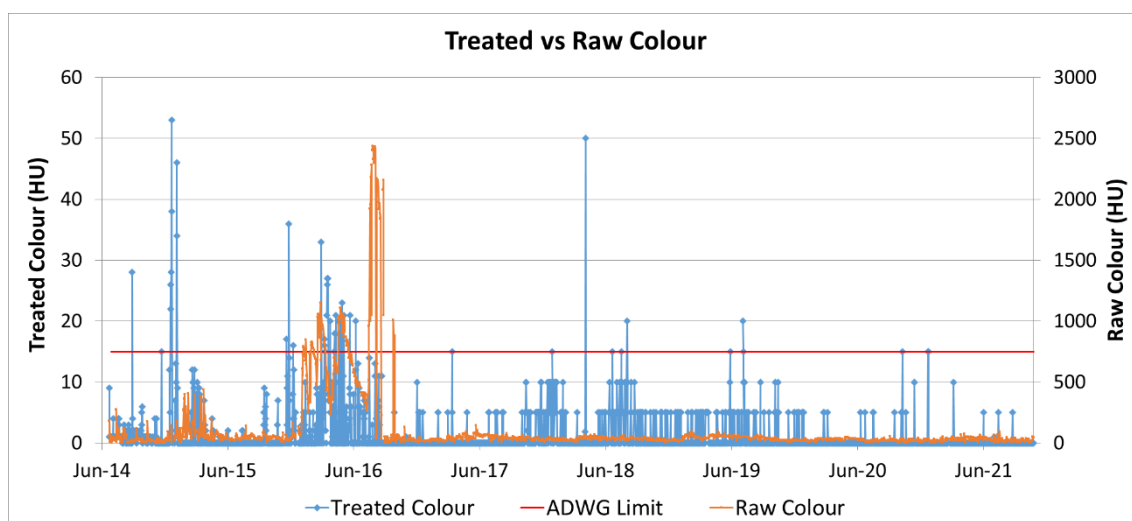
Figure 0-3: Dysart Raw and Treated Water Colour

Figure 0-3 shows raw and treated water levels for colour. Colour in the raw water is highly variable and significant peaks are observed in late 2016. Variability has also historically been observed in the treated

water colour however this has improved in recent years. With some spikes well above the ADWG aesthetic limit in December 2014, 2016, April 2018 December 2020 and June 2021.

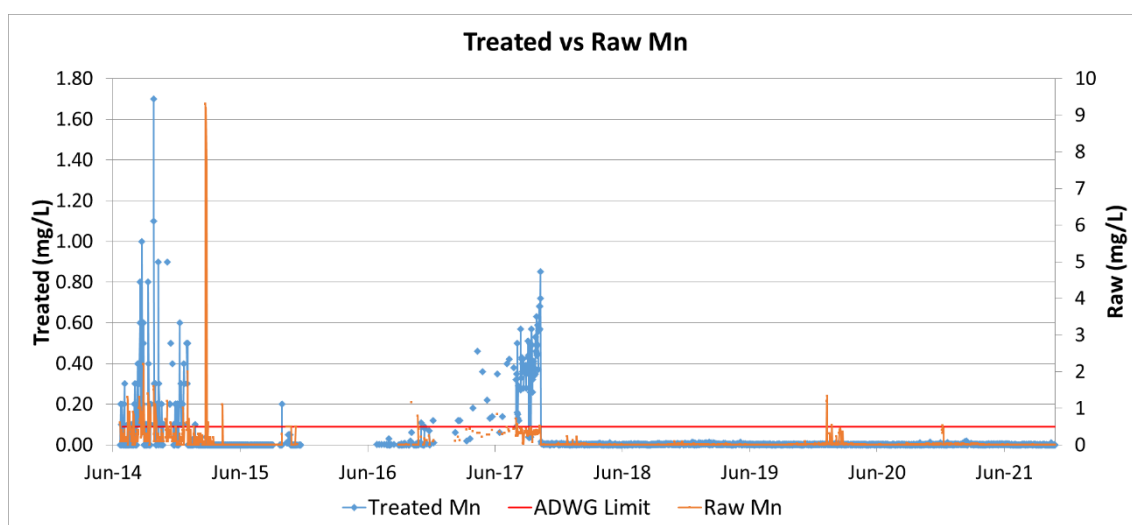
Figure 0-4: Dysart Raw and Treated Water Manganese

Figure 0-4 shows manganese levels in the raw and treated water at Dysart. Significant peaks in both raw and treated water are observed in 2014. Since this time, there have been far fewer exceedances of the ADWG limit. This can be attributed to the upgrade of Dysart WTP to incorporate potassium permanganate dosing when required and a major upgrade of the filters. There was a small spike in raw water manganese in January 2020 but had no observable effect on treated water manganese concentrations.

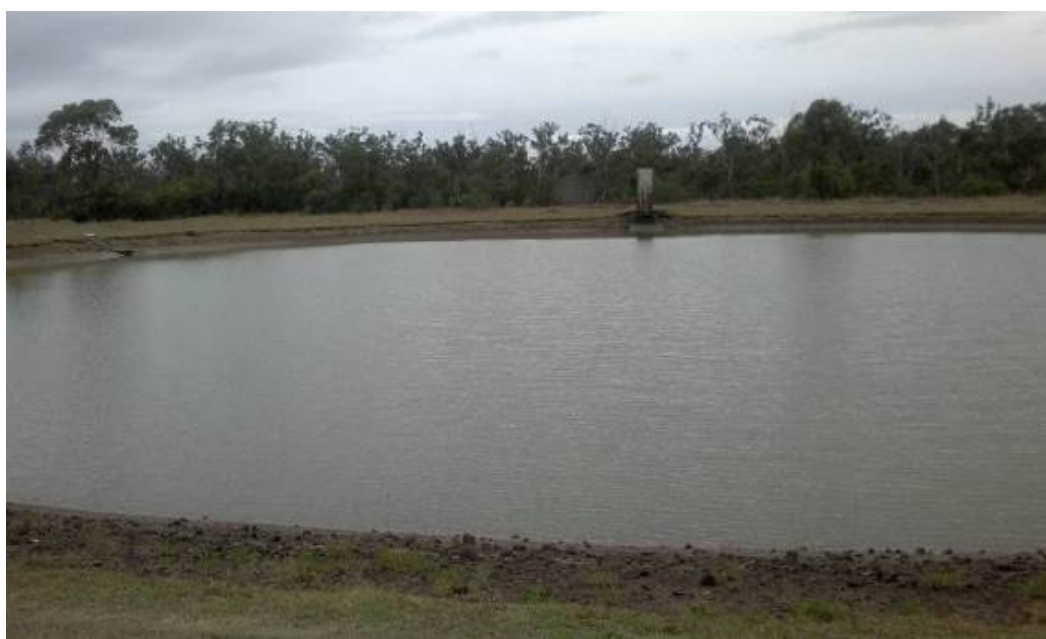
Figure 0-3: Middlemount Raw Water Turkey's Nest

There is one Turkey's Nest at the WTP which stores up to 10 ML of raw water. An aeration system has been installed in the turkey's nest dam to help manage influent water quality and minimise algal blooms.

The raw water from the turkey's nest is used to feed the Middlemount WTP. The turkey's nest at Middlemount is operated by Council and because the turnover rate of water is higher, algal growth is not a major problem (unlike downstream at Dysart). However large and more frequent blooms have been experienced in recent years, leading to treatment upgrades at the WTP including an aerator in the dam and additional chemical dosing.

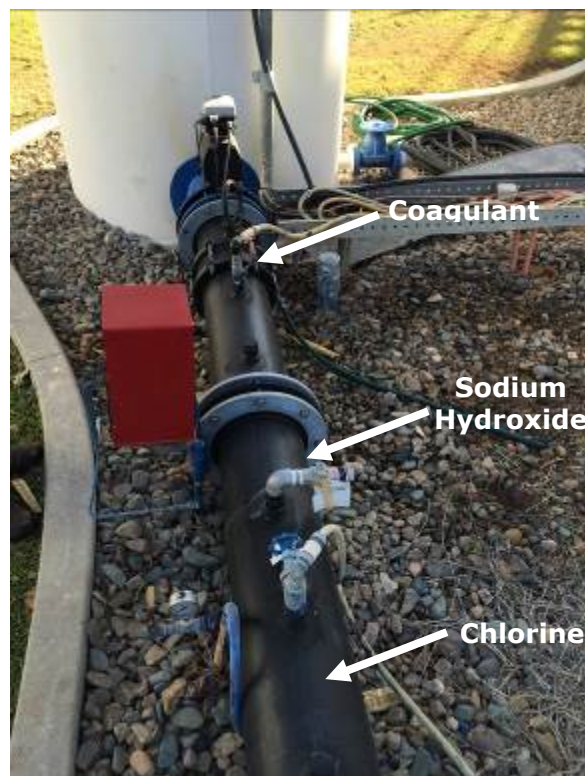
*Figure 0-4: Dosing Points on Flash Mixer Inlet*

The flash mixer tank has baffles which promote turbulent mixing of the raw water and coagulant.

Water flows by gravity from the flash mixer to the flocculation chamber in the centre of one of two clarifiers. Flow to each clarifier is evenly split by a manually adjusted valve. Polymer is dosed at the inlet to each clarifier to improve coagulation.

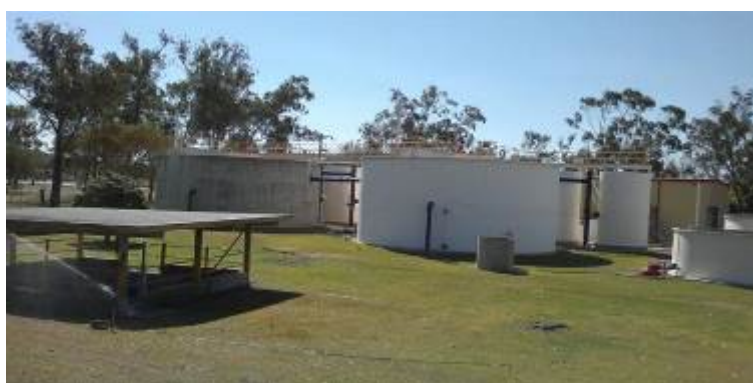
*Figure 0-5: Middlemount Clarifiers and Sand Filters*

There are two clarifiers at Middlemount, one constructed of welded steel and the other of concrete. Based on visual inspection the internal surfaces of the clarifiers appear to be in poor condition. The internal painted surface of the steel clarifier is peeling and risks blocking the sludge outlet. Structural integrity of the clarifier is also unknown as the deterioration of the protective coating may have enabled pitting and corrosion. The internal surface of the concrete clarifier is also in poor condition with the smooth cement finish eroded in some areas. The external surfaces, structures and ancillaries appear to be in good condition with no signs of deterioration.

Sludge is released by opening an air-actuated de-sludge valve at the bottom of the clarifier. The de-sludge valve opens automatically based on an operator adjustable timer setting. Blowdown is currently scheduled to occur for ~30 seconds every 10 minutes.

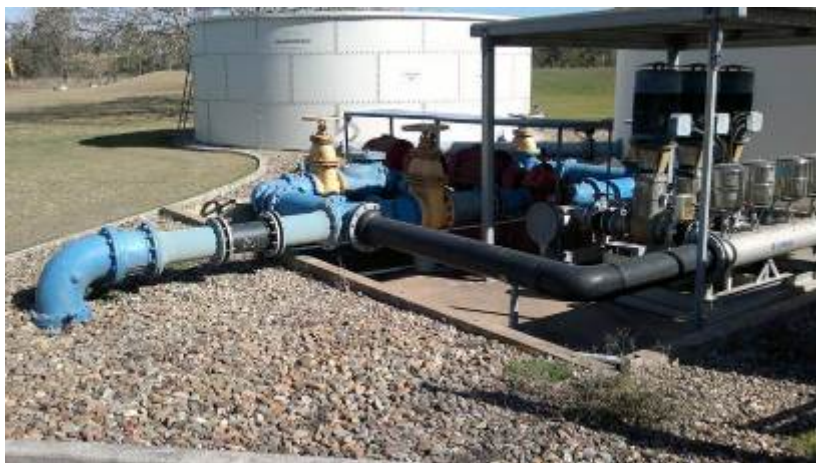
*Figure 0-6: Middlemount WTP Lift Pumps*

There are two Clearwater tanks which are hydraulically linked and only one of them is usually in use. From the clear water tanks, water is pumped by a set of pressure pumps to a high level reservoir. The old centrifugal pumps remain as a standby system in the event of duty pumps failure.

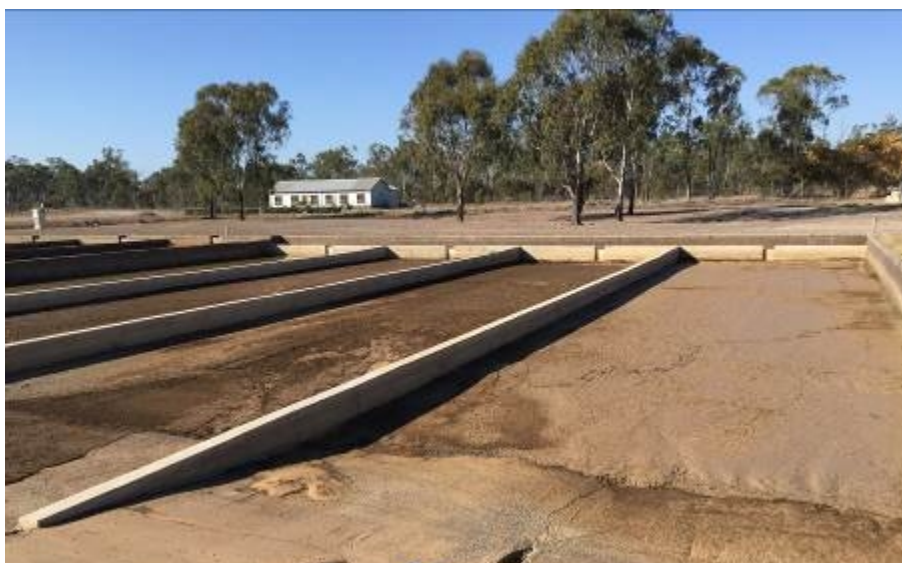
Figure 0-7: Sludge Drying Beds

There is also a 6 kL wastewater pump station with programmed operating modes that directs wastewater to appropriate onsite uses. Supernatant can be used for irrigation directly from the Backwash Recovery Tank,

settled sludge is pumped to the sludge drying beds and remaining supernatant can be recycled back into the raw water turkey's nest dam.

Clarifier sludge is sent to the sludge drying beds. A decant pump located at the drying beds, recycles supernatant to the raw water turkey's nest.

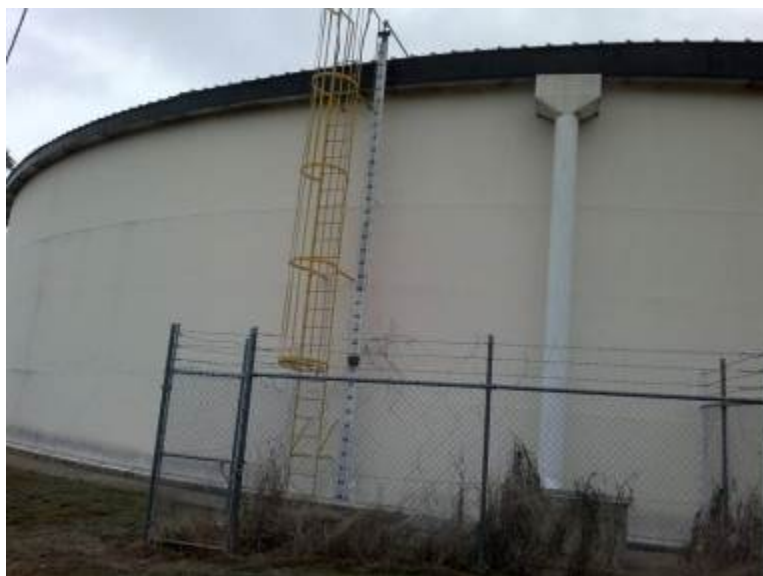
*Figure 0-8: Middlemount Treated Water Reservoir*

Volume	8 ML
Materials of construction	Steel
Roof	Yes
Vermin-Proof	Yes

The Middlemount Reservoir has a common inlet/ outlet arrangement. This configuration could risk short circuiting of flow and insufficient chlorine contact time for effective disinfection.

additional pressure boosting is required. The reservoir site is fenced, and the reservoir roof is enclosed. Some areas of corrosion are present on the reservoir roof.

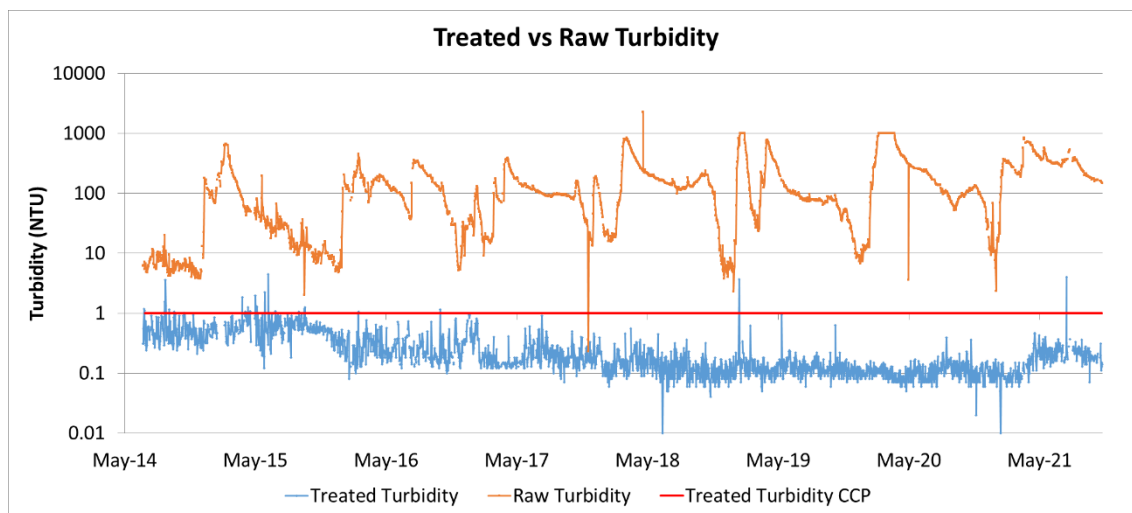
Figure 0-1: Middlemount Treated and Raw Water Turbidity

Figure 0-1 shows raw and treated water turbidity for Middlemount WTP on a logarithmic scale. Raw water turbidity is seen to be highly variable, however treated water turbidity generally remains below the CCP limit. Slightly improved turbidity removal is observed from late 2015 onwards. There was recently a single treated water turbidity exceedance of >1 NTU in July 2021.

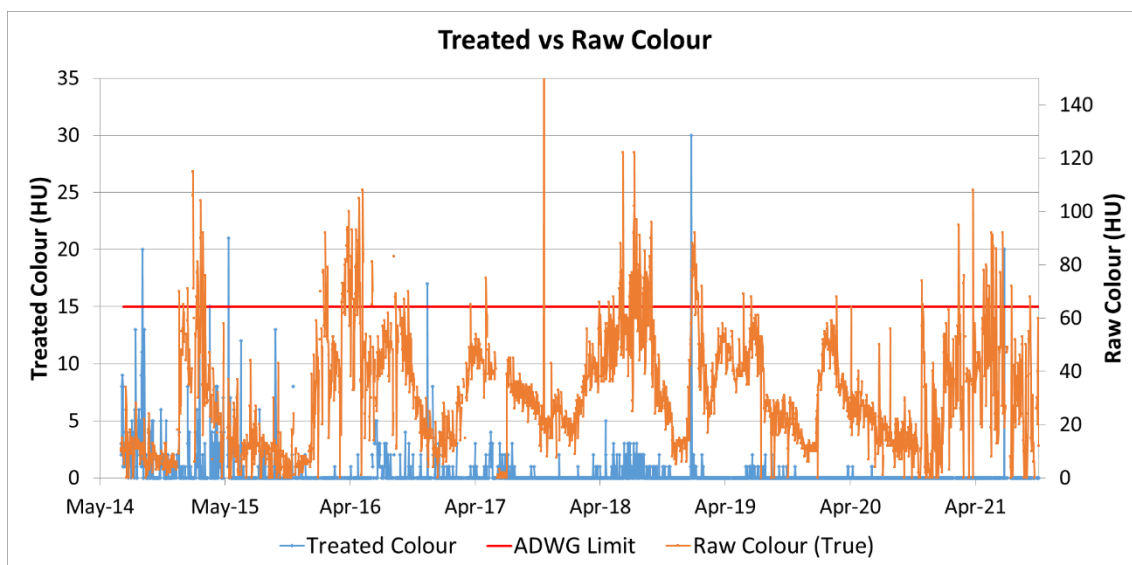
Figure 0-2: Middlemount Treated and Raw Water Colour

The figure below shows raw and treated water colour for Middlemount. True colour in the raw water is seen to vary, however does not show extreme peaks. Few exceedances of the treated water colour are observed over the last five years.

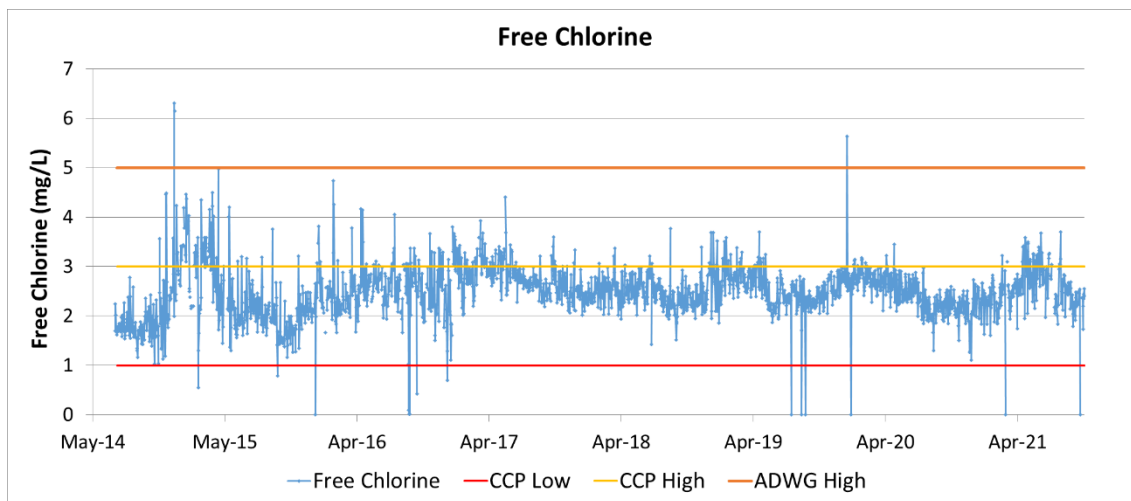
Figure 0-3: Middlemount Treated Water Free Chlorine

Figure 0-3 below shows free chlorine residual in the treated water for Middlemount. The residual is frequently observed to exceed the CCP limit of 3 mg/L. It is important to maintain a chlorine residual to all extremities of the reticulation; therefore it is usually preferable to maintain a slightly higher residual than to fall below the lower limit of the CCP. A review of the CCP limits for Middlemount has been included on the Improvement Plan and reservoir operating levels have been adjusted to minimise issues of residual maintenance in the short term.

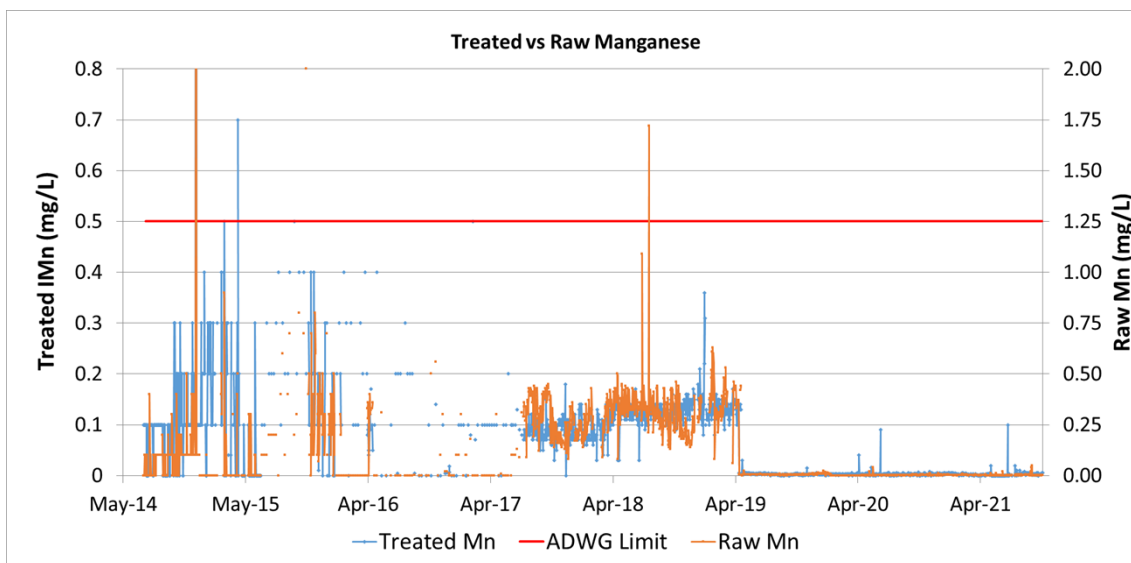
Figure 0-4: Raw and Treated Water Manganese Content

Figure 0-4 and Figure 0-5 show iron and manganese levels for the raw and treated water at Middlemount. The ADWG Limit is not shown on the iron graph as treated water levels were always well below the limit of 0.3 mg/L. There are a few significant spikes in the treated water manganese levels, however manganese has remained well below the ADWG health limit since 2015, despite some large spikes in raw water concentrations. Treated manganese levels have further dropped since June 2015 due to better management of the raw water and additional treatment processes being available at the WTP.
