# DRINKING WATER QUALITY MANAGEMENT PLAN

2021

Presented by: Water & Waste Directorate

This Drinking Water Management System document was compiled for Isaac Regional Council by project consultants:

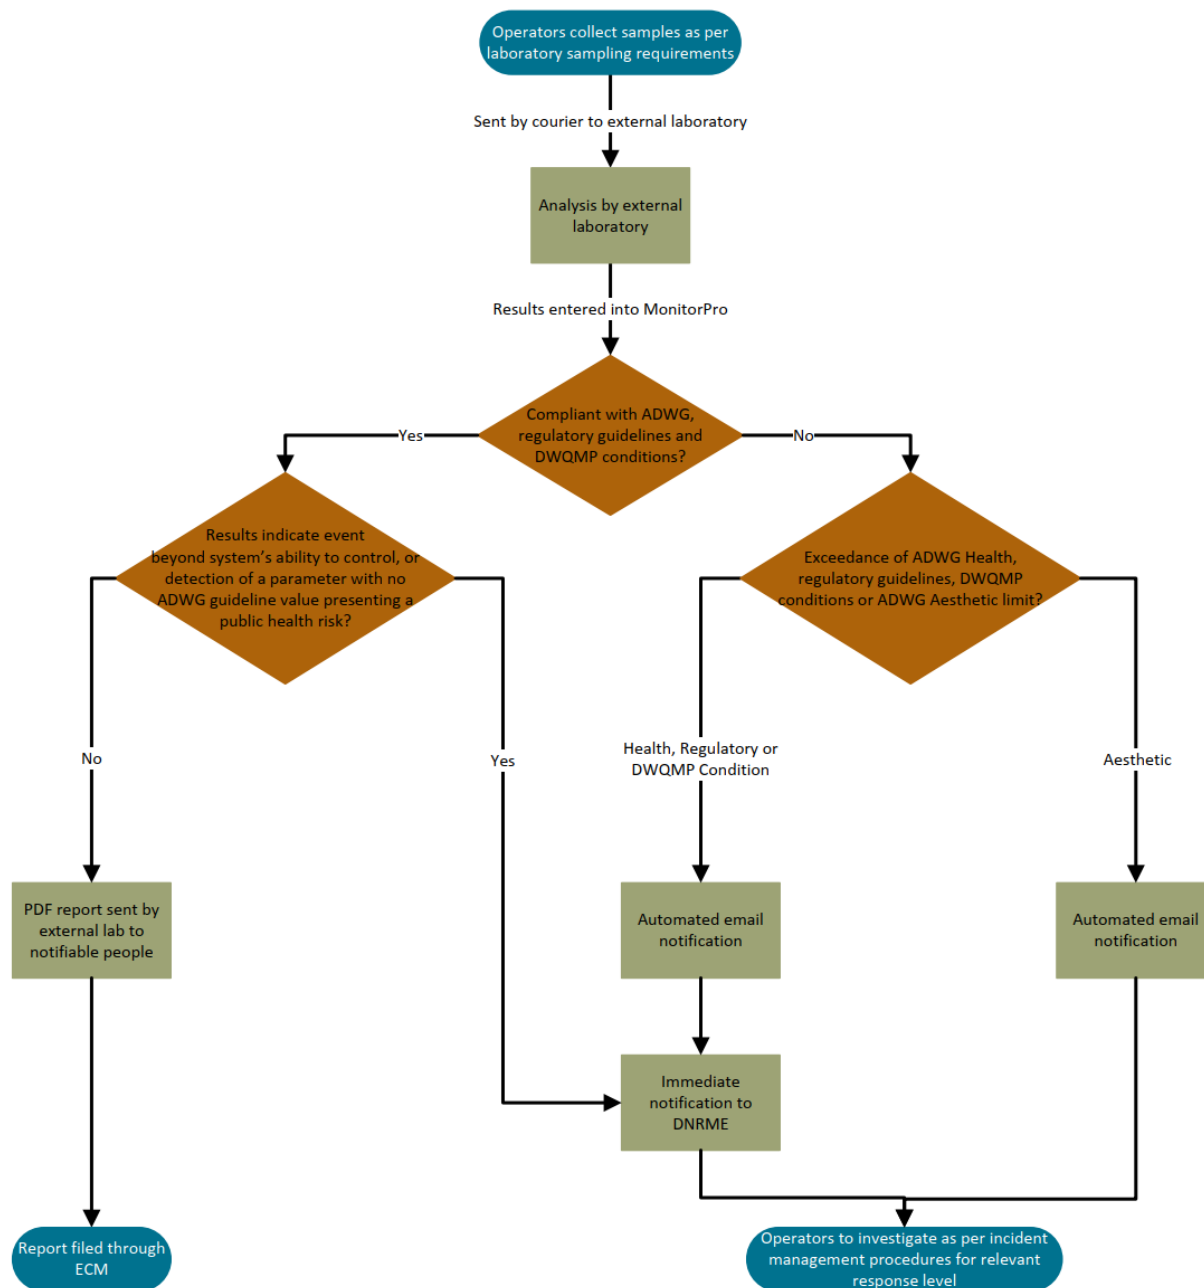
Figure 0-1: Current Verification Water Quality Test Reports Information Flow

The flow of information for the current verification procedure for water quality test reports is presented schematically in Figure 0-1.

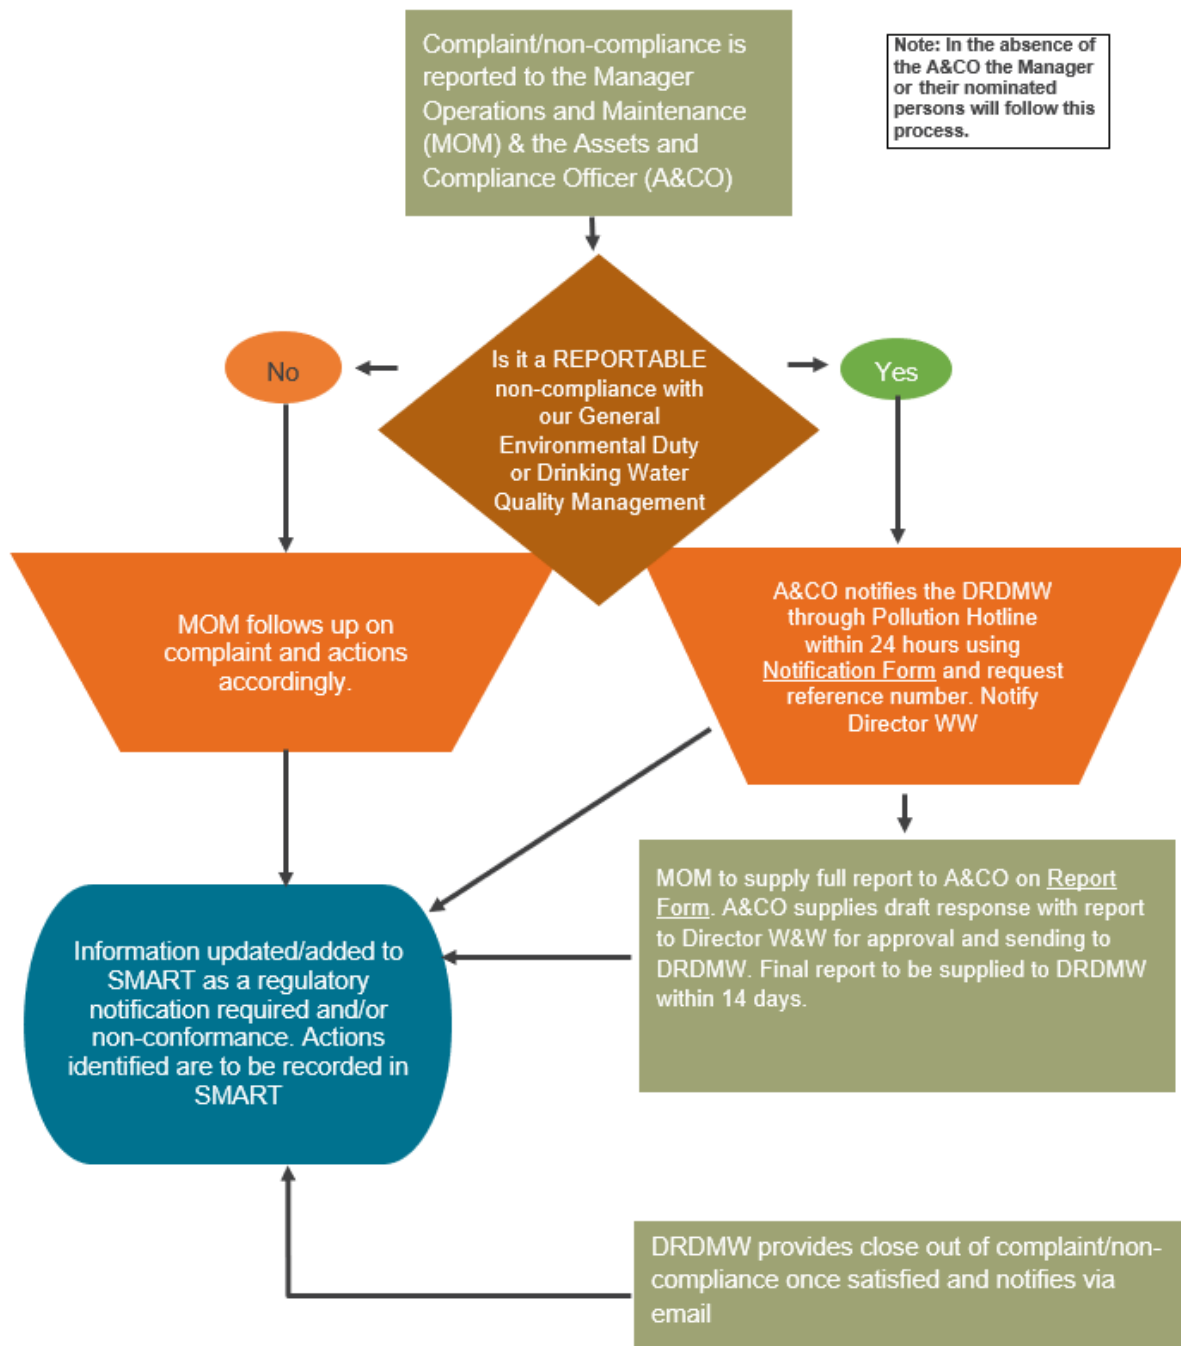
Figure 0-2: Non-Compliance Water and Effluent Water Reporting Process

In addition to the above flowchart, an additional procedure providing more details around the requirements for actioning complaints and investigating non-compliant water quality results has been developed. A summary of this procedure is presented as a flow chart in Figure 0-2.

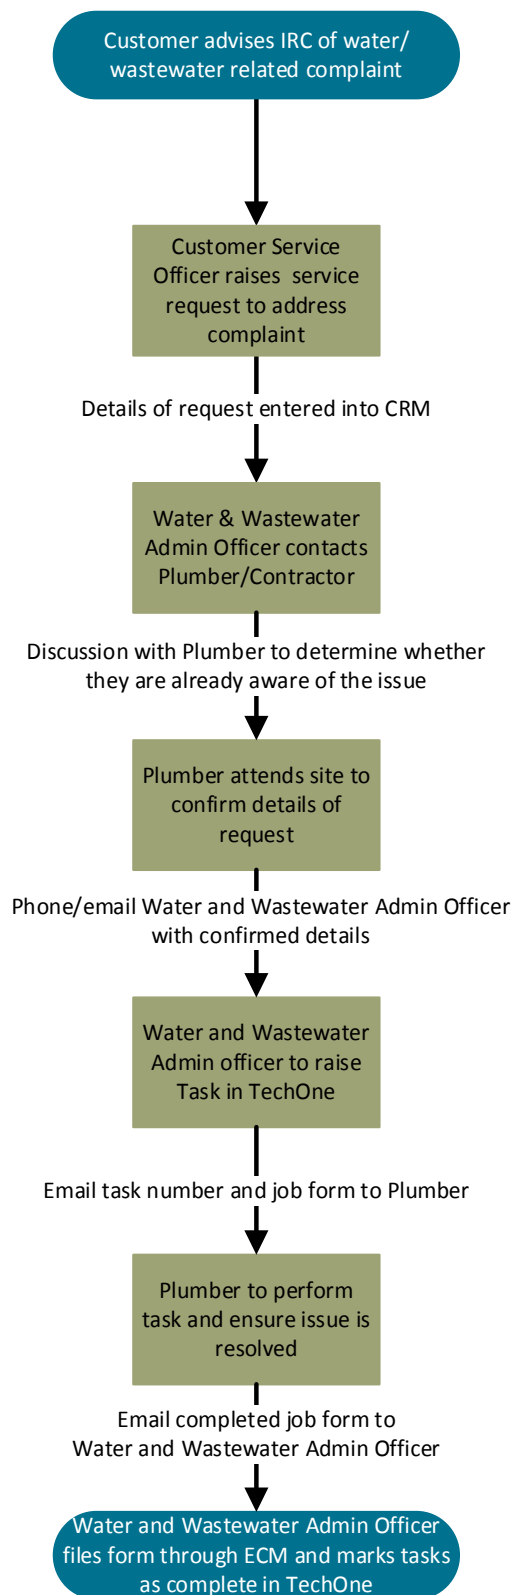
Figure 0-3 Complaint Processing Flow Diagram

Customer complaints are received at Council's offices during working hours. Afterhours enquiries and service complaints are diverted to after-hours duty officers. Figure 0-3 details the Council's complaints processing procedure.
